## AIRPROX REPORT No 2020019

Date: 03 Feb 2020 Time: 1122Z Position: 5239N 00218W Location: Cosford ATZ

### PART A: SUMMARY OF INFORMATION REPORTED TO UKAB

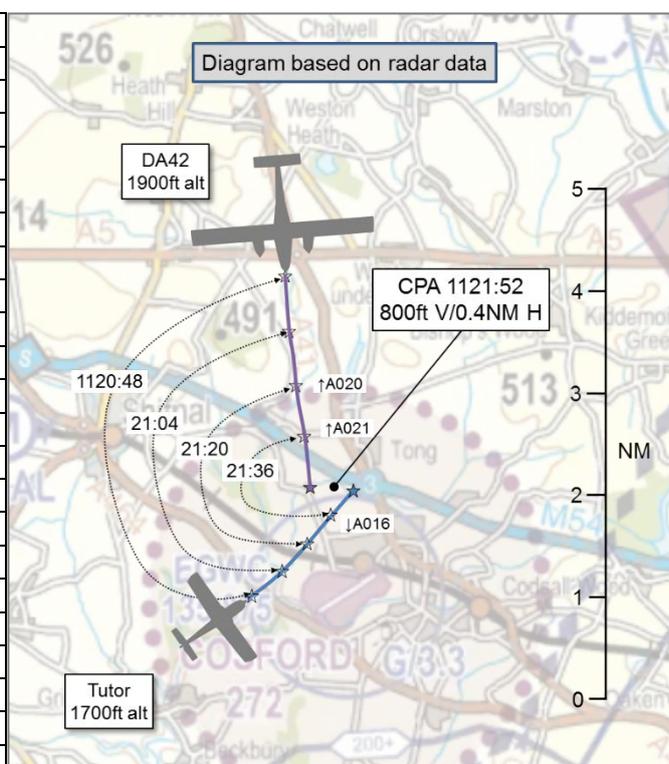
| Recorded | Aircraft 1 | Aircraft 2 |
|---|---|---|
| Reported | 100ft V/500m H | Not Seen |
| Recorded | 800ft V/0.4NM H | |

During the time leading-up to the Airprox, the DA42 pilot was in receipt of a Basic Service from Shawbury LARS. The NATS radar replay was examined and showed the aircraft tracking towards the Cosford overhead and maintaining 2000-2100ft from 1115:00 until CPA (1121:52). At CPA, the aircraft's SFL is seen to change from '20' to '23' and the aircraft climbs to exit the Cosford ATZ.
