AIRPROX REPORT No 2020026

Date: 08 Jan 2020 Time: 1047Z Position: 5135N 00039E Location: Southend CTR

PART A: SUMMARY OF INFORMATION REPORTED TO UKAB

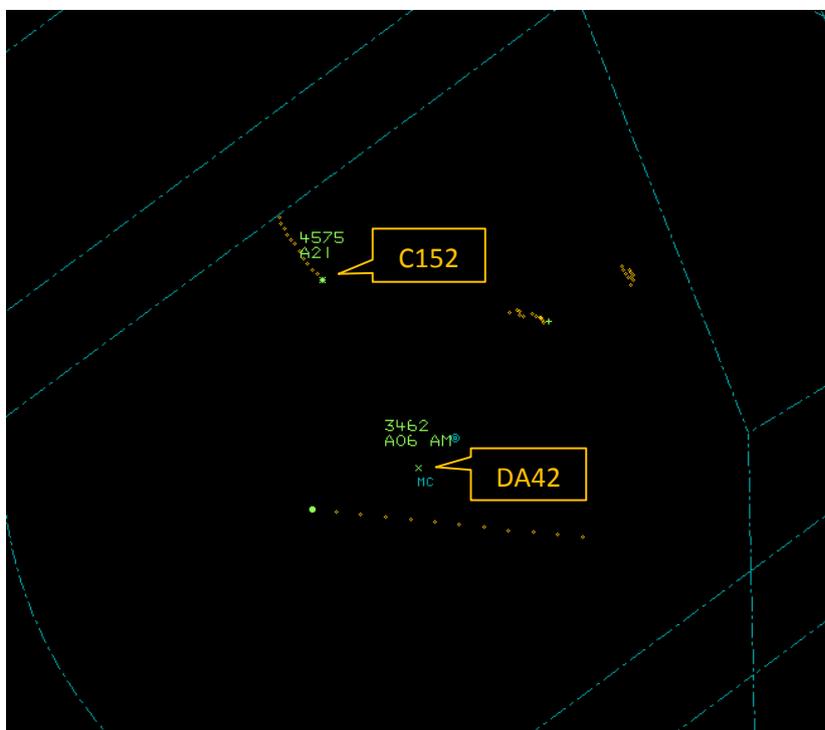
Figure 1 – 1045:51

The DA42 first became visible on the radar replay at 1045:51. The C152 was approximately 3NM NE of and tracking towards the Southend overhead (Figure 1).

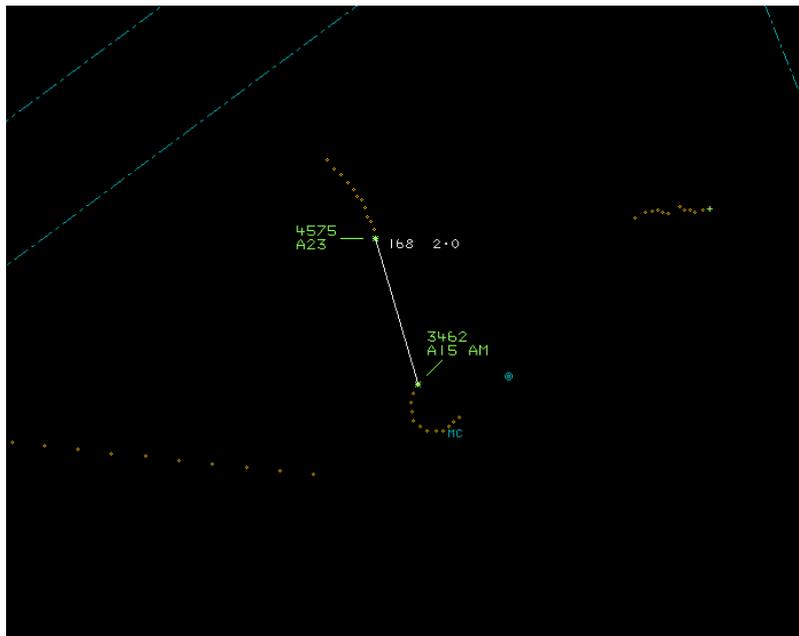
Figure 2 – 1046:35

The pilot of the DA42 reported receiving a clearance to the Clacton VOR, and this track (about 050°) can be seen in Figure 2 at 1046:35.

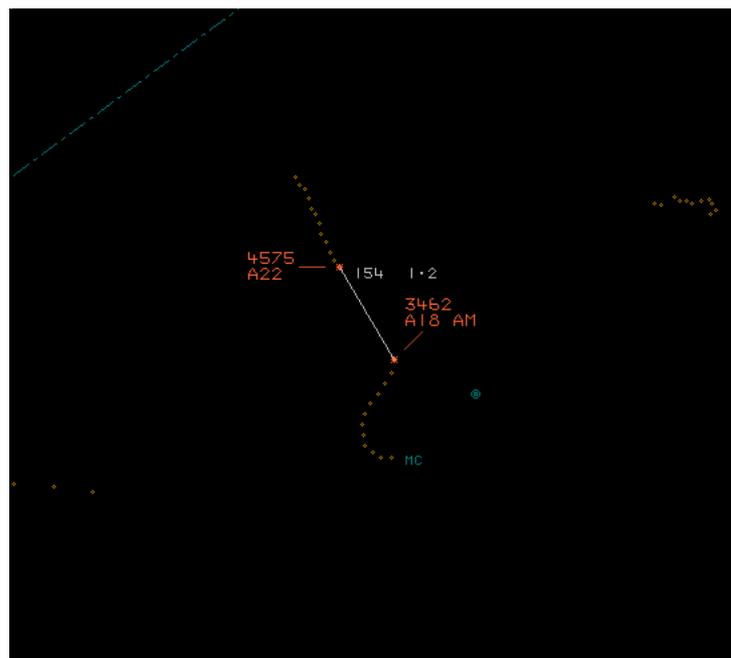
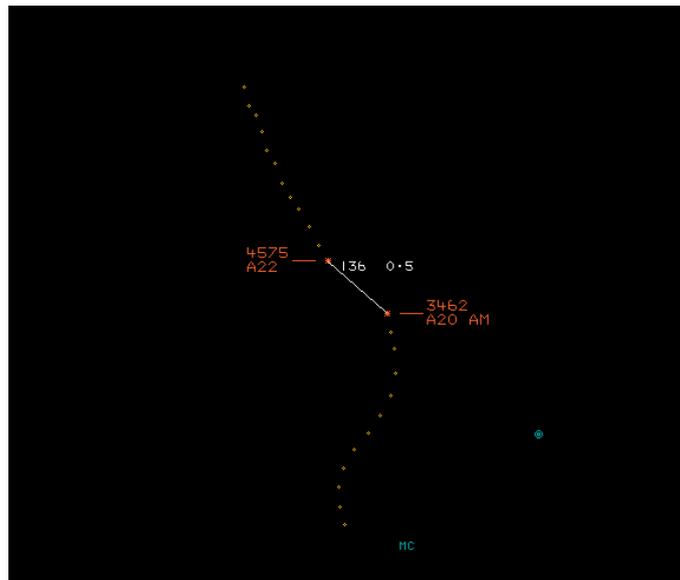
The pilot of the DA42 then reported hearing and responding to an instruction to turn left onto a heading of 270° (Figures 3-4).

Figure 3 – 1046:51 (NATS STCA initiated)

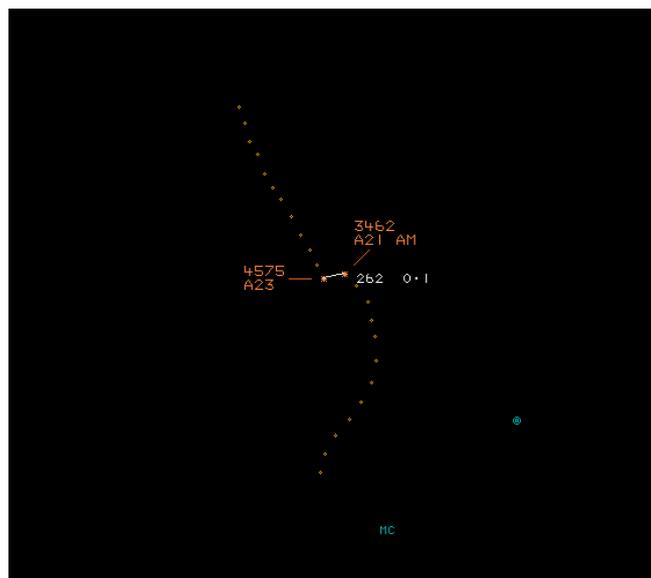
Figure 5 – 1047:11

CPA occurred at 1047:11, with the aircraft separated by 0.1NM and 200ft (Figure 5).

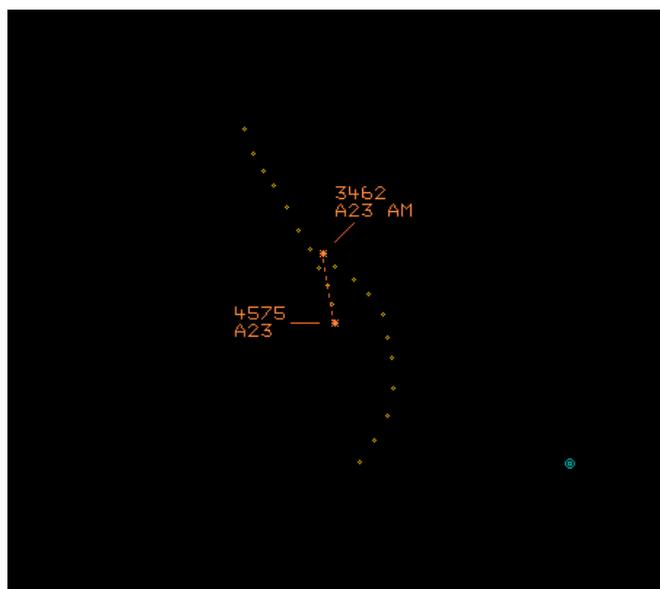
Figure 6 – 1047:22

The pilot of the DA42 reported not being sure as to whether they were still under the control of the Southend Tower controller, or if they were with the Radar controller at the time of the Airprox. They reported not receiving any Traffic Information on the C152 but becoming visual with it in sufficient time to make a right turn to avoid, as evidenced on the radar replay at 1047:22 (Figure 6).
