AIRPROX REPORT No 2020027

Date: 13 Mar 2020 Time: 1110Z Position: 5302N 00046W Location: 2NM S Newark

PART A: SUMMARY OF INFORMATION REPORTED TO UKAB

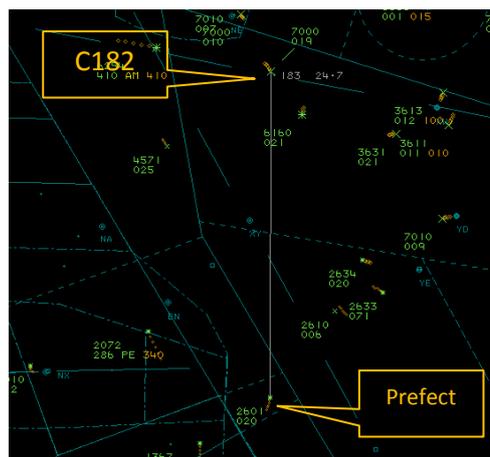
Figure 1

At 1105:45 (Figure 1) the Prefect was handed over to Cranwell Approach and placed under a Traffic Service. At this point separation between the Prefect and the C182 was in excess of 24NM.

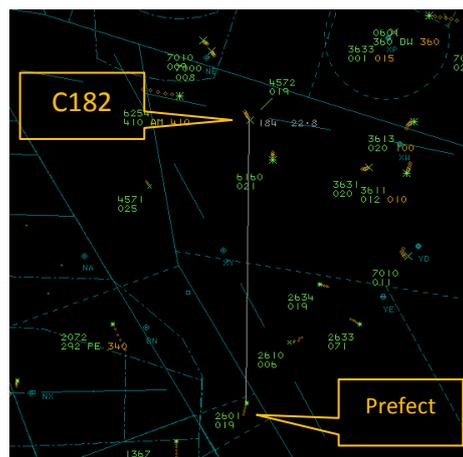
Figure 2

Over the next minute, the Cranwell Approach controller passed Traffic Information to the Prefect on another aircraft and it was during this time that the C182 changed their squawk to an East Midlands Listening Squawk (Figure 2). Separation at this point was in excess of 22NM.

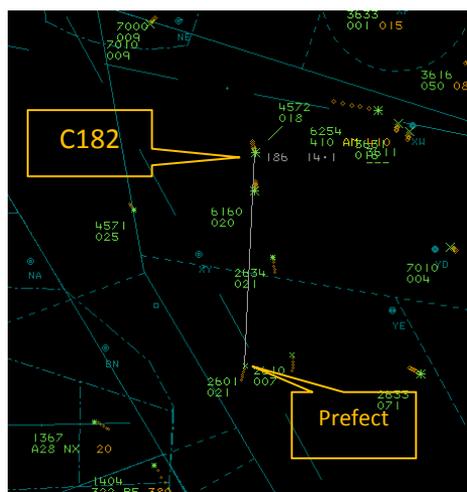
Figure 3

Over the next two minutes the Cranwell Approach controller's workload began to rapidly increase. Humberside attempted to handover a Phenom inbound to Cranwell but due to poor landline communications this handover became protracted and the Cranwell Approach controller advised Humberside to freecall the aircraft. In addition, Traffic Information was again passed to the Prefect pilot on another aircraft and a second Prefect pilot declared a Practice Pan, was given a steer for the airfield, and told to pass details when ready. Separation between the Prefect and C182 at this point had decreased to 14NM (Figure 3).

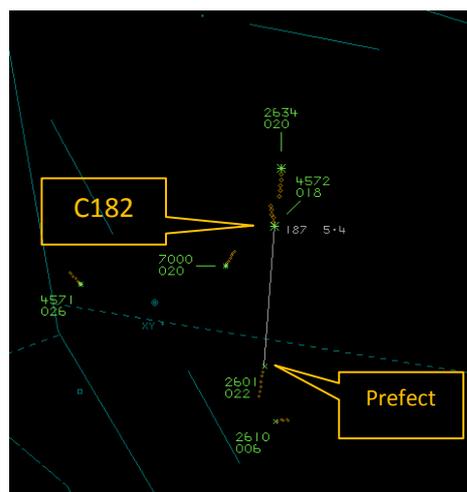
Figure 4

At 1109:14 the Phenom which had been the subject of the failed handover from Humberside freecalled for recovery, was identified, passed Traffic Information on a conflictor and vectored for sequencing. This RT exchange ended at 1109:54 by which point separation between the Prefect and C182 had decreased to 5.4NM (Figure 4).

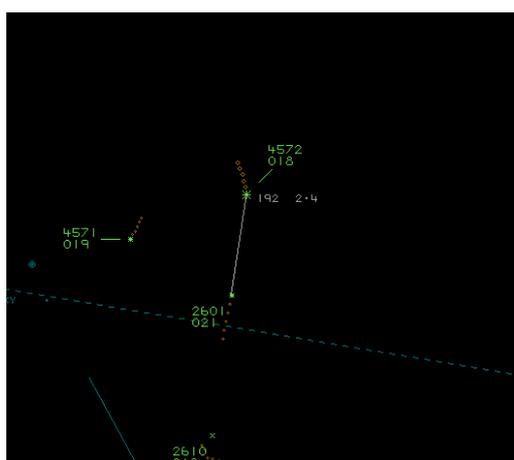
Figure 5

Nine seconds later, the Prefect pilot who had declared a Practice Pan began to pass details of the simulated emergency. This RT exchange took 22sec and on completion the Cranwell Approach controller immediately passed accurate Traffic Information to the incident Prefect on the C182 (Figure 5). This Traffic Information was passed at 2.4NM at which point the Prefect pilot reported being visual with the C182.

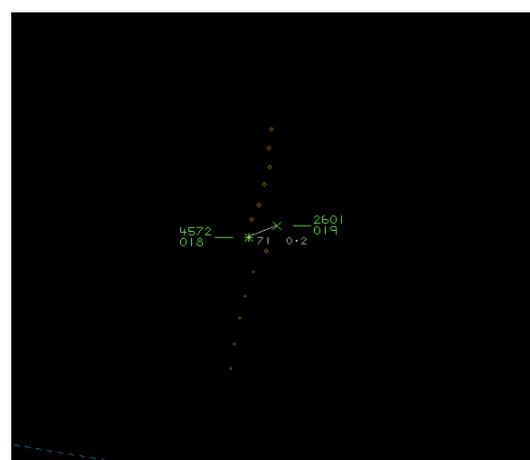
Figure 6 - CPA

CPA occurred 27sec after the Traffic Information was passed and was measured at 0.2NM and 100ft. The Prefect instructor reported taking control of the aircraft and manoeuvring away. This turn can be seen on radar.
