AIRPROX REPORT No 2020032

Date: 17 Mar 2020 Time: 1657Z Position: 5156N 00216W Location: 5NM NW Gloucester

PART A: SUMMARY OF INFORMATION REPORTED TO UKAB

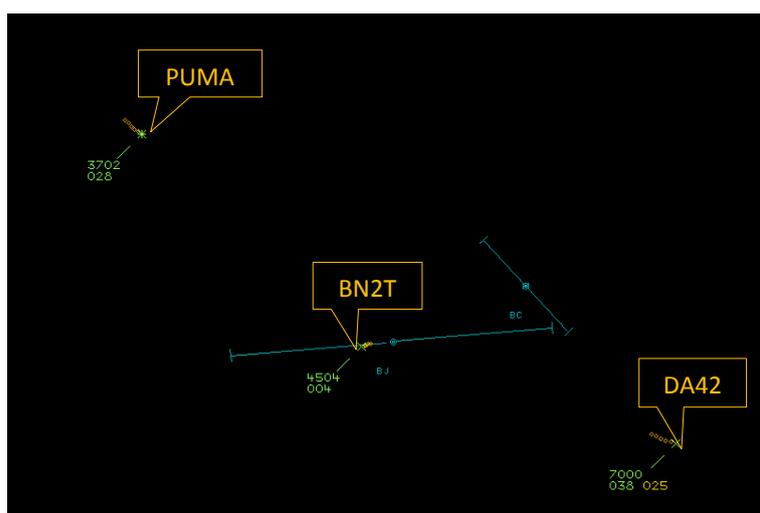
An Airprox was reported by the pilot of the Puma with the BN2T, whilst the Puma was in transit towards Gloucestershire Airport, with the intention of completing an instrument approach there. The BN2T was on an IFR departure from Gloucestershire Airport, intending to route to Oxford for an instrument approach. The BN2T first became visible on the area radar replay at 1655:00, and at 1655:28 a Procedural Service was agreed with the Gloucestershire controller who was operating as both Tower and Approach controller (Figure 1).

Figure 1 – 1655:28 - indicated levels are FL – add 270ft for altitude

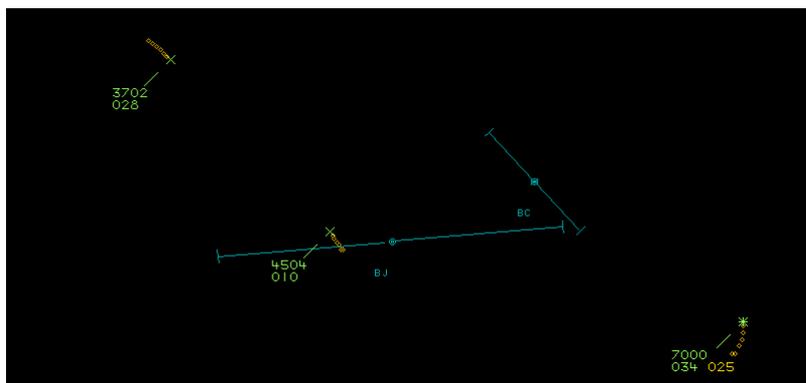
At 1656:18 the Gloucestershire controller took a telephone call from the Brize Radar controller who passed Traffic Information to them on the Puma: “northwest of yourselves, 10 miles, tracking through your overhead at 3000ft” (Figure 2).

Figure 2: 1656:18 aircraft 7.3NM apart

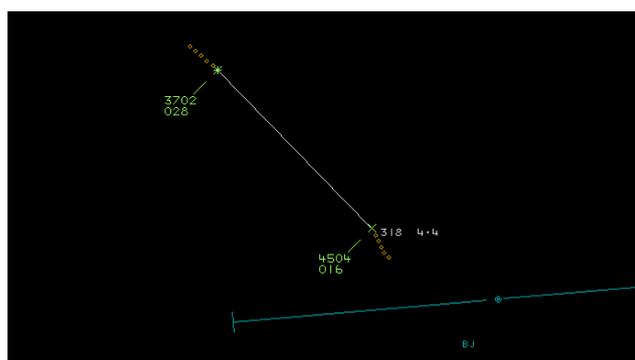
At 1656:43 the Brize Radar controller advised the Gloucestershire controller that the Puma was in fact inbound to Gloucestershire. The Gloucestershire controller asked for the level of the Puma again. The Gloucestershire controller then passed Traffic Information to the Brize Radar controller “OK I’ve got traffic squawking 4504, (Brize Radar controller reports “contact”), northwest of me northwest-bound, climbing to altitude 4000ft”. The Brize controller told the Gloucestershire controller to “standby” and was then heard to pass Traffic Information to the Puma: “traffic 12 o’clock 2 miles opposite direction, indicating 1000ft below, climbing to altitude 4000ft”.

Figure 3: 1657:00

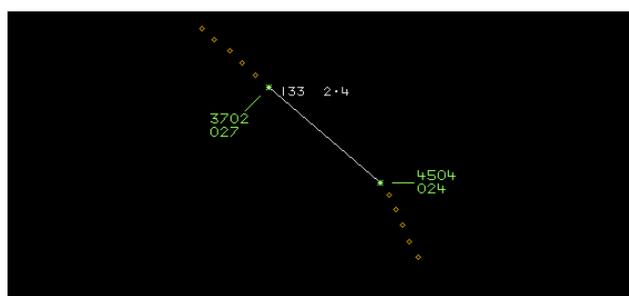
Whilst the Brize Radar controller was passing Traffic Information, at 1657:05 the Gloucestershire controller called the BN2T: “you’re not under a radar service but I believe you have traffic left 11 o’clock, 3 miles, opposite direction, altitude 3000ft – a Puma working Brize”. The Brize Radar controller then informed the Gloucestershire controller that they had “called traffic to the Puma”. The Gloucestershire controller stated that they had also passed TI to the BN2T. The Gloucestershire controller started to inform the Brize radar controller that “I’m turning, I’m going to turn that 4504”, but the Brize controller was updating the Traffic Information to the Puma pilot: “traffic now 12 o’clock, 1 mile opposite direction, indicating 400ft below 200ft below, climbing” (Figure 4).

Figure 4: 1657:32

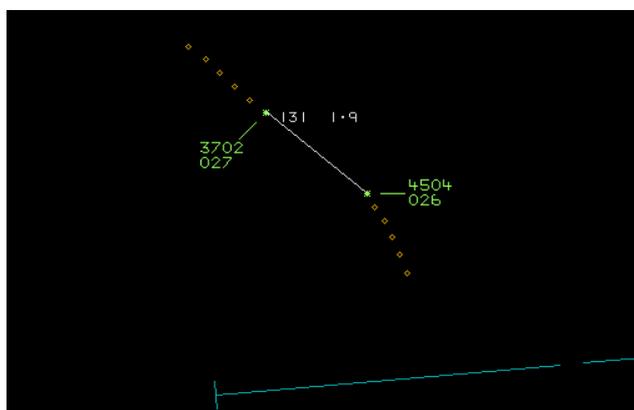
Again, the Gloucestershire controller attempted to inform the Brize Radar controller that they were turning the BN2T, but the Brize Radar controller informed them that the Puma was not visual with the traffic and then immediately following that, at 1657:40, passed further traffic information to the Puma pilot: *“now left 11 o’clock 1 mile passing down your left-hand side indicating 100ft above”* (Figure 5).

Figure 5: 1657:40

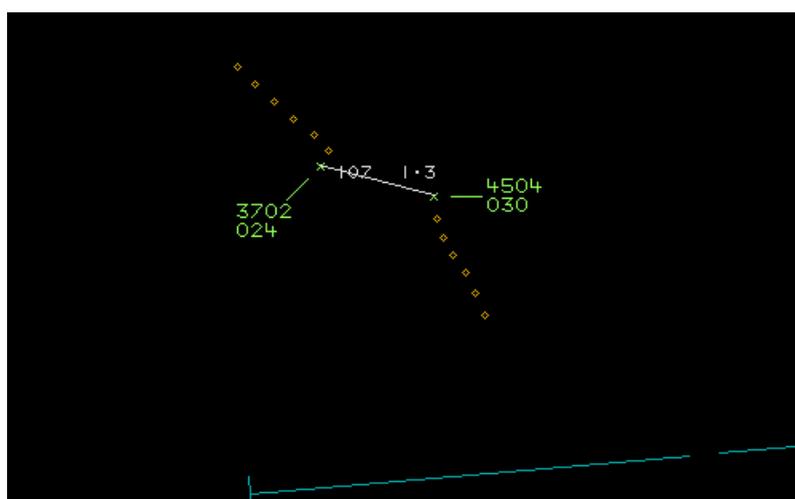
CPA occurred at 1657:50 with the aircraft separated by 1.3NM and 600ft (Figure 6).

Figure 6: 1657:50

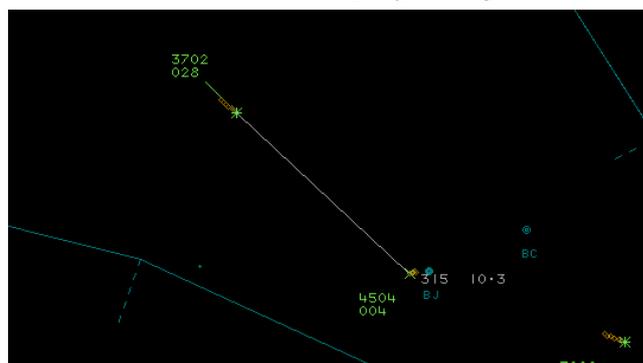
Having prenoted the Puma to Brize, the Swanwick (Mil) Controller passed Traffic Information to the Puma pilot who reported not being visual but did not mention being IMC. At this point, the BN2T was indicating 400ft. Having passed this Traffic Information, the Puma pilot was transferred to Brize Approach.

Figure 7: Traffic Information passed by Swanwick

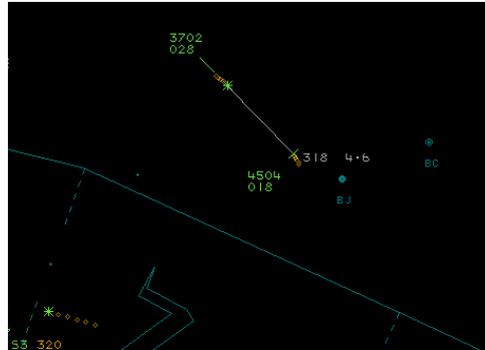
Having received a prenote on the Puma, the Brize Controller, who was unaware of the intended practice diversion at this time, correctly identified that the aircraft would fly close to Gloucester and began liaising with Gloucester about the transit. During this period, the Puma contacted Brize, articulated the intent to make an approach at Gloucester and was passed Traffic Information by the Brize Approach Controller on the BN2T. This range information passed was not accurate, the controller stated 2NM when it was actually 4.6NM, although Brize were operating SSR only at the time of the incident which may account for the disparity.

Figure 8: First Traffic Information from Brize

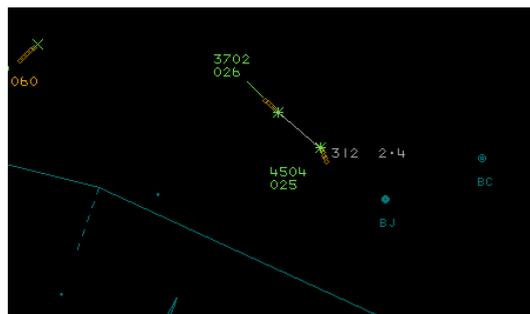
Brize passed Traffic Information to the Puma pilot for a second time following further discussion with Gloucester. Again, the range on this Traffic Information was not accurate, the controller stated 1NM when it was actually 2.4NM.

Figure 9: Second Traffic Information from Brize

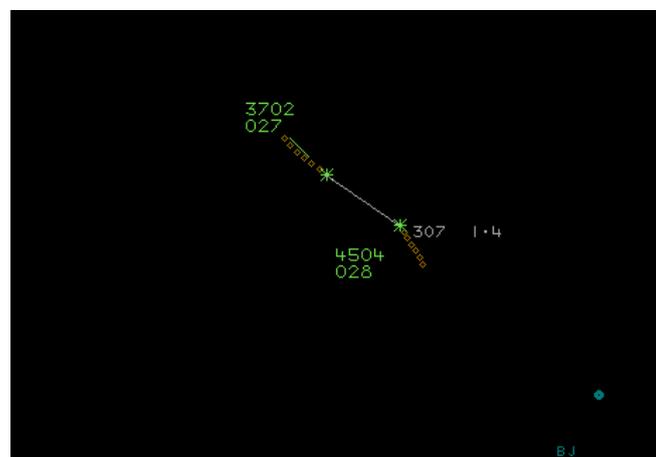
Traffic Information was passed for a third and final time by Brize shortly afterward. This traffic information was accurate, and it was at this point that the Puma pilot reported being IMC. Separation at this point was 1.4NM.

Figure 10: Final Traffic Information from Brize

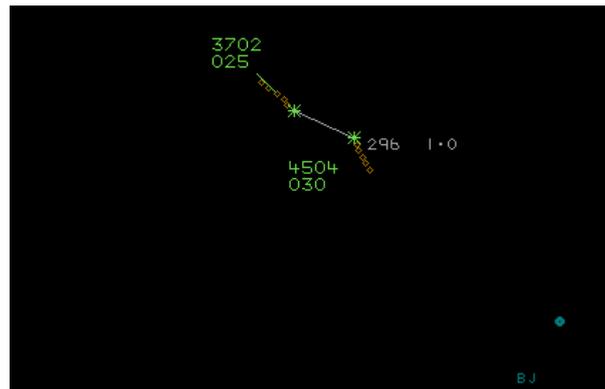
CPA occurred 10 seconds after this final piece of Traffic Information and was measured at 1NM and 500ft.

Figure 11: CPA
