AIRPROX REPORT No 202040

Date: 20 May 2020 Time: 1230Z Position: 5145N 00110W Location: 1.5NM NE Oxford

PART A: SUMMARY OF INFORMATION REPORTED TO UKAB

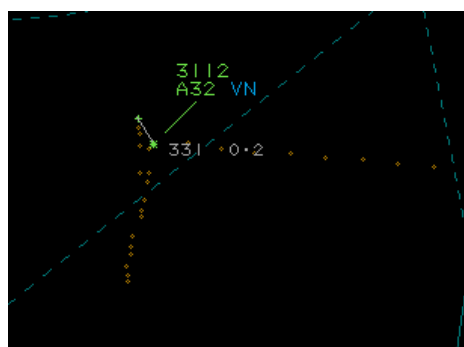
Figure 1: 1230:55 Voyager squawk 3112

Prior to CPA an unknown track can be seen on the area radar replay, it is not known if this is the unknown glider or not but is coincident with the time the Voyager pilot turns to avoid the glider. Separation between the Voyager and the unknown radar contact is 0.2NM horizontally.

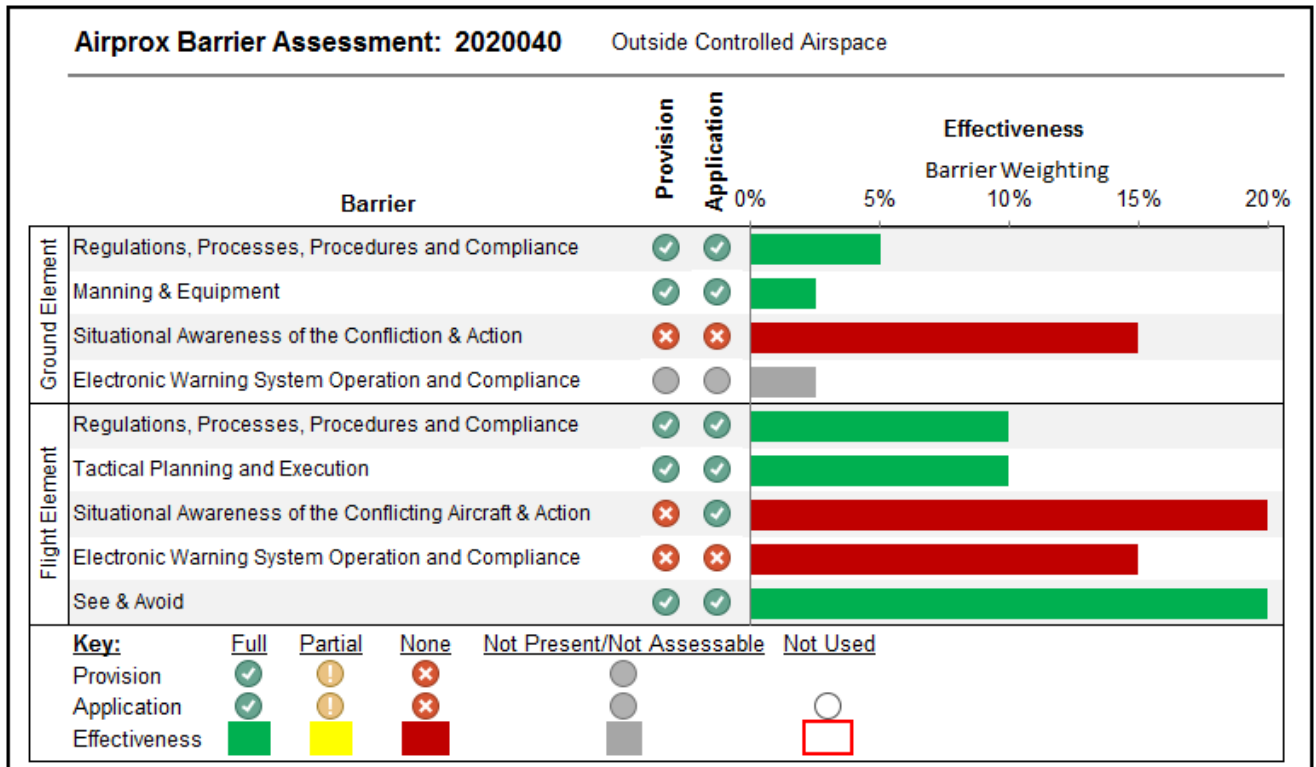
Situational Awareness of the Confliction and Action were assessed as **ineffective** because the glider was not visible on the Brize controllers radar screen.

Situational Awareness of the Conflicting Aircraft and Action were assessed as **ineffective** because neither pilot had any information on the other aircraft.

Electronic Warning System Operation and Compliance were assessed as **ineffective** because the Voyager’s TCAS could not detect the glider.
