AIRPROX REPORT No 2020045

Date: 30 May 2020 Time: 1433Z Position: 5259N 00007E Location: 4NM E of Boston

PART A: SUMMARY OF INFORMATION REPORTED TO UKAB

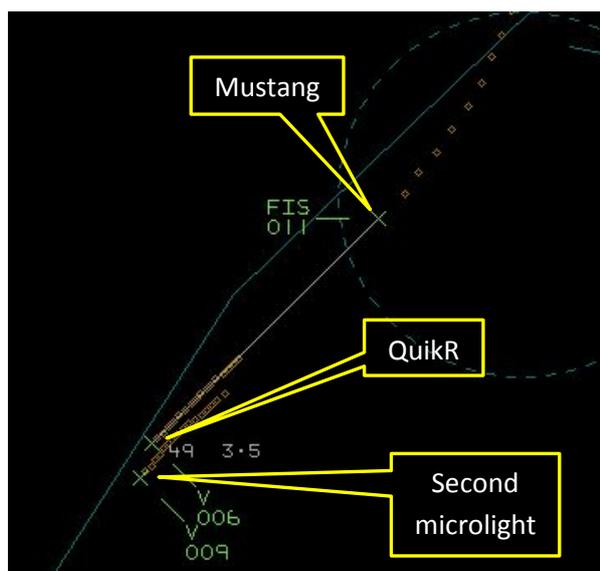
Figure 1 - 1431:50

At 1431:50, the Mustang could be seen paralleling the coastline directly behind the QuikR microlight at a range of 3.5NM; the aircraft were separated by 500ft at this point (Figure 1). The Mustang then continued on the same track, descending to FL009 (1100ft altitude) at 1432:14 (Figure 2); the pilot then maintained this altitude until CPA.

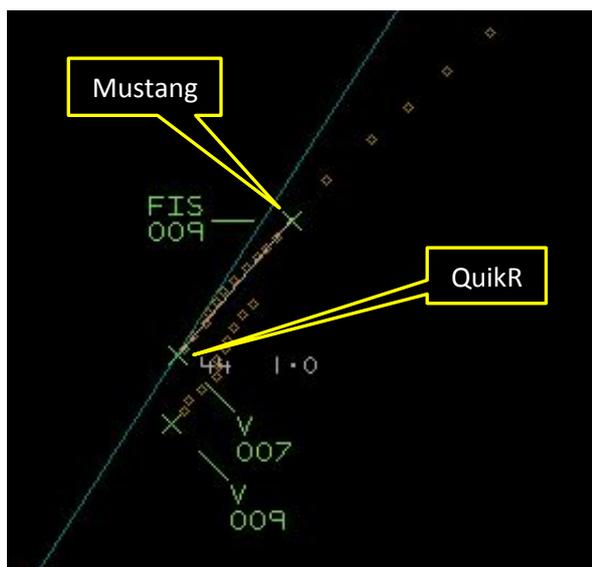
Figure 3 – 1432:34

At 1432:34, the QuikR pilot commenced a gradual climb (Figure 3); the Mustang was 1NM behind and 200ft above the microlight at this time. The QuikR pilot continued the climb and CPA occurred

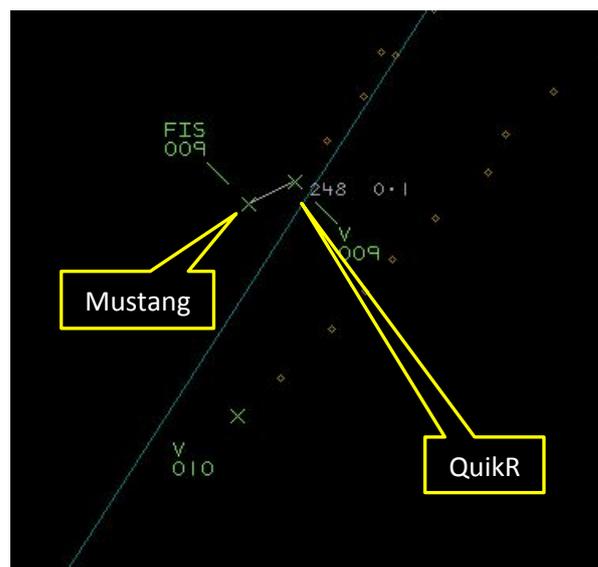
Figure 4 - CPA

some 20sec later and between radar sweeps; the closest radar-measurable separation occurred at 1432:54 and was measured at <0.1NM with no vertical separation (Figure 4).
