AIRPROX REPORT No 2020059

Date: 14 Jun 2020 Time: 1422Z Position: 5209N 00035W Location: 5NM NNE Cranfield

PART A: SUMMARY OF INFORMATION REPORTED TO UKAB

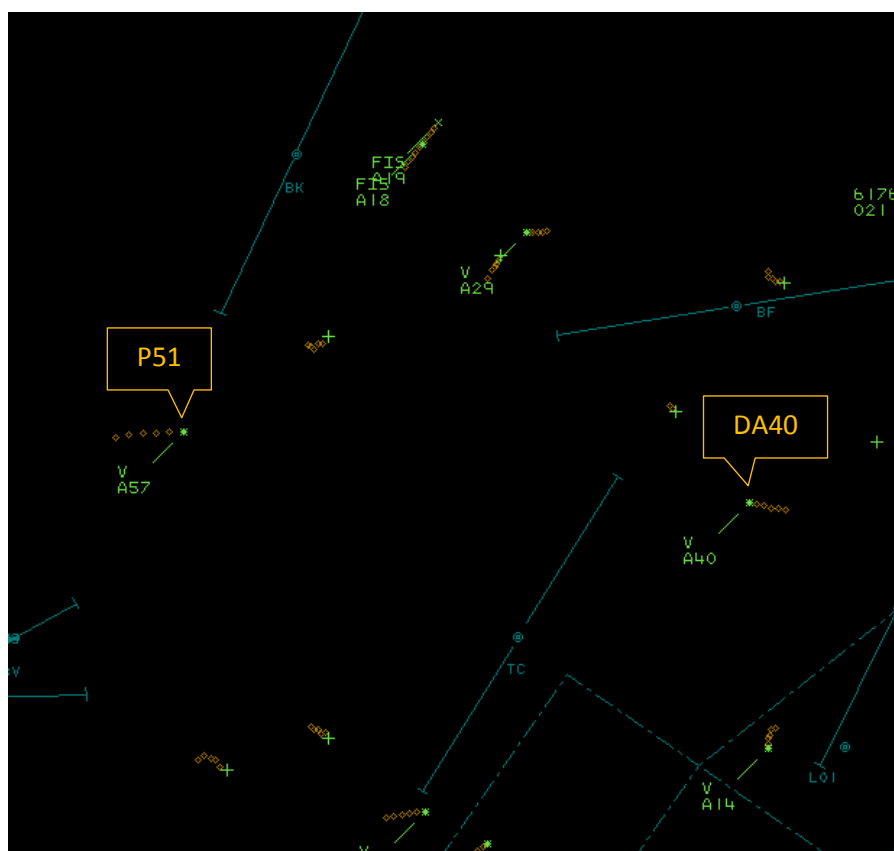
Figure 1: 1419:58 (a/c 16.5NM apart)

At 1419:58 the pilot of the DA40 called Oxford Radar requesting a Traffic Service (Figure 1).

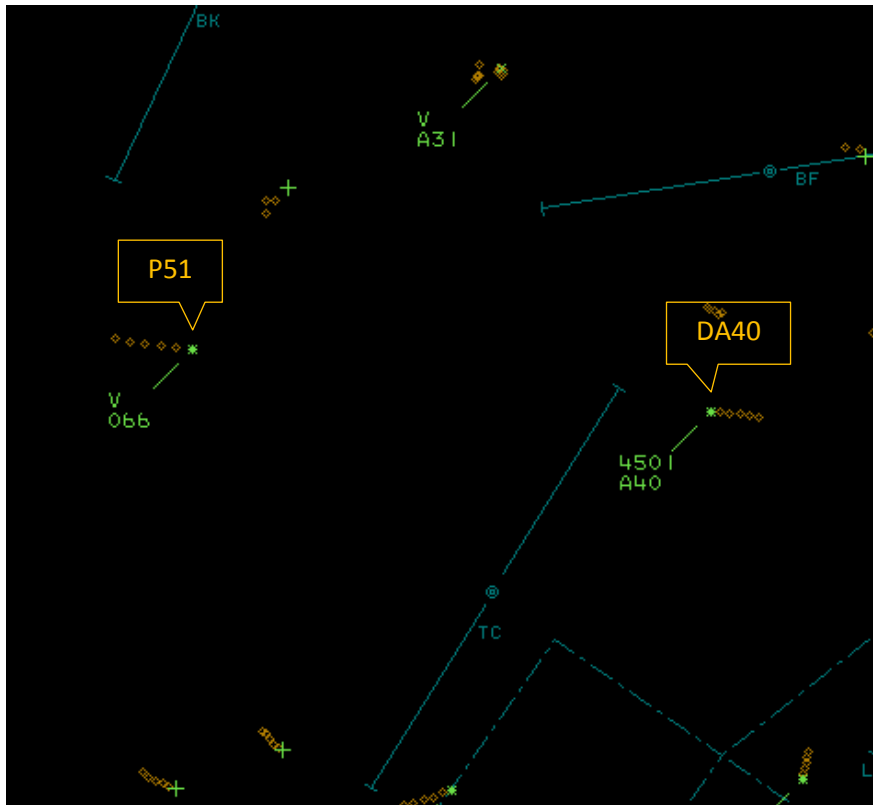
Figure 2: 1420:45 (a/c 11.8NM apart)

The trainee controller responded, asking the DA40 pilot to pass their details, and at 1420:32 issued a squawk and asked them to report their position. At 1420:45 the controller identified the

DA40 and confirmed the Traffic Service but advised that there would be reduced Traffic Information due to [their proximity to] the base of radar cover. (Figure 2).

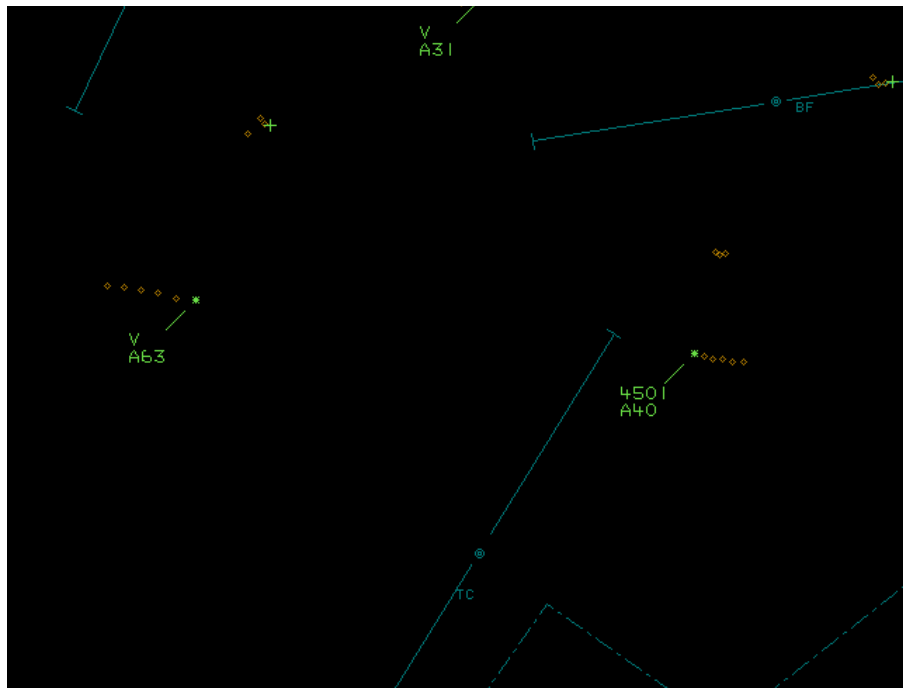
Figure 3: 1421:02 (a/c 10.7NM apart)

At 1421:02 the controller advised the DA40 pilot of *“traffic 12 o’clock 8 miles opposite direction, fast moving indicating altitude, correction, flight level 62 and descending”* which was acknowledged by the pilot (Figure 3).

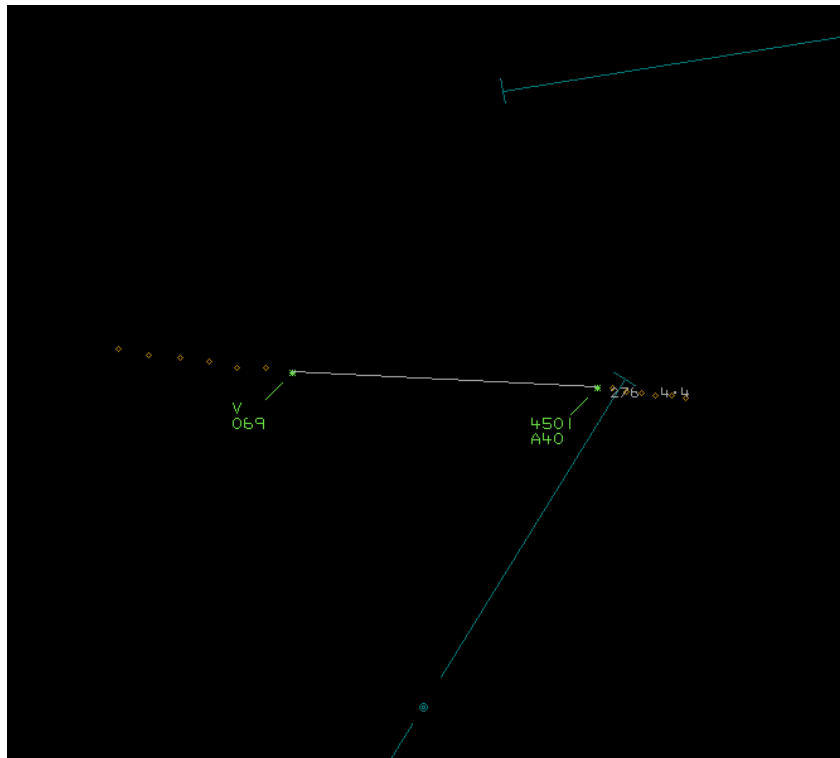
Figure 4: 1421:58

At 1421:50 the pilot of the DA40 requested an update on the traffic, and was given, at 1421:58, *“traffic now in your left half-past eleven opposite direction fast moving and flight level 69 climbing”* (Figure 4).

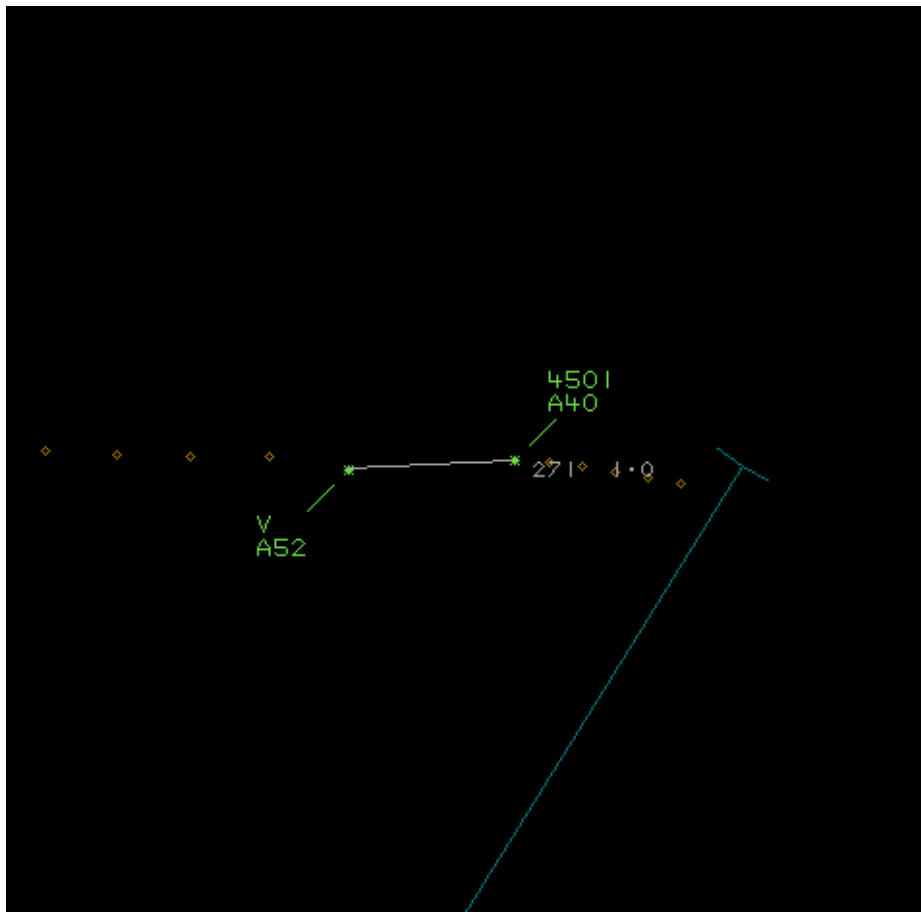
Figure 5: 1422:30 (P51 ground speed 283kts)

Between 1421:15 and 1422:40, the Oxford controller dealt with other aircraft calls. During this period, at 1422:15, the P51 was seen to commence a rapid descent with a subsequent significant increase in the aircraft's groundspeed from 1422:25 (Figure 5).

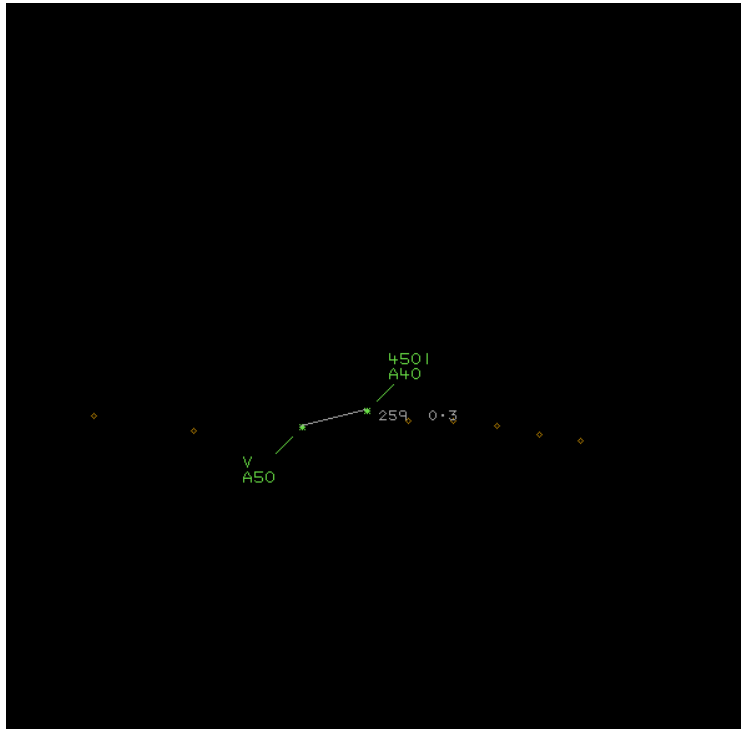
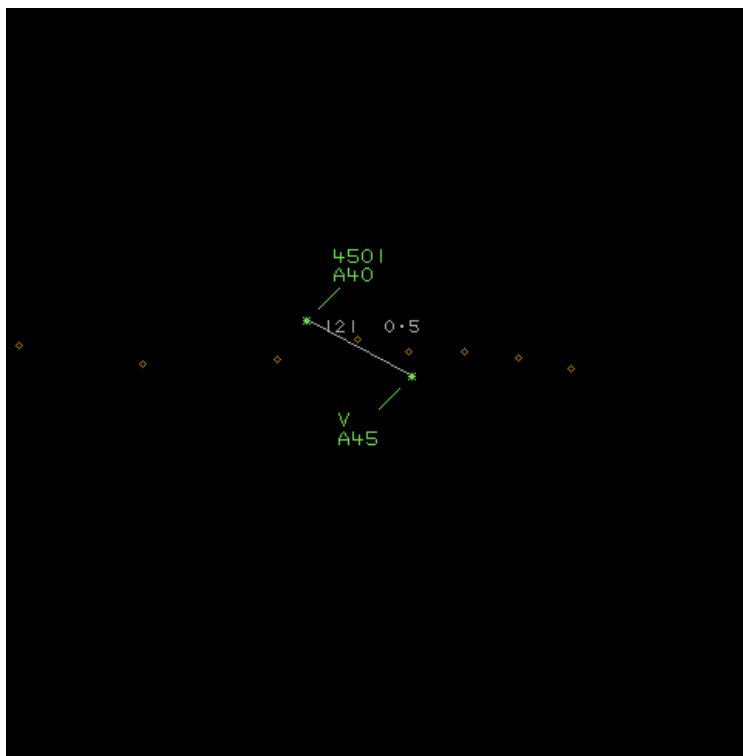
Due to the sweep rate of the area radar, CPA was estimated to have taken place between 1422:35 and 1422:41 (Figures 6 & 7).

Figure 6: 1422:35 (P51 ground speed 283kts)

Figure 7: 1422:41 (P51 ground speed 292kts)
