AIRPROX REPORT No 2020060

Date: 07 Jul 2020 Time: 1310Z Position: 5036N 00436W Location: Bodmin Moor

PART A: SUMMARY OF INFORMATION REPORTED TO UKAB

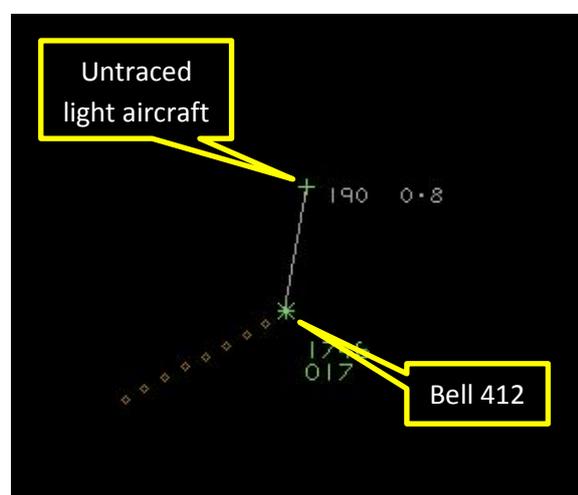
Figure 1 – 1309:19

The Bell 412 had been tracking northeast-bound for at least 2min prior to the Airprox and at a relatively stable altitude of 1900ft. The untraced light-aircraft first appeared on the NATS radar as a primary-only return 16sec (4 radar sweeps) prior to CPA, at 1309:19 (Figure 1). The 2 aircraft continued on their relative flightpaths until CPA at 1309:35 (Figure 2). At this time, according to SSR data, the Bell 412 pilot had descended by 100ft; this was most likely due to their sighting of the untraced light-aircraft.

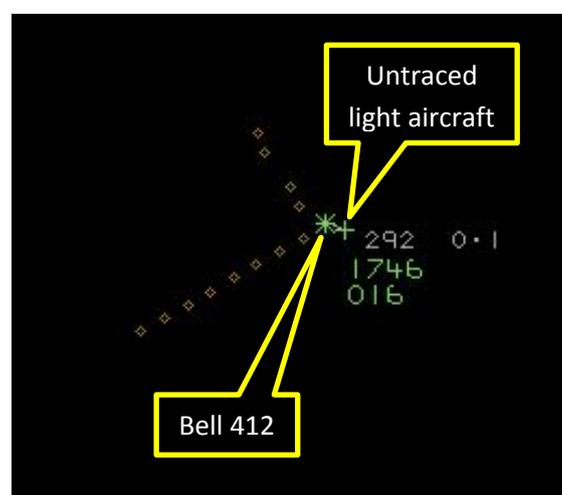
Figure 2 – 1309:35 (CPA)

CPA occurred between radar sweeps; the nearest measurable return is shortly after the aircraft tracks crossed and is measured at 0.1NM horizontal separation; the vertical separation is unknown due to the lack of SSR data from the untraced light-aircraft.
