AIRPROX REPORT No 2020067

Date: 14 Jul 2020 Time: 1132Z Position: 5236N 00059W Location: Leicester aerodrome

PART A: SUMMARY OF INFORMATION REPORTED TO UKAB

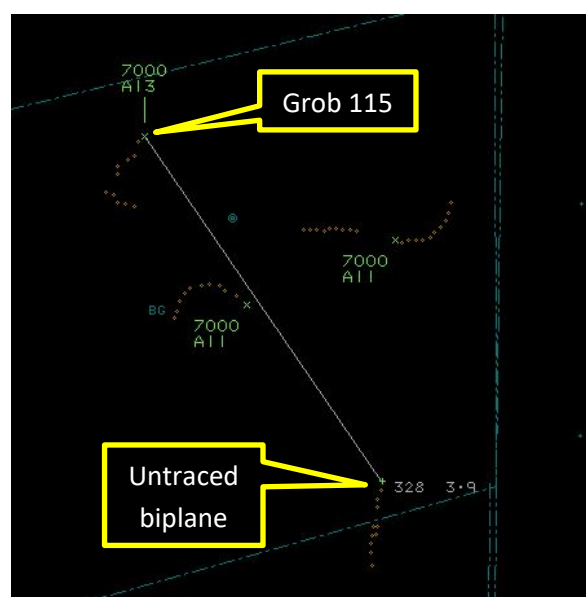
Figure 1 – 1130:30

Analysis of the NATS radar showed the Grob 115 in the circuit pattern at Leicester aerodrome and the biplane tracking north during the time leading up to the Airprox (see Figure 1). At 1131:30 the Grob 115 pilot commenced their turn onto base leg – the biplane was 1.8NM south of the Grob 115 at this time (see Figure 2); note the presence of radar jitter, which may have been due to the proximity of other traffic in the LH circuit pattern at Leicester aerodrome.

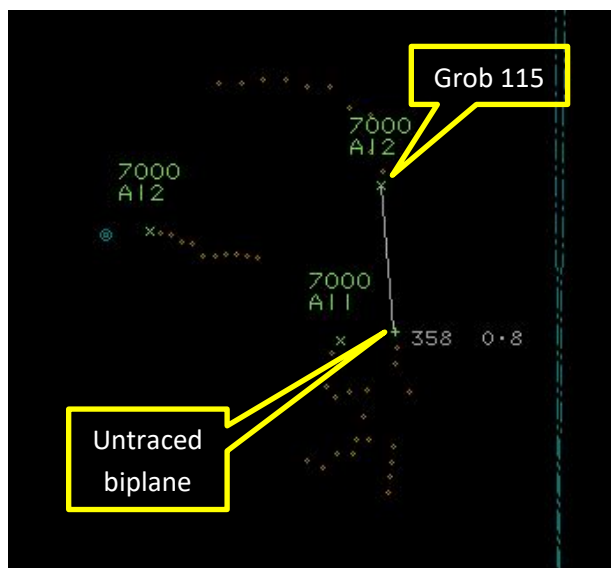
Figure 3 – 1131:54

At 1131:54, when the Grob pilot was approximately halfway along their base leg, the Grob 115 and untraced biplane were head-on to each other at a range of 0.8NM (see Figure 3). The 2 aircraft continued to close on each other until shortly after the Grob 115 pilot had commenced their final turn, at which point the Grob 115 pilot sighted the biplane and elected to continue their turn as it was increasing the separation between the 2 aircraft. CPA occurred as the 2 radar contacts merged at 1132:10 (see Figure 4).

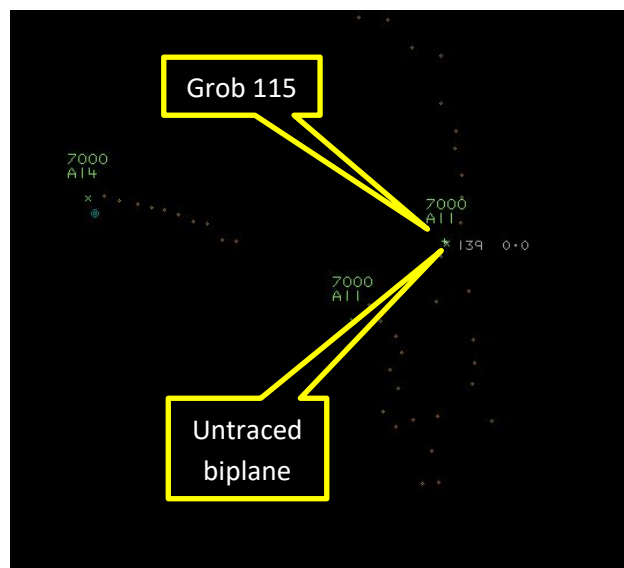
Figure 4 – 1132:10 (CPA)

Turning to the risk involved in this encounter, the Board noted that it had not been possible to accurately measure the vertical separation due to the fact that the biplane had not displayed any transponder information. However, the primary radar track of the biplane had been available and this had shown the horizontal separation to be <0.1NM. Members took account of the Grob 115 pilot's estimation of vertical separation and, whilst this could not be corroborated by any other means, the Board's view was that there had been sufficient vertical separation to at least remove any collision risk. This, coupled with the Grob 115 pilot's account that there was no need for avoiding action other than to continue their final turn, led the Board to the conclusion that, although safety had been degraded, there had been no risk of collision and therefore a Risk Category of C was agreed upon.
