AIRPROX REPORT No 2020074

Date: 21 Jul 2020 Time: 1010Z Position: 5222N 00019W Location: 5NM W Alconbury

PART A: SUMMARY OF INFORMATION REPORTED TO UKAB

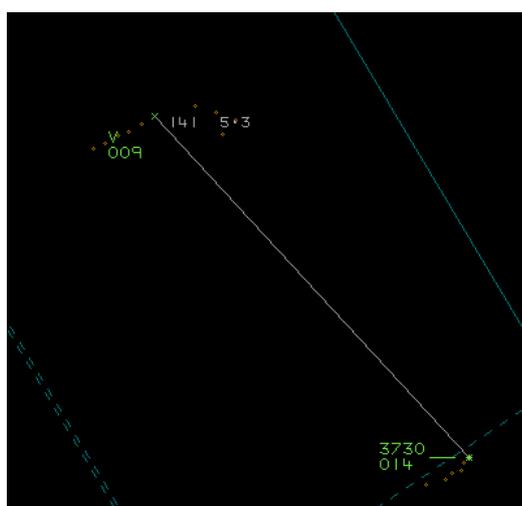
Figure 1:
Separation and flight profile of Tutor and Christen Eagle.

The Christen Eagle pilot was transiting from the NW in an easterly direction. Separation at this point was 5.3NM and 500ft.

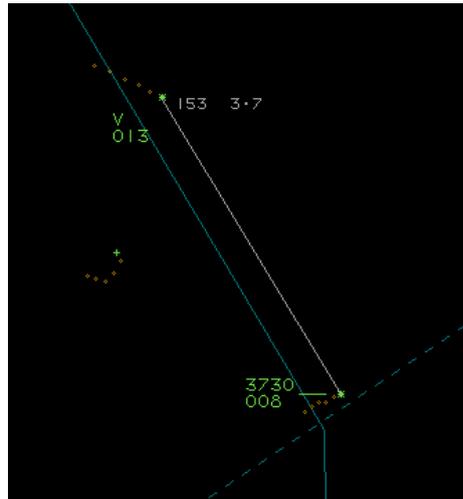
Figure Two:
Updated flight track of Christen Eagle.

One minute and 17 seconds later the Christen Eagle was tracking steady on a SW heading. Between Figure 1 and Figure 2, 8 transmissions were made between another Tutor pilot and the Wittering controller. Separation at this point had decreased to 3.7NM.

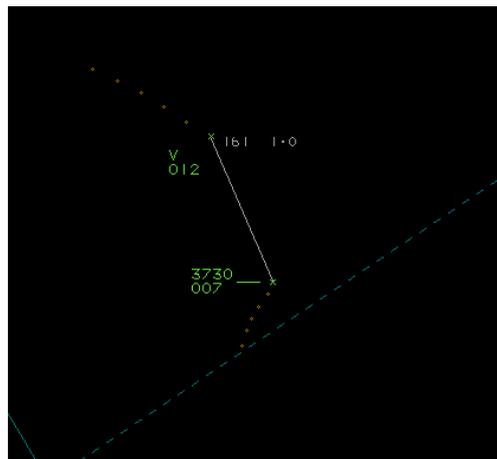
Figure 3:
Slight deviation in the Tutor flight profile.

After a further one minute and 13 seconds the Tutor trail appears to show a slight right turn however this could be associated with a PFL due to the lower altitude. No RT transmissions were made by the Wittering Controller or any aircraft on frequency. Separation decreased to 1NM.

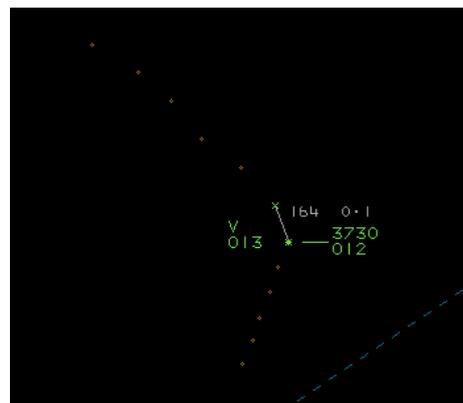
Figure 4:CPA

CPA was measured at 0.1NM and 100ft.

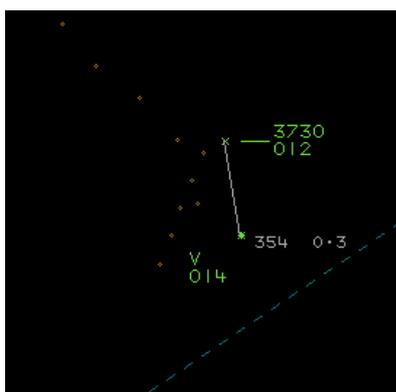
Figure 5: Christen Eagle track deviation.

Allowing the radar replay to run beyond CPA appears to show the Christen Eagle's reported right hand turn.
