AIRPROX REPORT No 2020095

Date: 10 Aug 2020 Time: 0941Z Position: 5238N 00250W Location: 15NM SW Shawbury

PART A: SUMMARY OF INFORMATION REPORTED TO UKAB

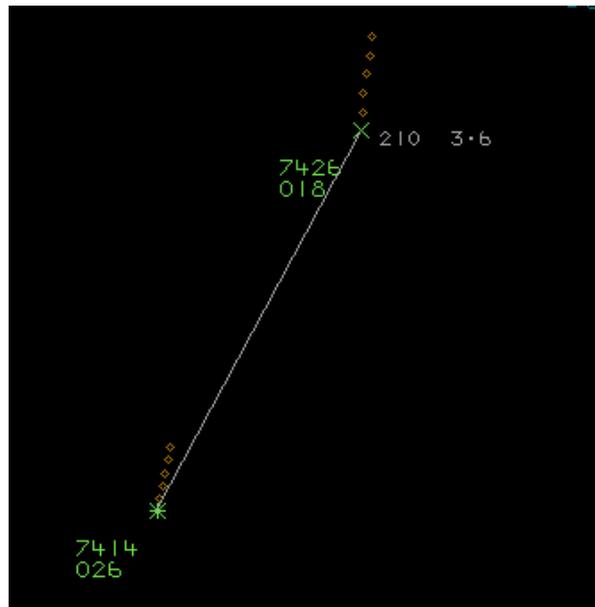
The Beech 55 was transiting to the west of the Shawbury MATZ. The Juno was late downwind in the radar training circuit and turned onto a heading of 090°, separation at this point was 3.6NM and 800ft.

Figure 1: Juno turned to a heading of 090°.

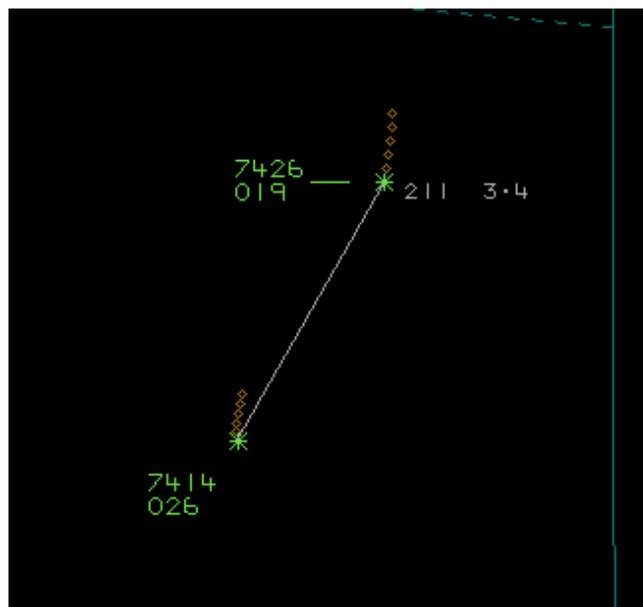
Nineteen seconds later the controller gave the Juno a further turn to 060°. Separation at this point had decreased to 3.4NM and 700ft.

Figure 2: Juno turned to a heading of 060°.

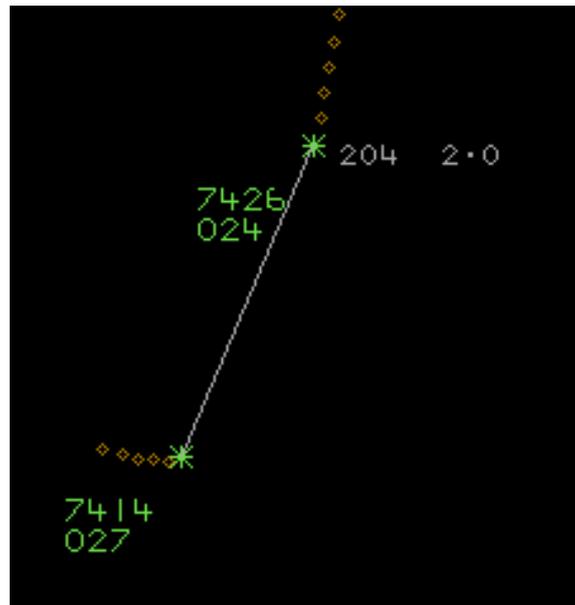
Traffic Information was passed to the Juno 40sec after the heading change to 060°. Separation decreased to 2NM and 300ft.

Figure 3: Traffic Information passed to the Juno.

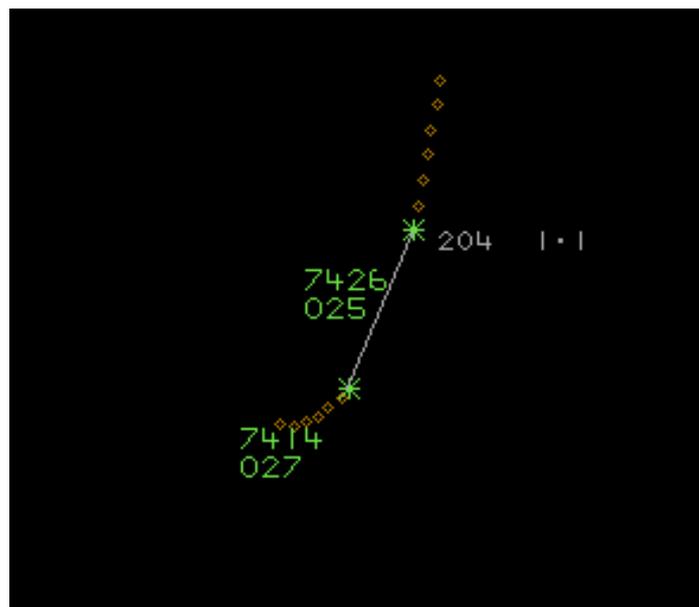
A further fourteen seconds elapsed before the Juno reported visual with the Beech 55. Separation decreased to 1.1NM and 200ft.

Figure 4: Juno reports visual with the Beech 55.

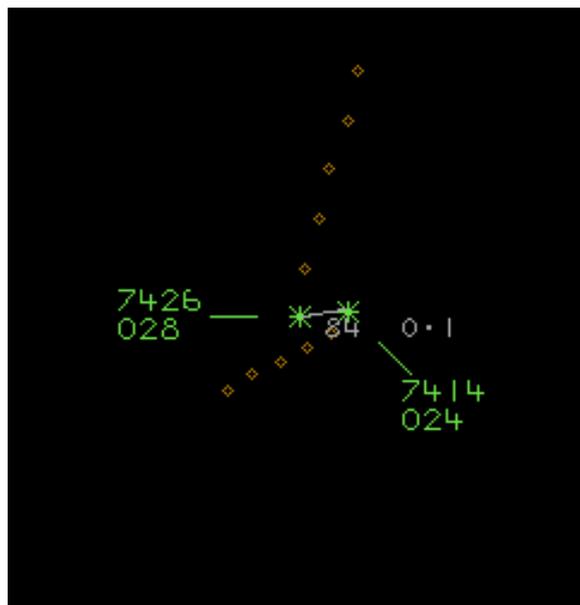
Nine seconds after the Juno reported visual, they report that they were descending. CPA was measured at 0.1NM and 400ft.

Figure 5: CPA.
