## AIRPROX REPORT No 2020103

Date: 31 Aug 2020 Time: 1307Z Position: 5145N 00006W Location: IVO Brookmans Park

### PART A: SUMMARY OF INFORMATION REPORTED TO UKAB

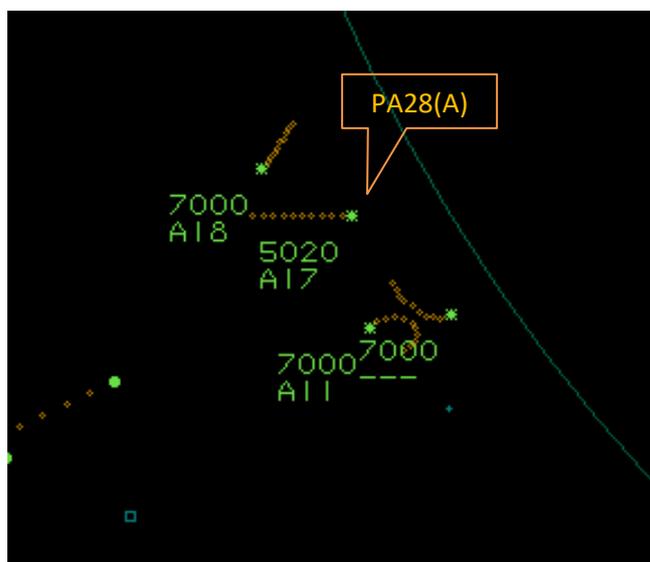
Figure 1 - 1235:30

At 1235:30 the controller asked the PA28(A) pilot to pass their details. The pilot responded that they were a PA28, with 2 POB, gave their destination, were currently over Potters Bar at 1800ft and requested a Basic Service. The controller instructed the pilot to Squawk 5020, a Basic Service was agreed and the London QNH of 1022hPa was passed. The squawk and QNH were accurately readback by the pilot (Figure 1).

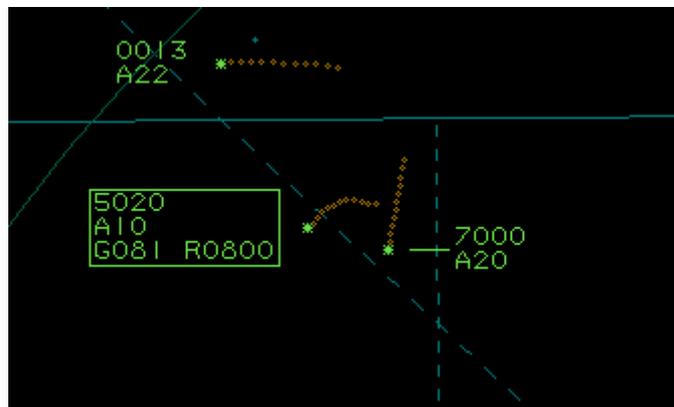
Figure 2 - 1255:10

At 1255:10 the controller called the pilot of PA28(A) and requested their position, explaining that they could no longer see their squawk of 5020 on the radar. The pilot responded that they were just to the west of Royston. There was no response from the controller. The 5020 squawk was showing on the area radar replay at this time but may not have been showing on the radar in use by the controller (Figure 2).

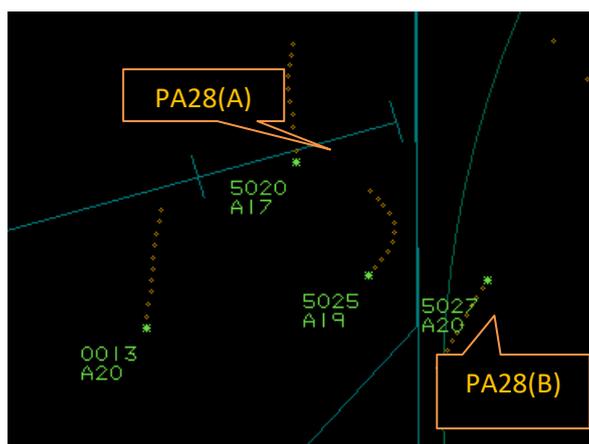
Figure 3 - 1302:00

At 1302:00 PA28(A) and PA28(B) were in proximity to each other (Figure 3).

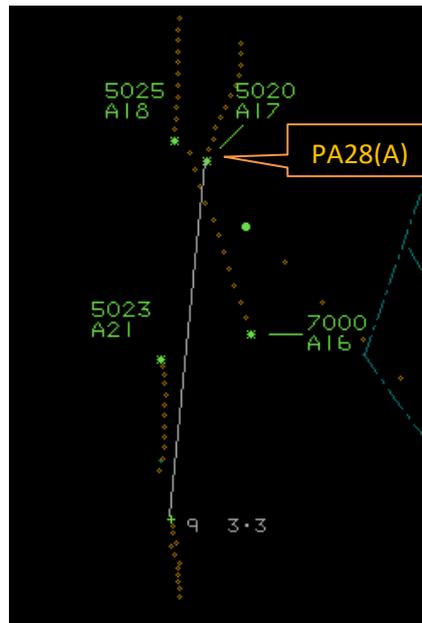
Figure 4 - 1306:30

At 1304:20 PA28(B) pilot requested a frequency change to Duxford and this was approved. At 1306:30 a primary contact was displayed 3.3NM south of PA28(A) (Figure 4). At this point in time the controller was engaged in a very lengthy initial and subsequent RTF exchanges with another pilot who had requested a service.

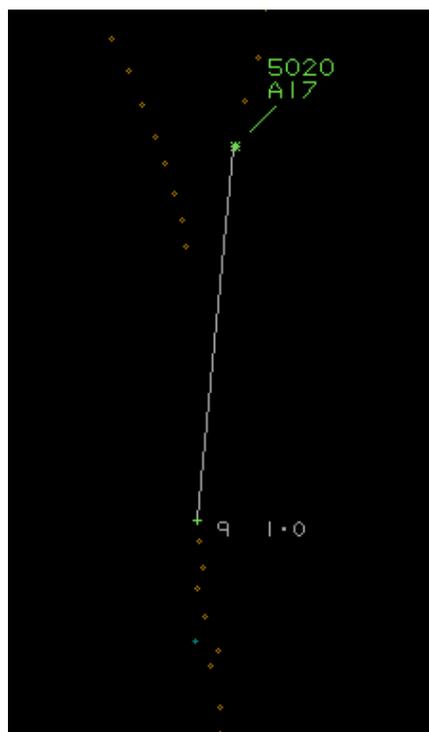
Figure 5 - 1307:20

At 1307:20 the primary contact was 1.0NM south of PA28(A) (Figure 5).

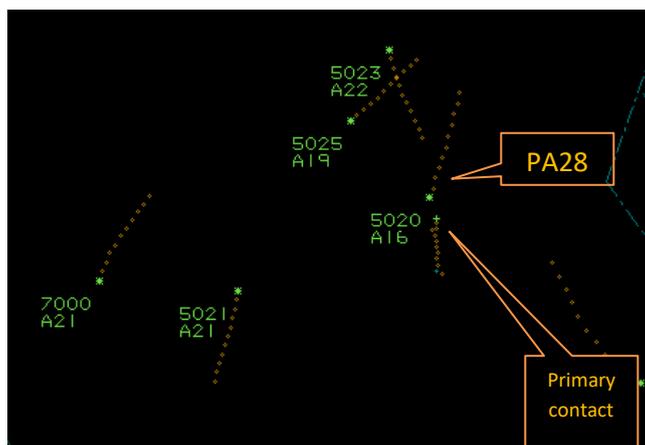
Figure 6 - 1307:40 (BPK area)

At 1307:40 the controller made a general broadcast, "all stations multiple contacts operating in the Brookmans Park area", this warning was then repeated (Figure 6).

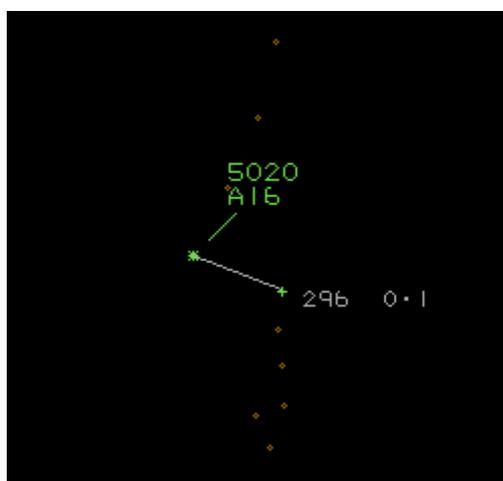
Figure 7 - 1307:42 (CPA)

At 1307:42 CPA occurred, with the aircraft separated by 0.1NM laterally, vertical separation could not be measured.

In determining the risk, the Board discussed that the separation described by the Skyrainger pilot was probably largely due to startle factor, in that the pilot had looked out of the cockpit and had seen the PA28 looming towards them. However, given that the radar indicated that there was only around 0.1NM separation and the PA28 pilot had not seen the Skyrainger, they thought that this had been a risk bearing encounter. Accordingly, they assessed the event as Risk Category B, safety not assured.
