AIRPROX REPORT No 2020112

Date: 05 Sep 2020 Time: 1331Z Position: 5058N 00156W Location: 7NM east Compton Abbas

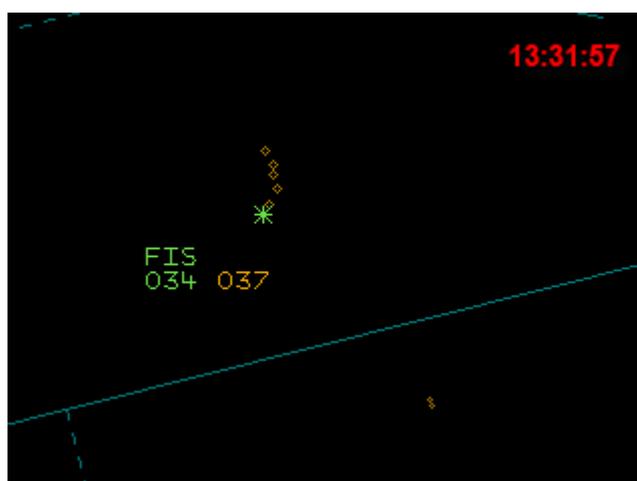
Figure 1

Analysis of the radar at the time of the event showed that one right turn was made by the pilot of the P68 in the time period between leaving the London FIS frequency and selecting a squawk assigned by Bournemouth ATC. At the time of the right turn (Figure 1) there were no corresponding radar returns to indicate the presence of a glider.

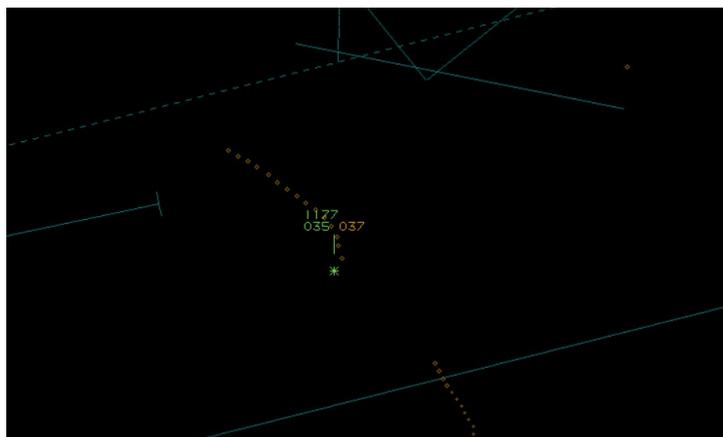
Figure 2: P68 squawk 1177

A primary only track was visible on the radar replay but faded prior to CPA. The initial track was commensurate with the P68 pilot’s report of the unknown glider, but it could not be fully identified as the conflicting aircraft (Figure 2) and would not have been known to the London Information FISO.

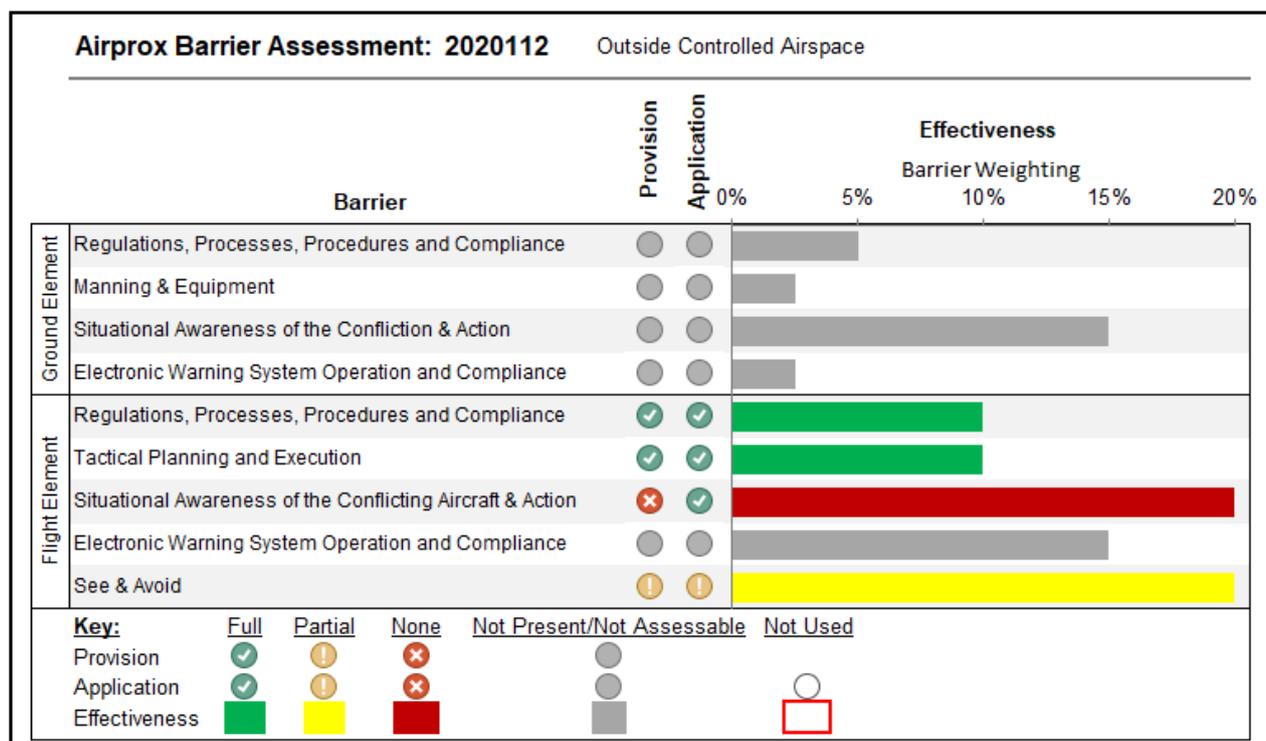
Situational Awareness of the Conflicting Aircraft and Action were assessed as **ineffective** because neither pilot had any information about the other aircraft.

See and Avoid were assessed as **partially effective** because the P68 pilot saw the glider late and made an emergency avoiding action turn. It is not known if the glider pilot saw the P68.
