AIRPROX REPORT No 2020116

Date: 12 Sep 2020 Time: 1229Z Position: 5119N 00048W Location: Blackbushe

PART A: SUMMARY OF INFORMATION REPORTED TO UKAB

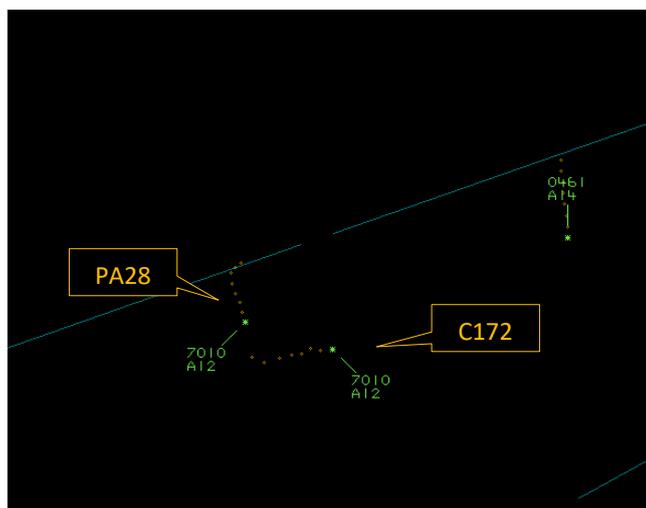
Figure 1 – 1227:27

An Airprox was reported by the pilot of a PA28 with an MD500 whilst the PA28 was carrying out circuit training at Blackbushe. The PA28 was sharing the circuit with a C172 ahead. At 1227:27 the C172 reported downwind (Figure 1).

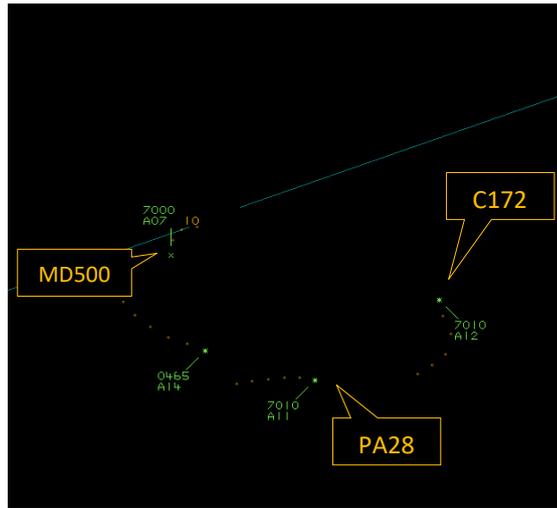
Figure 2 – 1228:30

At 1228:05 the PA28 pilot reported downwind for a touch-and-go. The Blackbushe AFISO advised them that there was an aircraft ahead, and requested they report final. The PA28 pilot reported being visual with that aircraft. At 1228:30 the MD500 appeared on the area radar replay (Figure 2).

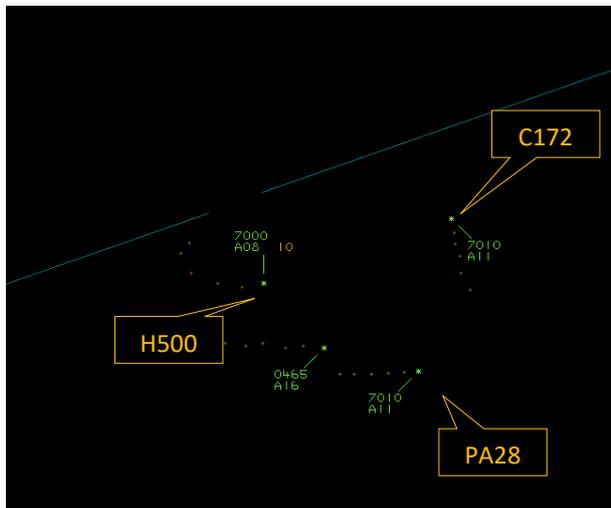
Figure 3 – 1228:50

At 1228:38 the MD500 pilot reported ready to leave the frequency for Farnborough which led to a short discussion about routing and frequency (Figure 3 at 1228:50).

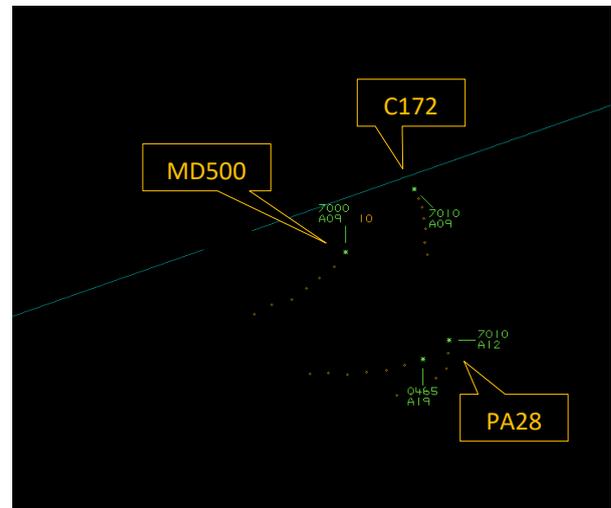
Figure 4 - 1229:10
(H500 had left the frequency)

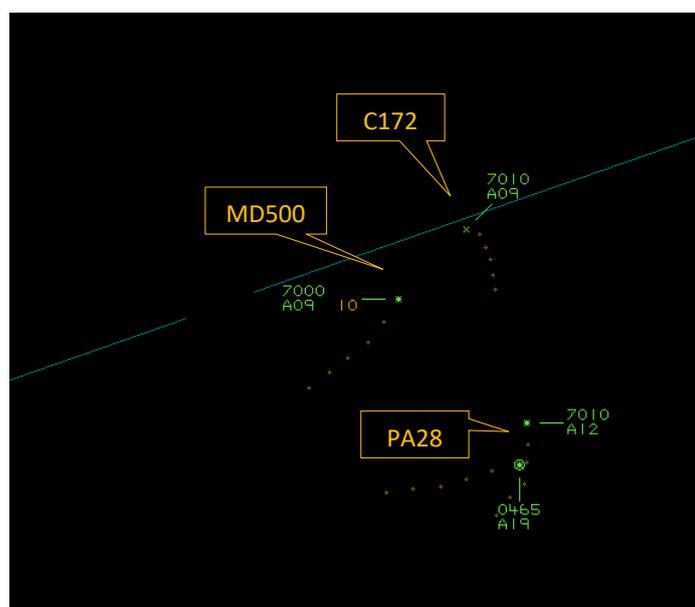
Figure 5 – 1229:21

At 1229:21 the AFISO advised the C172 pilot “caution I’ve got a rotary just departing across the approach”, to which the C172 pilot confirmed they were visual (Figure 5).

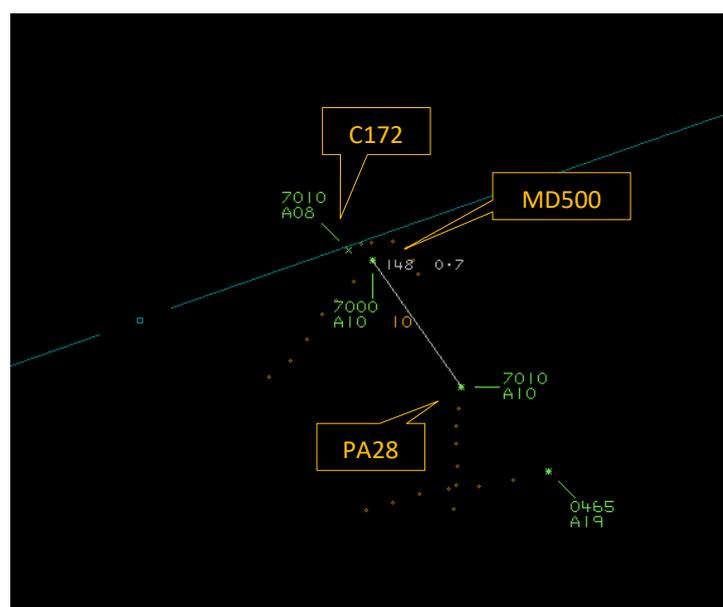
Figure 6 – 1229:27 - CPA

Whilst the MD500 came within 0.1NM of and passed behind the C172 at 1229:27, the CPA with the PA28 was never less than 0.7NM (Figure 6).

[UKAB Secretariat Note: Allowing the radar to run on until 1229:36 gave a CPA of 0.6NM)
