## AIRPROX REPORT No 2020122

Date: 14 Sep 2020 Time: 1107Z Position: 5126N 00118W Location: 1.5NM NE of Newbury

### PART A: SUMMARY OF INFORMATION REPORTED TO UKAB

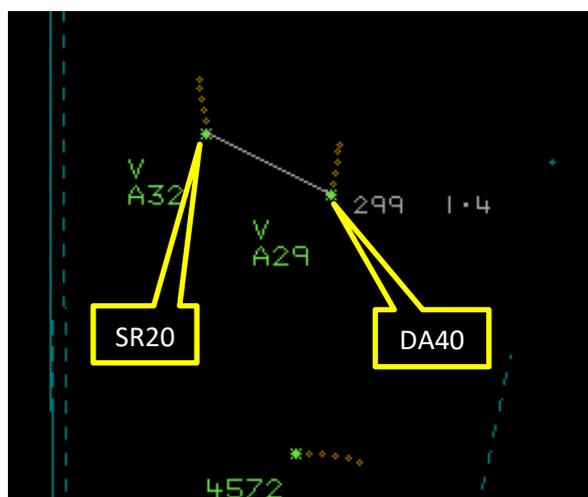
Figure 1

Seven seconds prior to Figure 1, the DA40 pilot was given a squawk and regional pressure setting and told to standby. Separation was measured at 1.4NM and 300ft. In Figure 2, separation had reduced to 0.7NM and 300ft whilst navigation and Danger Area avoidance advice was provided to another aircraft. The DA40 pilot was requested to confirm the squawk and RPS and was given a MATZ penetration clearance.

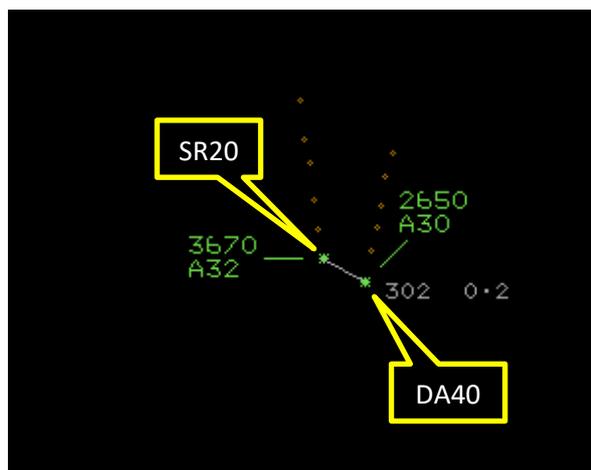
Figure 3

In Figure 3, Traffic Information was passed to the DA40 pilot. The SR20 squawk changes to a Solent Radar squawk. Separation had reduced to 0.2NM and 200ft. CPA is shown at Figure 4 and was measured at <0.1NM and 100ft (radar zoomed in to <3NM).
