AIRPROX REPORT No 2020124

Date: 16 Sep 2020 Time: 1029Z Position: 5207N 00146W Location: 1NM SW Long Marston

PART A: SUMMARY OF INFORMATION REPORTED TO UKAB

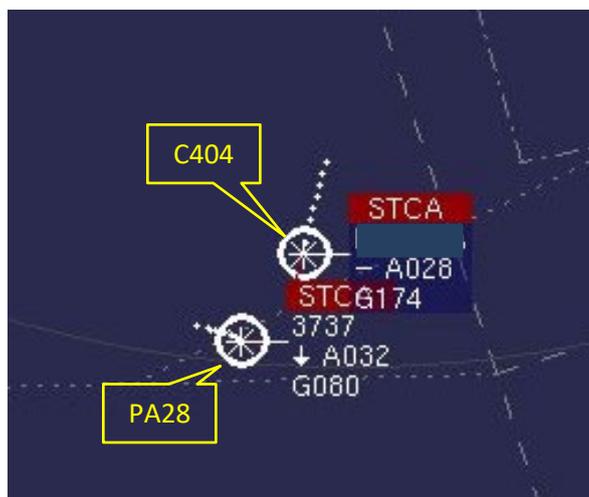
Figure 1

An STCA was activated as the two contacts were on diverging tracks and at similar heights (Figure 1).

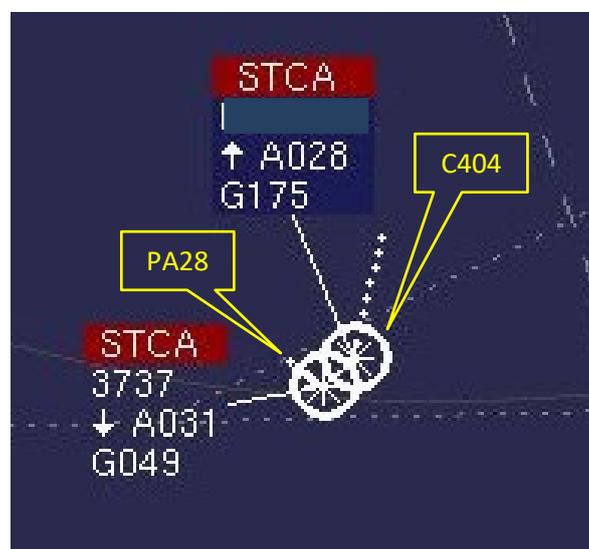
Figure 2

The STCA alert ceased as the contacts tracked away from each other (Figure 2).

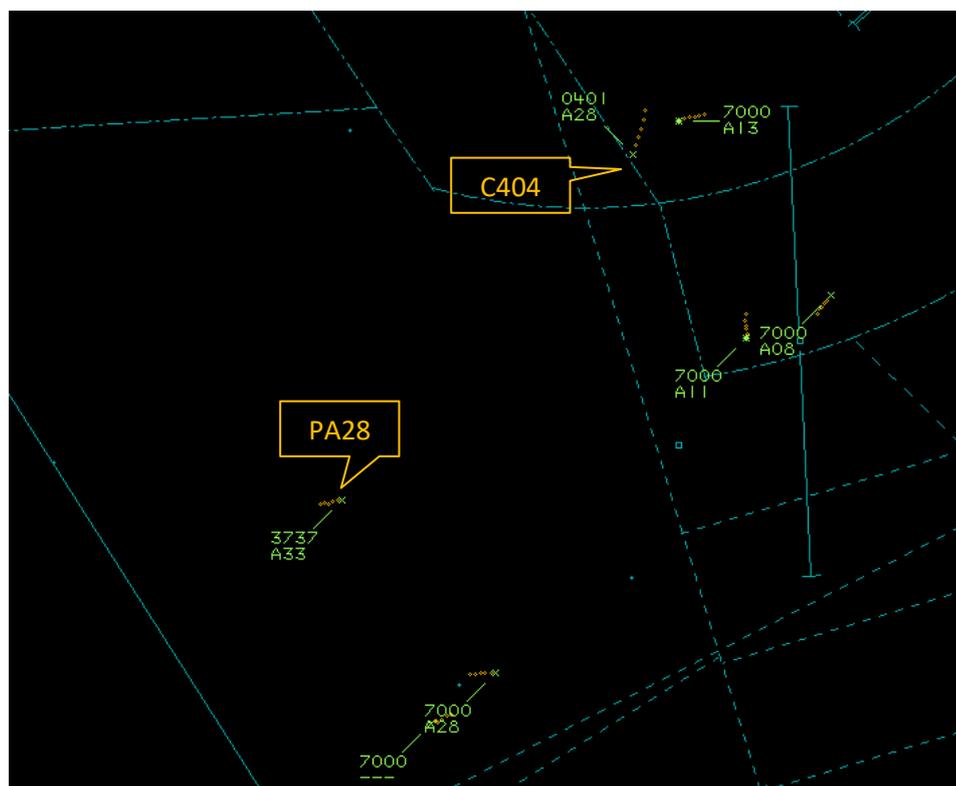
The C404 had just completed a transit of Birmingham's controlled airspace, and on exiting, at 1026:10, was advised by the Birmingham controller of a change of service from Radar Control to Traffic Service which was acknowledged. The PA28 was 10NM to the southwest of the C404, and according to its transponder code in communication with Brize Radar, (subsequently found not to be the case) (Figure 3).

Figure 3: 1026:10 – P28A 10NM SW of C404

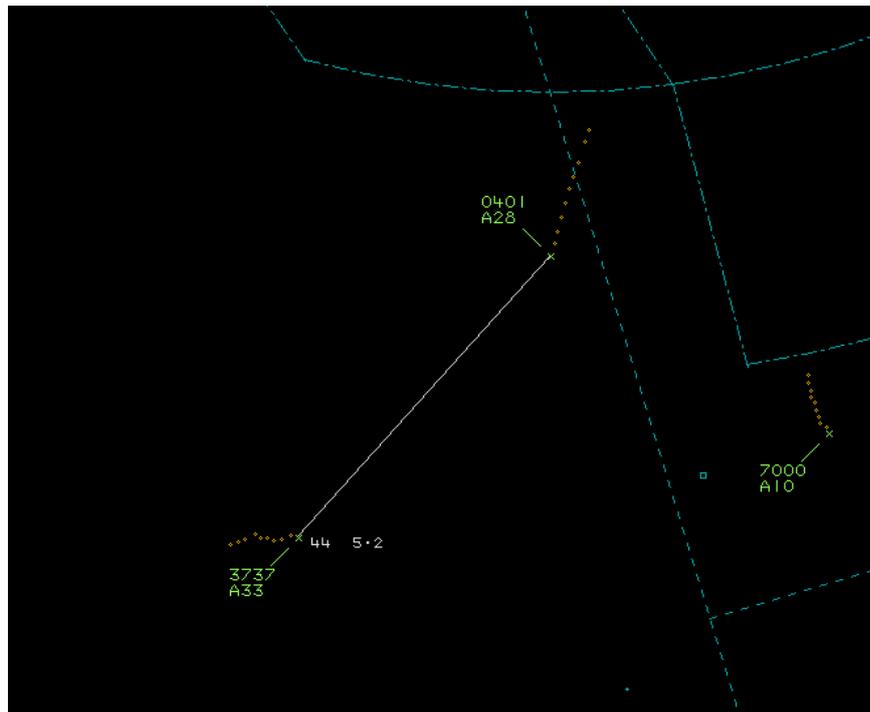
Figure 4: 1027:25

At 1027:25 the Birmingham controller passed Traffic Information to the C404 pilot on the PA28; *“there’s traffic in your right one o’clock range of five miles, crossing you right to left, looks like it’s working Brize, indicating three thousand three hundred feet”* (Figure 4).

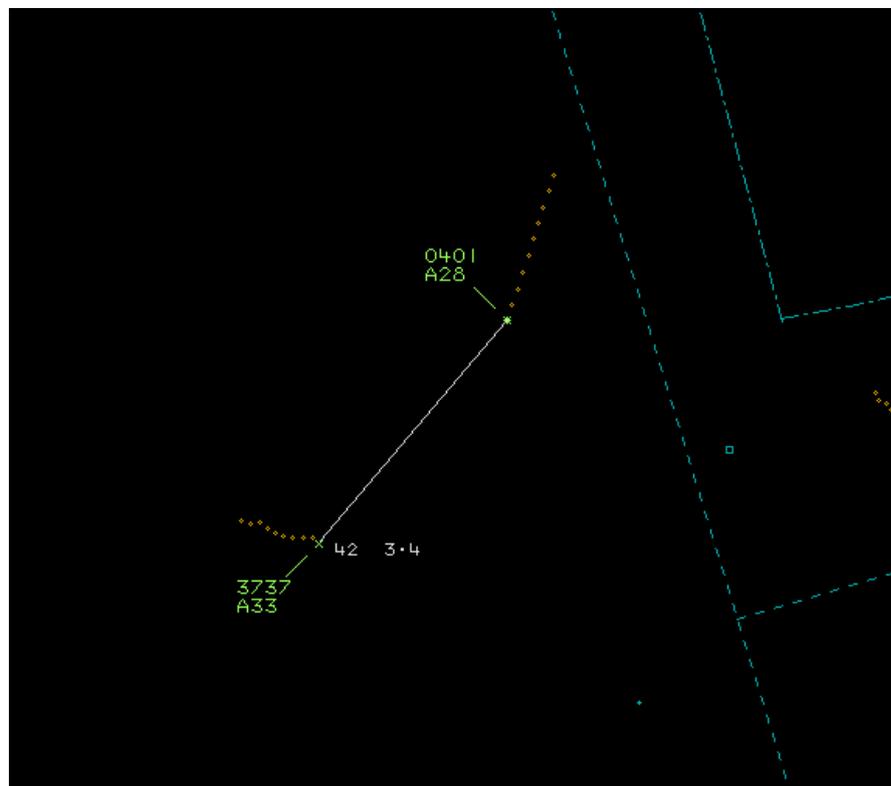
Figure 5: 1027:57

The controller received no reply from the C404, and repeated the Traffic Information to the C404 pilot at 1027:40 and 1027:45, before finally receiving a response at 1027:50. The controller repeated the Traffic Information at 1027:57; *“there’s traffic just coming into your twelve o’clock now at a range of three miles, indicating three thousand three hundred feet routing eastbound”* (Figure 5).

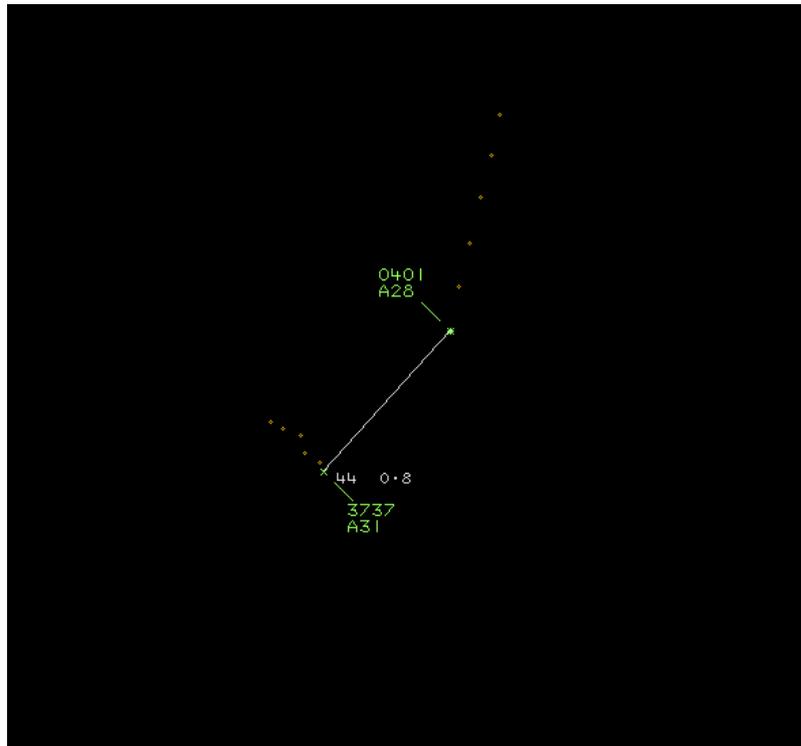
Figure 6: 1028:49

At 1028:49 the PA28 was observed to be in a descent (Figure 6).

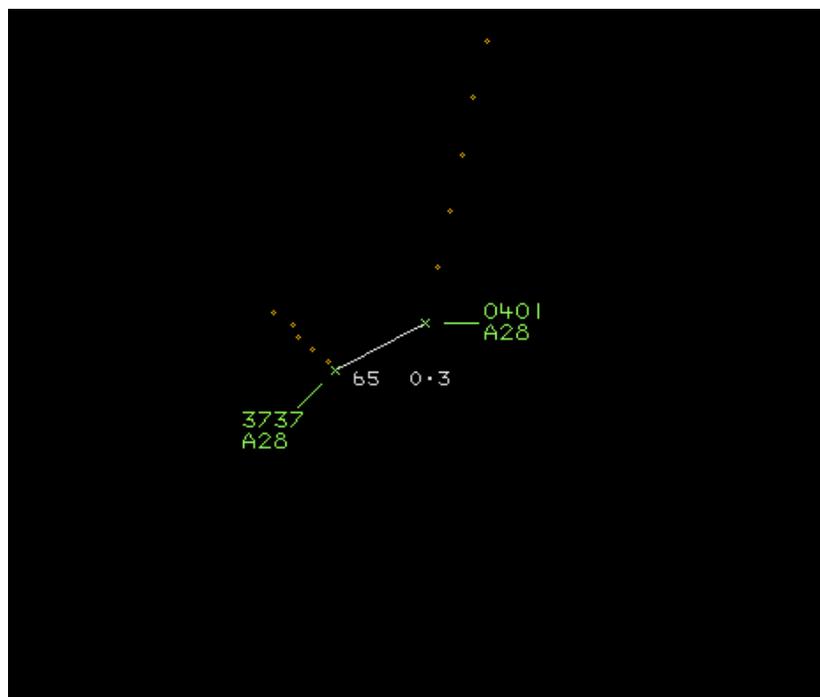
Figure 7: 1029:00

The PA28 was indicating at the same level as the C404 at 1029:00 (Figure 7)

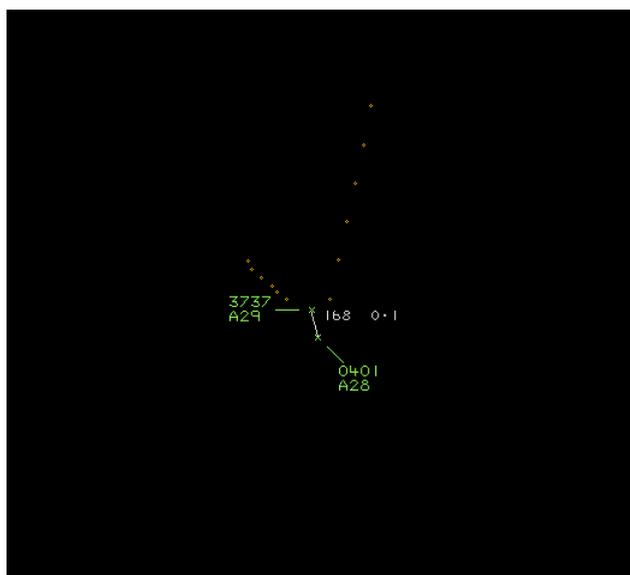
Figure 8: 1029:07

CPA took place, according to the radar replay, just before 1029:07 (Figure 8).
