AIRPROX REPORT No 2020133

Date: 27 Sep 2020 Time: 1459Z Position: 5205N 00019W Location: Old Warden

PART A: SUMMARY OF INFORMATION REPORTED TO UKAB

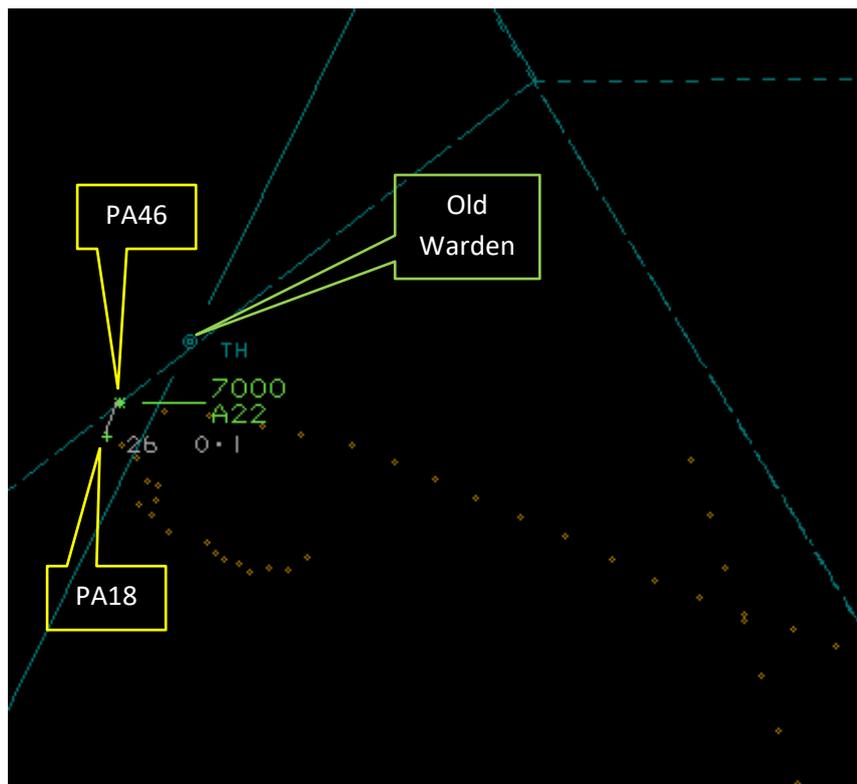
Figure 2: 14:59:03 CPA

The radar replay of the track of the PA46 and PA18 up to CPA is at Figure 2.

pre-flight planning as this would have alerted them to arrange their flight to avoid the RA(T) at Old Warden (CF3). Although the PA46 pilot saw the PA18/glider combination they did not believe they needed to avoid it and therefore they did not alter their course or height to provide adequate separation from the PA18/glider (CF12), this and their flight profile took them through the RA(T) and into conflict with the PA18/glider combination (CF2 & 5).
