AIRPROX REPORT No 2020146

Date: 11 Oct 2020 Time: ~1528Z Position: 5056N 00222W Location: Vicinity of Henstridge airfield

PART A: SUMMARY OF INFORMATION REPORTED TO UKAB

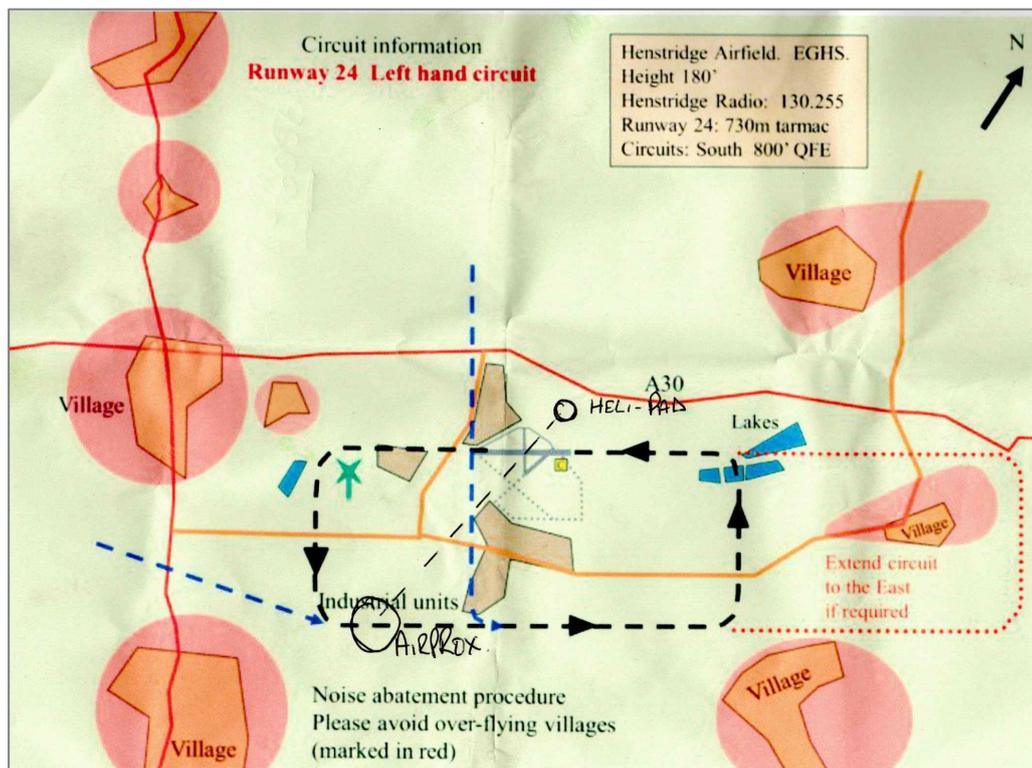
Figure 1

THE PA28 PILOT reports that they had re-joined the airfield from the west – for a standard downwind join – and were established downwind in the circuit for RW24LH. They called downwind 24LH and heard the helimed pilot make their 'lifting' call immediately afterwards on the RT. The helimed aircraft was only seen at the last second, behind and above them.

Analysis of the NATS radar replay was undertaken; neither aircraft was detected by radar at or around the reported time of the Airprox. However, the AW169 pilot provided a GPS log of their flights on that day and the PA28 pilot provided the UKAB with a pictorial representation of their position in the circuit (see Figure 1).

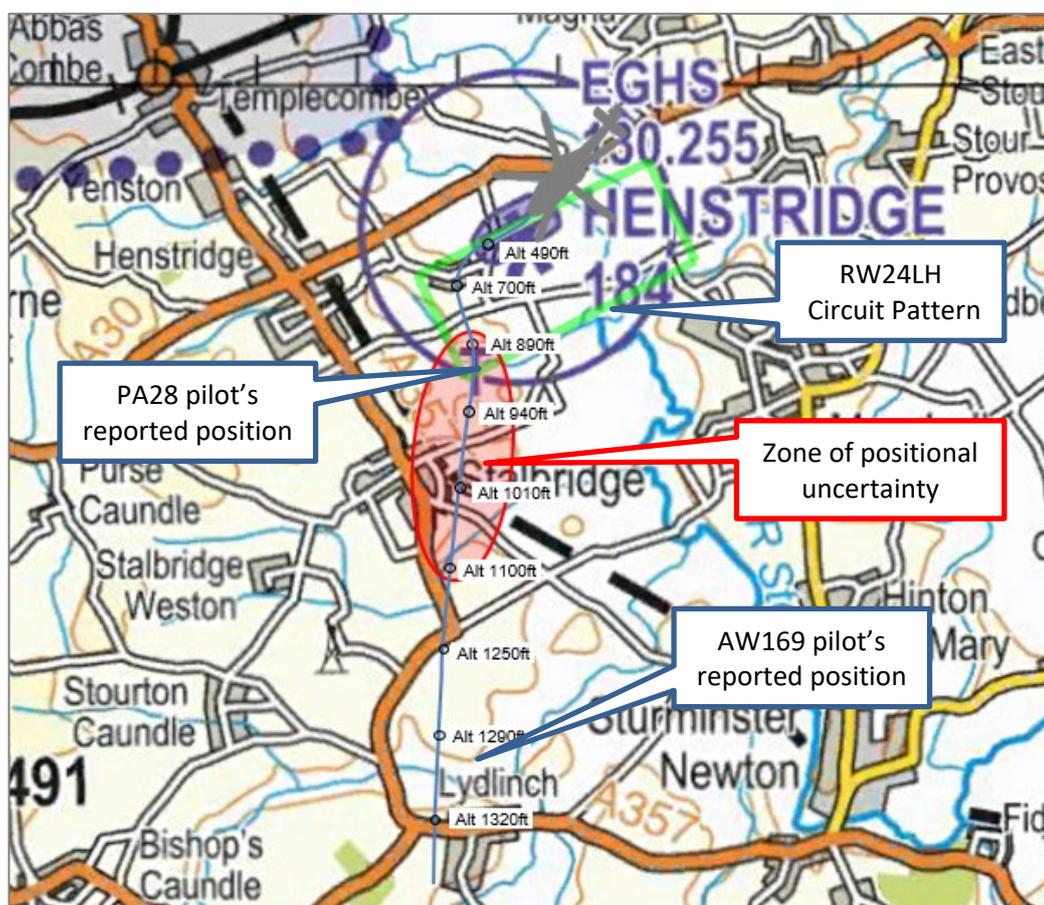
Figure 2

The AW169 crew had recorded the position of the Airprox using 2 different sources of navigational equipment – this position was recorded as N5055.46 W00222.22 which placed the aircraft approximately 3.4NM south of Henstridge airfield. The PA28 pilot reported joining the airfield from the west, positioning between the villages of Henstridge and Stalbridge to establish directly onto the downwind leg. The approximate positions of each pilot's report of the Airprox location are shown in Figure 2.

The reported positions of the Airprox from both pilots differed by approximately 2.5NM. However, from the GPS data provided, the AW169 pilot's reported altitude of 1300ft was coherent with their reported position of the event. Without any recorded data for the PA28, it has not been possible to establish the true location of the Airprox. The pilots' reports were consistent in that they both reported the AW169 as passing above the PA28 – of note, the AW169's altitude as it crossed the published downwind track of the Henstridge RW24LH circuit was recorded at 915ft (~730ft aal), and the AW169 reached an altitude of 1010ft (~835ft aal – slightly above the published Henstridge circuit height) when slightly to the SE of Stalbridge. There is, therefore, a zone of uncertainty as to the true location of the Airprox (as depicted in Figure 2).
