## AIRPROX REPORT No 2020151

Date: 22 Oct 2020 Time: 1405Z Position: 5153N 00126W Location: 3.5NM NW Oxford

### PART A: SUMMARY OF INFORMATION REPORTED TO UKAB

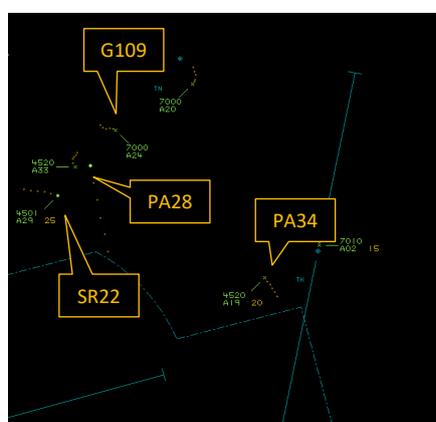
Figure 1 – 1403:00

The PA34 pilot contacted Oxford Radar at 1403:00 requesting a Basic Service. The Oxford Radar controller confirmed the Basic Service, the QNH and issued a transponder code which was all read back correctly (Figure 1).

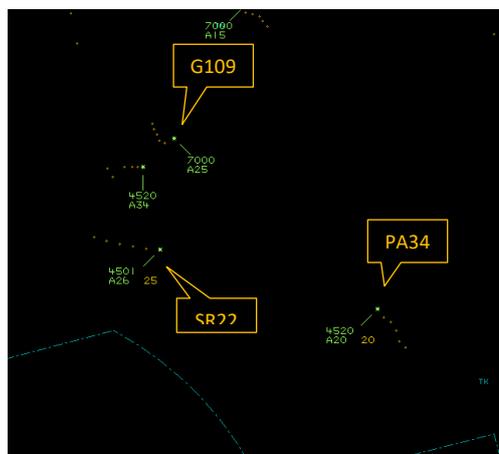
Figure 2 – 1403:36

At 1403:36 the radar controller passed Traffic Information on the PA34 to an SR22 pilot who was receiving a Traffic Service to the west of Oxford tracking east (Figure 2). The Traffic Information was updated at 1403:55 and the SR22 pilot reported visual with the PA34 (Figure 3).

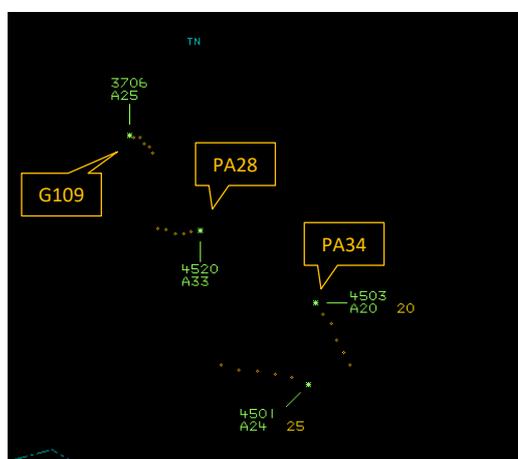
Figure 4 – 1404:20

The transponder code for the Grob 109 was seen to change to 3706 (Brize Norton) at 1404:03. At 1404:08 the Oxford controller passed reciprocal Traffic Information to the PA34 pilot on the SR22. The pilot reported visual with the aircraft and requested removal of a level restriction. The controller removed the level restriction at 1404:20 and then passed Traffic Information; *“traffic northwest 2 miles indicating 3400ft”*. The PA34 pilot acknowledged the Traffic Information and advised *“traffic sighted, two, two targets in our north west”* (Figure 4). The controller then reduced the Traffic Service to the SR22 as it approached the radar overhead and dealt with an aircraft leaving the frequency (1404:40 – Figure 5).

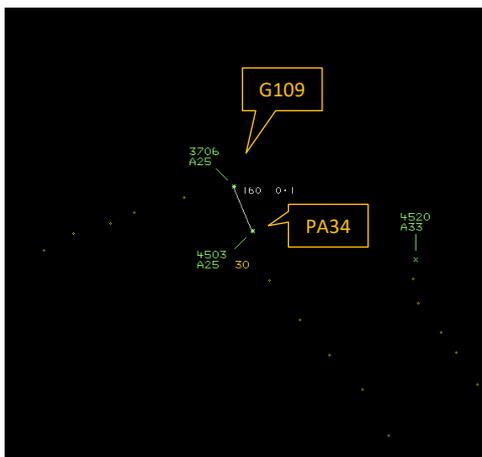
Figure 6 – 1405:15 (CPA)

There were no further transmissions and CPA occurred at 1405:15 with the aircraft separated by less than 100ft and 0.1NM (Figure 6). At 1408:10 the pilot of the PA34 called the Oxford controller advising that they wished to file an Airprox against the Grob 109.

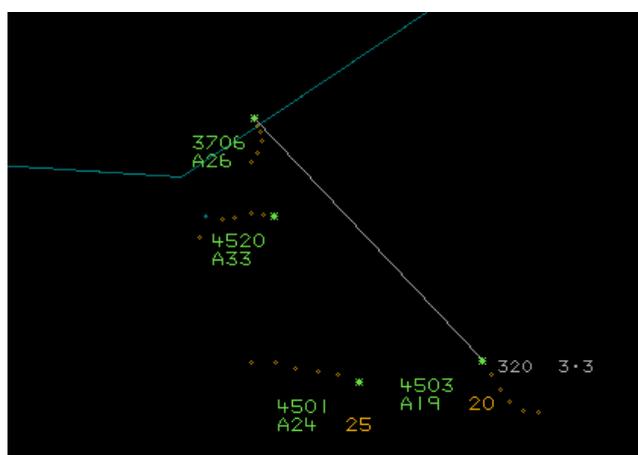
The Grob 109 had requested a Basic Service and a zone crossing clearance from Brize Zone and was issued a squawk by the Brize Norton controller. Twenty six seconds after the squawk was issued it could be seen on the radar screen. Separation between the Grob 109 and the PA34 was 3.3NM and 700ft (Figure 8).

Figure 8:  
Grob 109 squawk observed.

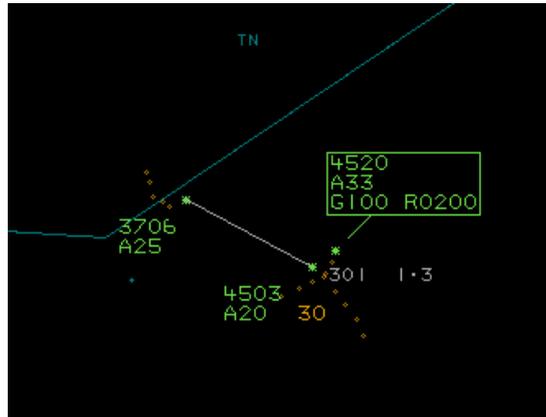
The Grob 109 pilot readback the Brize Norton CTR crossing clearance and was passed the Brize Norton QNH. Separation had decreased between the Grob 109 and the PA34 to 1.3NM and 500ft. One second after passing the Brize QNH the PA34 Mode C changed to indicate the PA34 was climbing.

Figure 9:  
Grob 109 passed the Brize Norton QNH

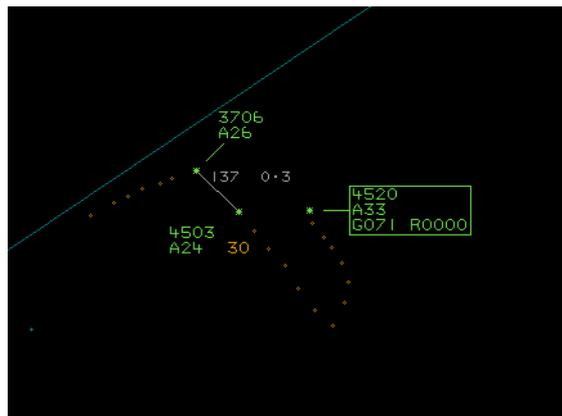
Traffic Information was passed to the Grob 109 pilot on multiple tracks SE, 1NM similar level, 17sec after the Brize QNH was passed. Separation between the Grob 109 and the PA34 reduced to 0.3NM and 200ft.

Figure 10: Grob 109 Passed Traffic Information

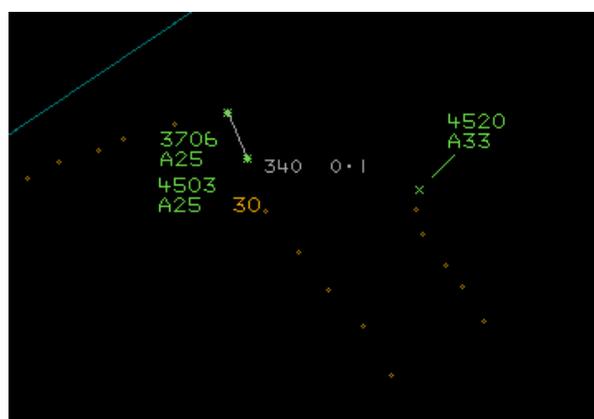
CPA occurred six seconds after the Traffic Information was passed between the Grob 109 and the PA34. Separation was measured at 0.1NM and 0ft.

Figure 11:  
CPA between Grob 109 and PA34
