## AIRPROX REPORT No 2020154

Date: 26 Oct 2020 Time: 1551Z Position: 5239N 00032E Location: RAF Marham

### PART A: SUMMARY OF INFORMATION REPORTED TO UKAB

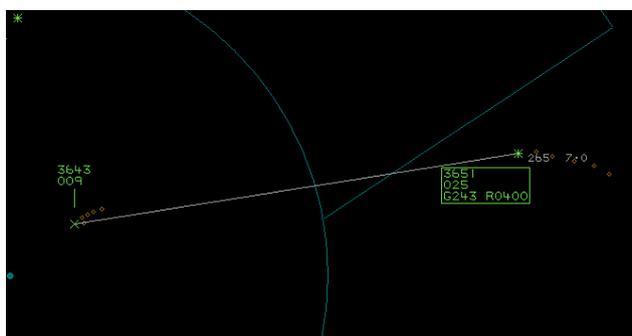
Figure 1:  
F35s report visual with the Aerodrome.

Figures 1-5 show the positions of the F35s and the Tutor at relevant times in the lead up to and during the Airprox. The screen shots are taken from a replay using the NATS Radars, which are not utilised by Marham and therefore may not be entirely representative of the picture available to the Marham Controllers. The F35s, under a Traffic Service, were conducting a visual recovery to the airfield and had been provided with Traffic Information on the Tutor which was conducting an ILS approach. The F35s were advised that the Tutor would be departing after their approach climbing to 4000ft. After the F35s reported visual with the aerodrome (Figure 1) they were provided with further Traffic Information on another formation before being directed to switch to the Tower frequency 12sec later. The separation between the Tutor and the F35s when they were directed to switch frequency was estimated to be 5.8NM and 1600ft (Figure 2).

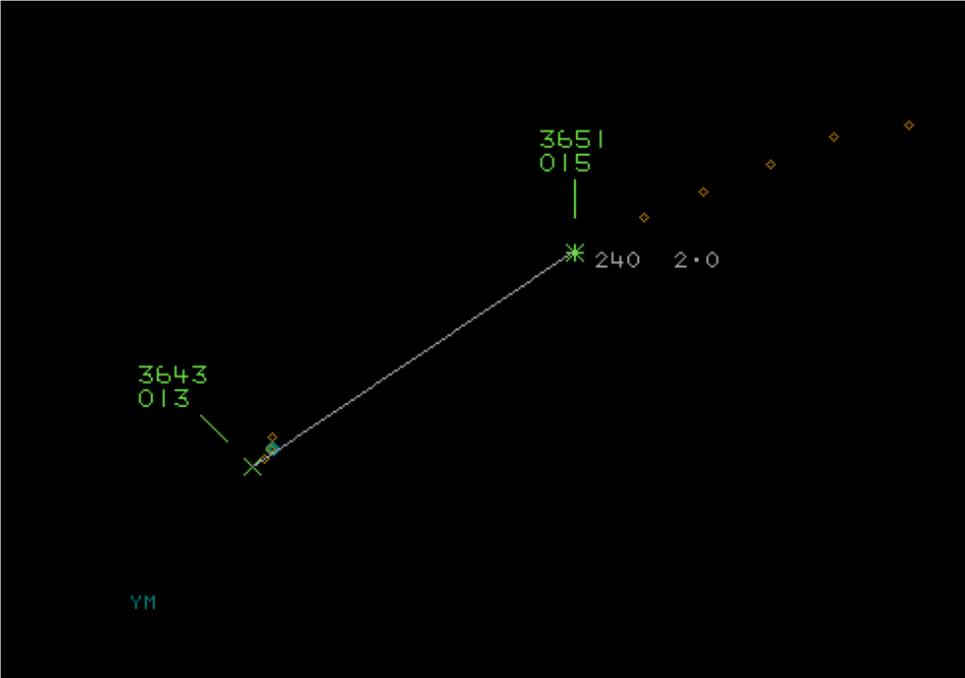
Figure 3: Traffic Service agreed between the Tutor and Marham Approach.

The Tutor reported on frequency with Marham Approach after completing their ILS approach and requested a Traffic Service. Eleven seconds later a Traffic Service was agreed (Figure 3). Separation decreased to 2nm and 200ft.

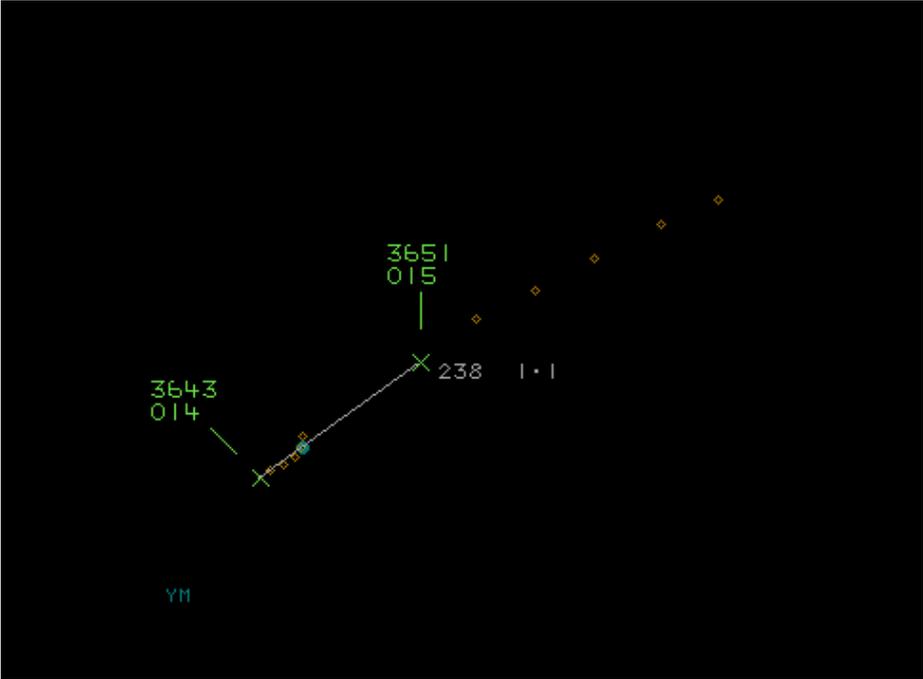
Figure 4: Tutor advised Marham Approach of the approach F35s.

Eleven seconds later the Tutor reports that they had two fast jets approaching from the rear (Figure 4). Separation between the Tutor and the F35s decreased to 1.1nm and 100ft.

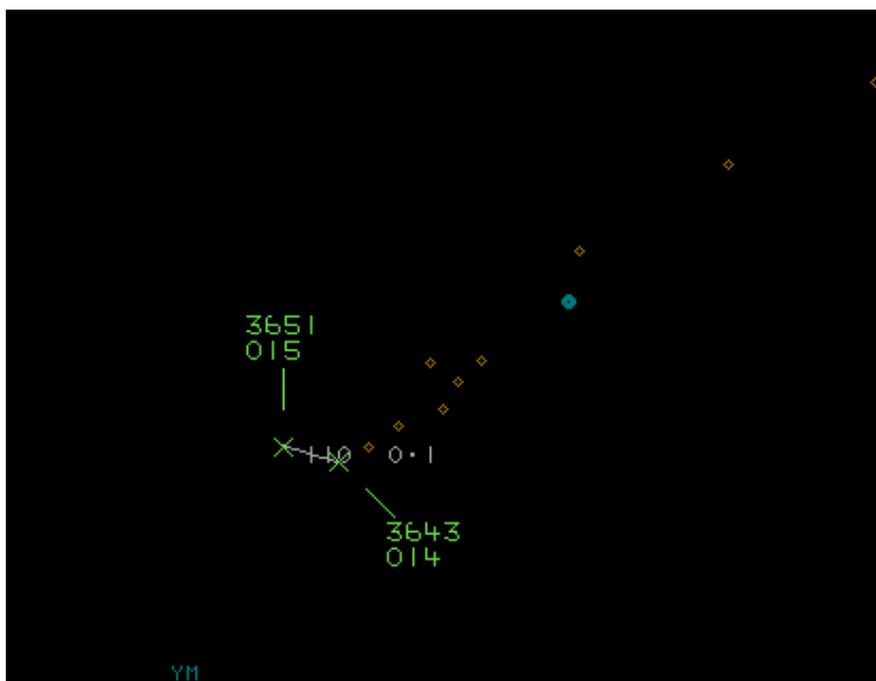
Figure 5: CPA

The Tutor was advised that the F35s were joining the Visual Circuit and CPA occurred six seconds later (Figure 5). Separation was measured at 0.1NM and 100ft.
