## AIRPROX REPORT No 2020157

Date: 02 Nov 2020 Time: 1810Z Position: 5804N 0606W Location: 11NM SE of Stornoway

### PART A: SUMMARY OF INFORMATION REPORTED TO UKAB

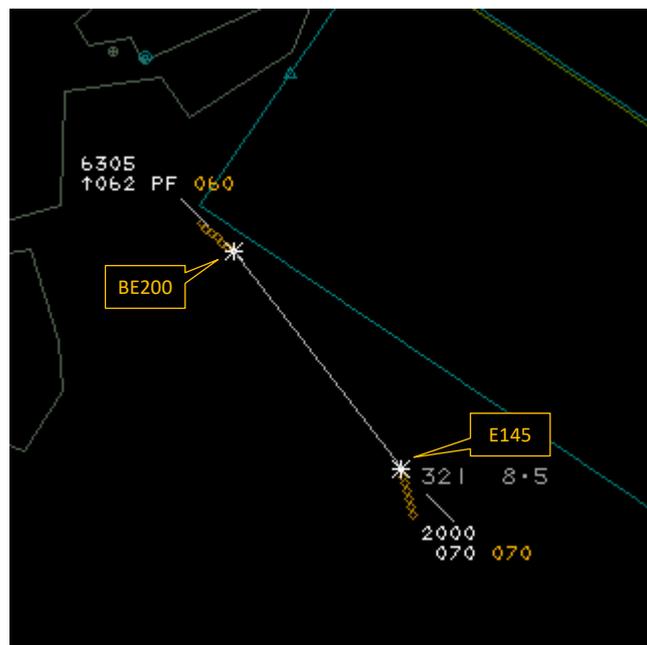
Figure 1 - 18:09.40

At 18:09.40 the BE200 pilot was instructed to report reaching FL060. The pilot confirmed that they were just levelling at FL060 (Figure 1).

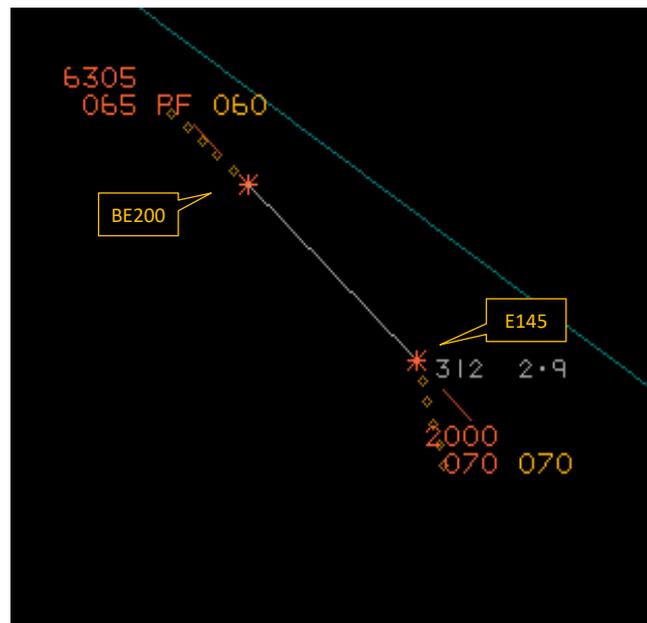
Figure 2 - 18:10:30

At 18:10.30 the controller asked the Embraer 145 pilot to report their level. The pilot responded that they were at FL070 and had a TCAS RA (Figure 2).

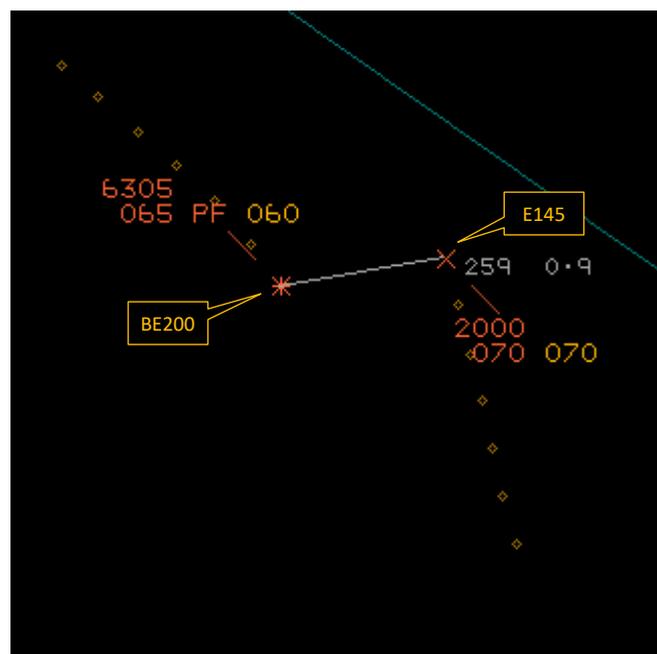
Figure 3 - 18:10:49 CPA

At 18:10.49 CPA occurred, with the aircraft separated by 0.9NM horizontally and 500ft vertically (Figure 3).

The instruction for the BE200 pilot to establish on the 161 radial was issued when the aircraft was in the initial climb phase and during a period of high cockpit workload, resulting in the pilot becoming distracted and omitting to set the standard 1013hPa. The QNH of 995hPa had been set by the BE200 pilot prior to departure, and this resulted in a level bust from what should have been FL060 to FL65.

- Provision of a Flight Information Display (FID) to aid situational awareness and highlight any potential safety issues.
- Use the scenario to increase ATCO awareness on pilot workload in an APP environment.
- ATCOs should include any planned radial, track, route or time restriction instruction as part of the local restriction prior to departure, where applicable.
