**AIRPROX REPORT No 2020158**

Date: 03 Nov 2020 Time: 2017Z Position: 5100N 00238W Location: Yeovilton

**PART A: SUMMARY OF INFORMATION REPORTED TO UKAB**

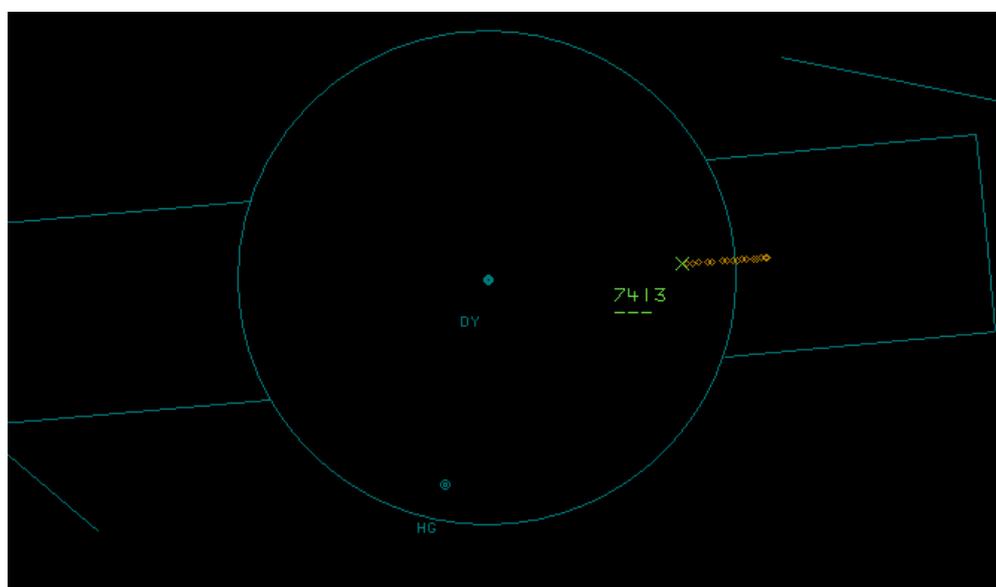
Figure 1: 2016:23

The Airprox could not be seen on the NATS radars due to the aircraft being beneath the radar coverage. At Figure 1 the Wildcat(A) can be seen on the ILS to RW26, however the visual circuit traffic cannot be seen. The Wildcat fades from the NATS radars at the next radar sweep.
