AIRPROX REPORT No 2020162

Date: 12 Nov 2020 Time: 2211Z (Night) Position: 5316N 00213E Location: AARA 8

PART A: SUMMARY OF INFORMATION REPORTED TO UKAB

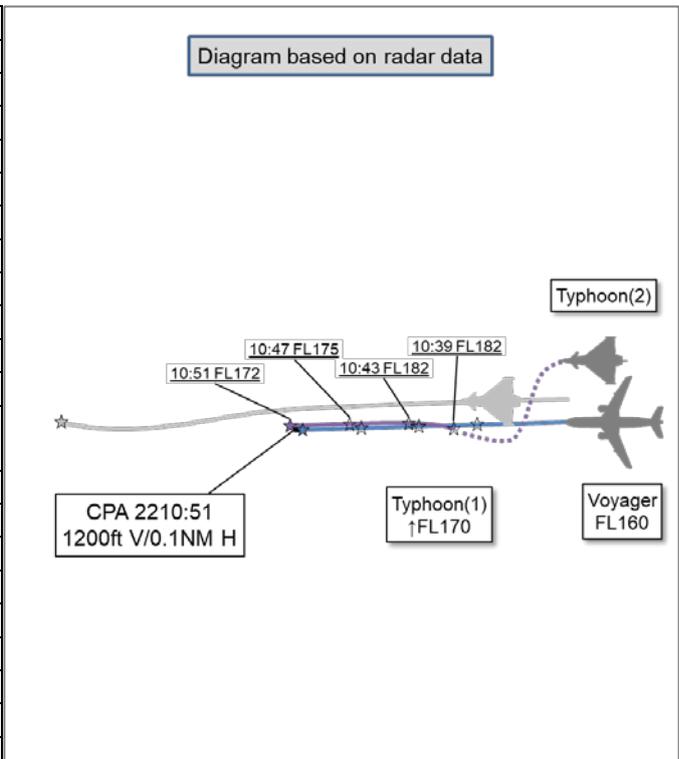
Recorded	Aircraft 1	Aircraft 2
Aircraft	Voyager	Typhoon(2)
Operator	HQ Air (Ops)	HQ Air (Ops)
Airspace	London FIR	London FIR
Class	G	G
Rules	IFR	VFR
Service	Traffic	Traffic
Provider	Swanwick Mil	Swanwick Mil
Altitude/FL	FL160	FL172
Transponder	A, C, S	A, C (S off)
Reported		
Colours	Grey	Grey
Lighting	Strobes, beacons, nav, formation	Strobes, nav
Conditions	VMC	VMC
Visibility	100km	>10km
Altitude/FL	FL160	FL170
Altimeter	SPS	SPS
Heading	280°	NK
Speed	280kt	350kt
ACAS/TAS	TCAS II	Not fitted
Alert	RA	N/A
Separation		
Reported	NK V/NK H	NK V/NK H
Recorded	1200ft V/0.1NM H
