AIRPROX REPORT No 2021005

Date: 28 Jan 2021 Time: 1430Z Position: 5118N 00122W Location: 4NM NE Bourn Park

PART A: SUMMARY OF INFORMATION REPORTED TO UKAB

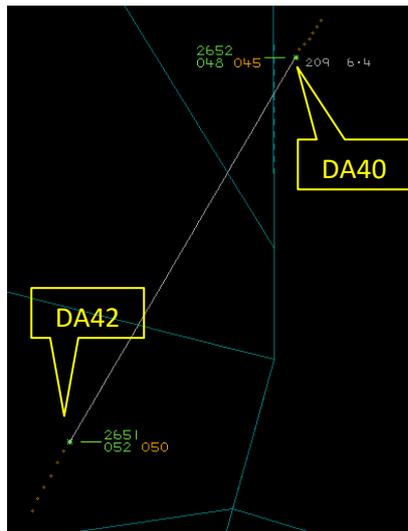
Figure 1: Traffic Information was passed for the second time to the DA42.

Twelve seconds prior to Figure 1, Traffic Information was passed to the DA42 pilot for the first time. Accurate Traffic Information was passed to the DA42 by the controller who was informed that the pilot was not visual with the DA40. Separation was measured at 6.4NM and 400ft.

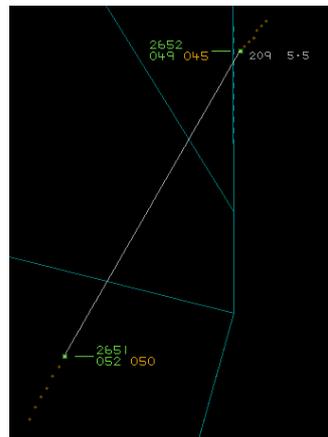
Figure 2: Traffic Information passed to the DA40.

Traffic Information was passed to the DA40 pilot about the DA42 which was acknowledged. Separation decreased to 5.5NM and 300ft (Figure 2).

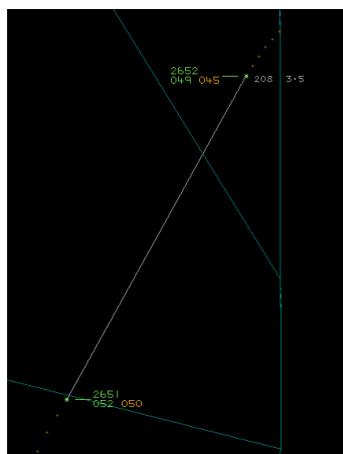
Figure 3: Avoiding action turn given to DA42.

The controller gave the Deconfliction Service 5sec after it was requested by the DA42 pilot, along with an avoiding action turn to the right. After 27sec the DA42 appeared to turn left before initiating the given turn to the right. Separation was measured at 3.5NM and 300ft when the avoiding action turn was given (Figure 3). Separation then decreased to 1.5NM and 400ft when the DA42 appeared to turn left (Figure 4).

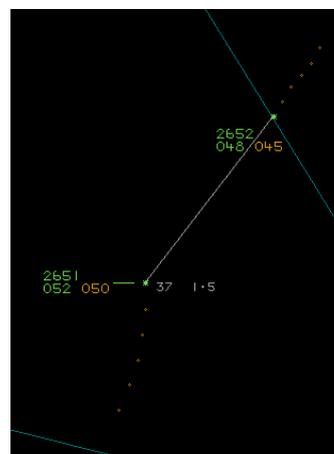
Figure 4: DA42 appeared to turn left.

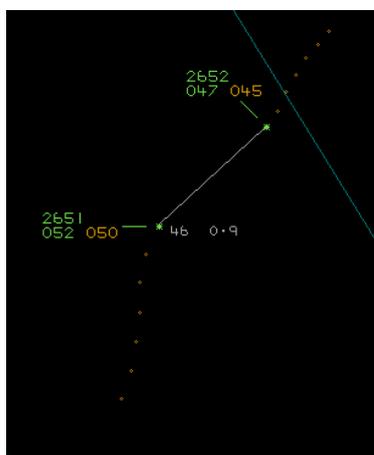
Figure 5:
DA42 begins to turn right as per the avoiding action.

Five seconds later the DA42 begins to turn right as per the avoiding action instruction. Separation was measured at 0.9NM and 500ft (Figure 5). CPA was measured at 0.1NM and 500ft (Figure 6).
