AIRPROX REPORT No 2021009

Date: 21 Feb 2021 Time: 1138Z Position: 5632N 00313W Location: Coupar Angus

PART A: SUMMARY OF INFORMATION REPORTED TO UKAB

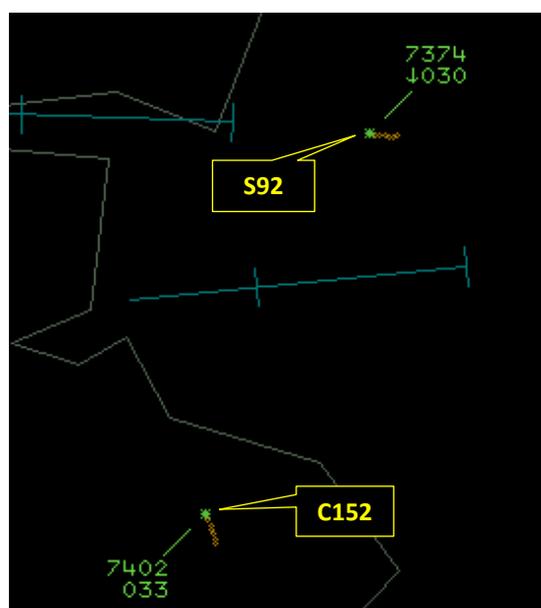
Figure 1 – 1112:20

At **1112:20** the S92 pilot made initial contact with the Dundee controller. The controller passed the Dundee QNH 1003, instructed the pilot to squawk 7374, cleared the pilot for the RNP procedure RW27 and instructed them to report passing OSVID. The pilot provided an accurate readback, advised that they were currently at OSVID, turning inbound for the RNP approach. The controller instructed the pilot to report passing the final approach fix, and this was read back by the pilot. The type of ATC service was not requested or agreed (Figure 1). At **1113:10** the controller asked the S92 pilot for their intentions after the approach. The pilot advised that it would be a low approach and go around, into the visual circuit, followed by a stop/go landing for departure VFR to the north. The controller advised that it would be a left-hand visual circuit RW27. At **1117:50** the positions of the aircraft are shown below (Figure 2).

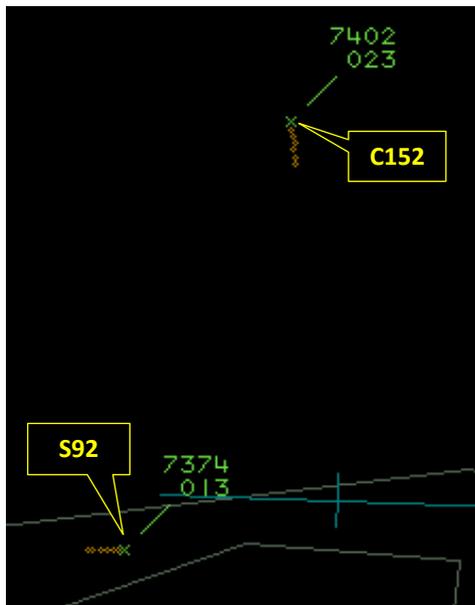
Figure 3 – 1125:00

At **1119:00** the S92 pilot reported at the final approach fix and was cleared for a low approach RW27 and provided with the surface wind. At **1124:00** the S92 pilot reported in the missed approach to join the visual circuit and was instructed to report downwind left-hand. At **1125:00** the positions of the aircraft are shown below (Figure 3). The S92 was approaching downwind left-hand and the C152

was 8NM north of Dundee Airport. At **1126:00** the S92 pilot reported downwind for the stop/go and was instructed to report final and to anticipate a late landing clearance. At **1126:21** the C152 was 9.9NM north of Dundee and the pilot changed from the Leuchars squawk of 7402 to the general conspicuity code of 7000, displayed as V below (Figure 4).

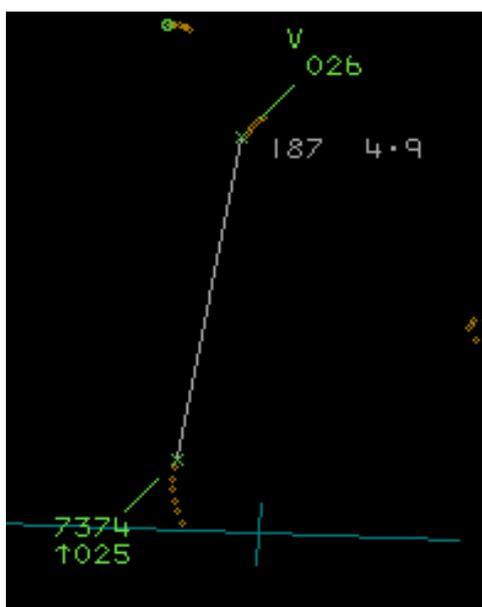
Figure 5 – 1136:04

At **1128:10** the S92 pilot was cleared to land RW27 and was instructed to report ready for departure. At **1131:30** the S92 pilot reported ready for departure and advised that this would be a rolling take-off for a visual departure to the north. The pilot was issued with an instruction to climb straight ahead to altitude 2000ft before turning north. The pilot provided an accurate readback and was cleared for take-off RW27. The type of ATC service to be provided after departure was not requested or agreed. At **1136:04** the positions of the aircraft are shown below (Figure 5). At **1137:33** CPA occurred, with the aircraft separated by 0.2NM laterally and 400ft vertically (Figure 6).

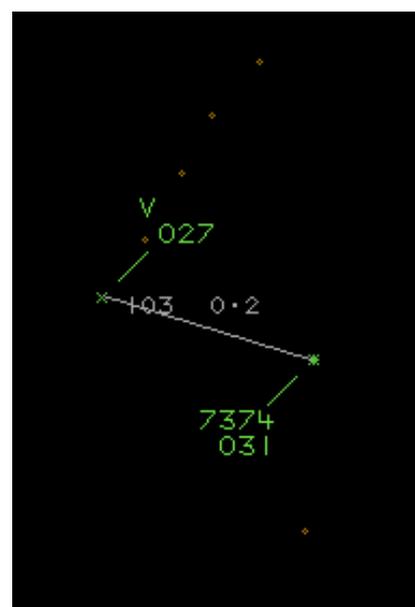
Figure 6 – 1137:33 - CPA
