AIRPROX REPORT No 2021014

Date: 16 Mar 2021 Time: 1749Z Position: 5200N 00141W Location: Moreton-in-Marsh

PART A: SUMMARY OF INFORMATION REPORTED TO UKAB

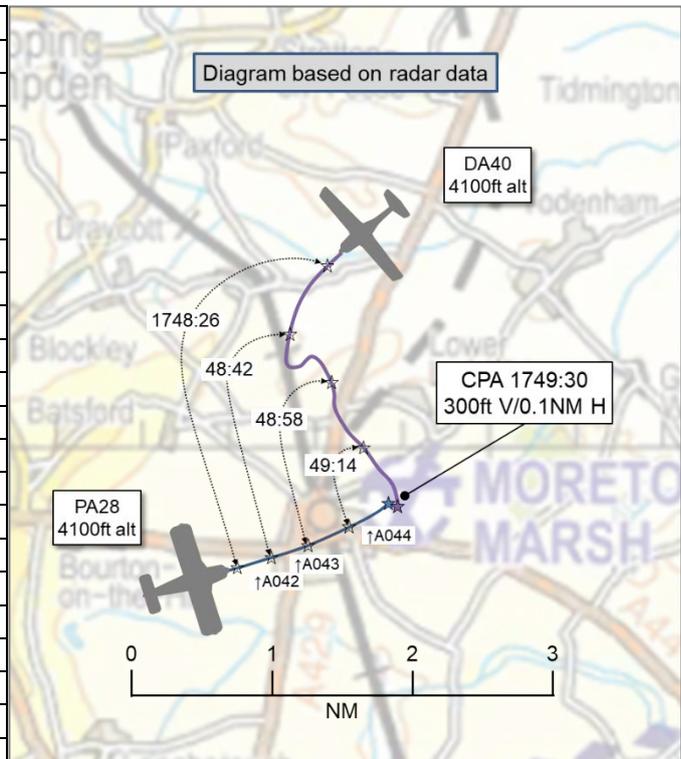
Recorded	Aircraft 1	Aircraft 2
Aircraft	PA28	DA40
Operator	Civ FW	Civ FW
Airspace	London FIR	London FIR
Class	G	G
Rules	VFR	VFR
Service	Listening Out ¹	Basic
Provider	Oxford Approach	Oxford Approach
Altitude/FL	A044	A041
Transponder	A, C, S	A, C, S
Reported		
Colours	White/blue	White/blue/green
Lighting	Beacon, Nav	Nav, position
Conditions	VMC	VMC
Visibility	NR	10km
Altitude/FL	4000ft	4000ft
Altimeter	QNH	QNH
Heading	070°	120°
Speed	90kt	NR
ACAS/TAS	Not fitted	Not fitted
Separation		
Reported	0ft V/350m H	100ft V/1.0NM H
Recorded	300ft V/0.1NM H

An Airprox was reported when a PA28 and a DA40 flew into proximity over Moreton-in-Marsh disused airfield at 1749Z on Tuesday 16th March 2021. Both pilots were operating under VFR in VMC, the PA28 pilot was listening out on the Oxford Approach frequency and the DA40 pilot was in receipt of a Basic Service from Oxford Approach.
