AIRPROX REPORT No 2021015

Date: 24 Mar 2021 Time: 1445Z Position: 5112N 00150W Location: D125 SPTA

PART A: SUMMARY OF INFORMATION REPORTED TO UKAB

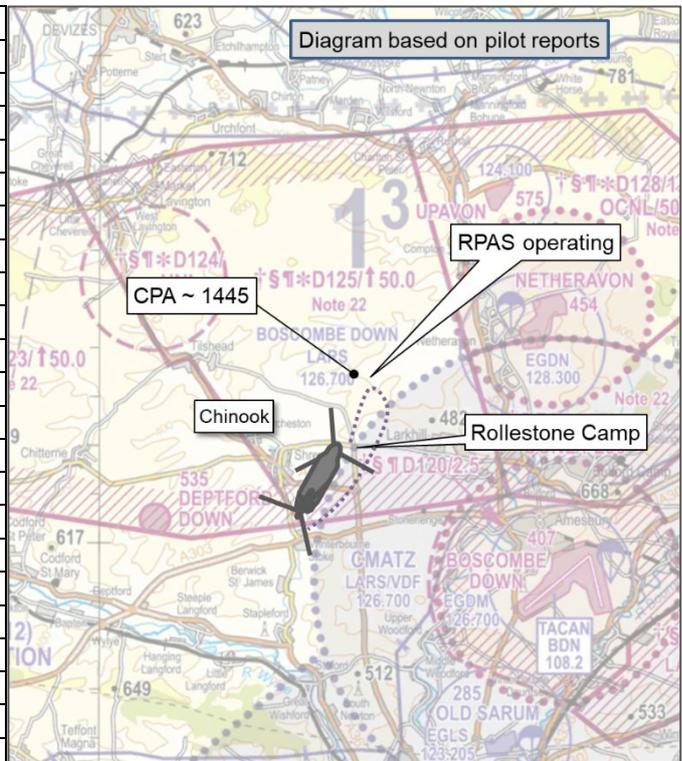
THE RPAS REMOTE PILOT reports that during an Instant Eye Remote Pilot Course live flying activity, they were conducting a basic sortie with a trainee pilot at the northern edge of Horton’s Folly, in Area 13, Salisbury Plain Training Area (SPTA). Another RSA instructor was operating under the same flying practice with another trainee on the middle eastern edge of Horton’s Folly. They had been allocated Area 13 ‘Hot’ from surface to 400ft agl by SPTA Air Operations at approximately 1315hrs. They were operating under Visual Line Of Sight (VLOS) flight rules and conducting flights at VLOS limits. At approximately 1445hrs they both heard a Chinook leaving Rolleston Camp approximately 1500m west of their position, where they knew training sorties were being conducted. At the time, they had two Instant Eye 2 RPAS in the air. Upon the Chinook’s departure from Rolleston Camp it was noted that its flight path was leading directly into their allocated airspace at a height well below their 400ft ceiling. At this point they saw the other instructor’s RPAS land and they had to immediately instruct the trainee to reduce height from around 100ft agl. Within a short time, whilst their RPAS was still in flight at around 30ft agl the Chinook passed directly over the top of Horton’s Folly from West to East, no higher than 150ft agl. This flight path was directly over the other instructor’s position. They immediately reported the incident to SPTA Air Operations. It was stated, by Ops, that the Chinook pilot had been made aware that they were operating in the area. They were not informed prior to the Chinook entering their allocated airspace that it was about to do so. Following the incident, they conducted a ten-minute grounding period to ensure all other air users were clear of their allocated airspace as they could see the Chinook handrailing the eastern edge of SPTA Centre (D125), heading North.

regarding UAS activity ivo Rollestone Camp was passed to 27 Sqn Ops. The pilot checked the SPTA Range Allocation sheet in the 18 Sqn Ops room, which also had no UAS activity briefed to be operating ivo Rollestone Camp. The Air Liaison Officer for the exercising troops had briefed 27 Sqn to utilise a clockwise flow around Rollestone Camp to deconflict air movements and a frequency on which to deconflict from any other traffic operating in the area (in addition to the SPTA Ops frequency). They made use of this frequency and were informed that there was no other known traffic in the area to affect. Following a period of transiting through poor weather and showers immediately south of SPTA, they made comms with SPTA Ops and called for entry to the Plain. They were informed by SPTA Ops that there was UAS activity in D123/D125 and that they should have been pre-briefed of the UAS activity prior to lift. Rollestone Camp is located within D125; as such they assumed that the surrounding area must be clear as they were cleared to the landing site. They were unaware of the proximity of the UAS activity in Area 13, immediately NE of Rollestone Camp. For an expeditious exit of the operating area; the pilot intended to route briefly to the NE of the camp until clear then directly east (through Area 13) on to the standard transit routes at Crossing C for a departure to the north at Rushal, instead of routing south about Durrington. They requested this routing via SPTA Ops in the north-easterly bound transition from the landing site which was denied. They had asked for this clearance after lift as they did not think they would reach SPTA Ops on the ground. The transmission asking them to route south also contained a warning that "*We will probably be DASOR'd against*", which was their first indication that this potential near miss had occurred. They immediately turned south upon hearing of the exact location of the UAS activity in Area 13. From reading the Airprox report, this south-bound turn appears to have taken them within close proximity of the UAS operator.

THE SPTA OPS OFFICER reports that at approximately 1430(Local) the Chinook, (who was participating in priority 1 exercise on SPTA) lifted from Rollestone Camp initially in a northerly direction before turning right to take up a southerly heading to pick up the helicopter low level route from Airman's Cross to route to Keevil. The aircraft took off from Rollestone Camp and at approximately 200ft agl and half way through the turn on to a southerly heading, routed over into Area 13 which was active with MUAS activity.
