**AIRPROX REPORT No 2021020**

Date: 30 Mar 2021 Time: 1114Z Position: 5144N 00023E Location: 3NM W of Chelmsford

**PART A: SUMMARY OF INFORMATION REPORTED TO UKAB**

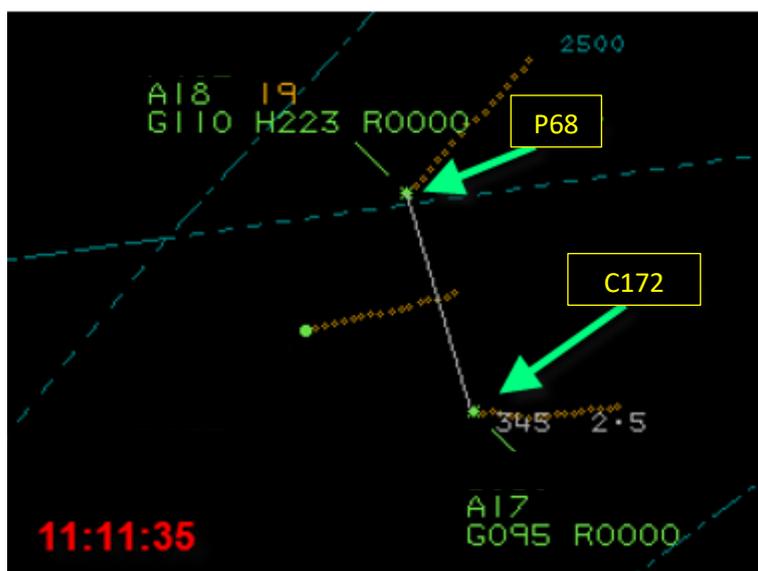
Figure 1

At **1111:35**, the SS INT [controller] provided further Traffic Information to [the P68 pilot], stating that the previous traffic had just cleared to the right, in [the P68] pilot's 12 o'clock, and that the "*next one is left, ten o'clock, two miles, westbound, indicating one thousand seven hundred feet*" (see Figure 1). This referred traffic was [the C172] (Mode-A code 5050, Southend Listening).

The pilot of [the P68] responded “*I have traffic in sight, thank you*”. As there were two aircraft positions described by the SS INT [controller] in this single transmission, it cannot be determined whether the pilot had both aircraft in sight.

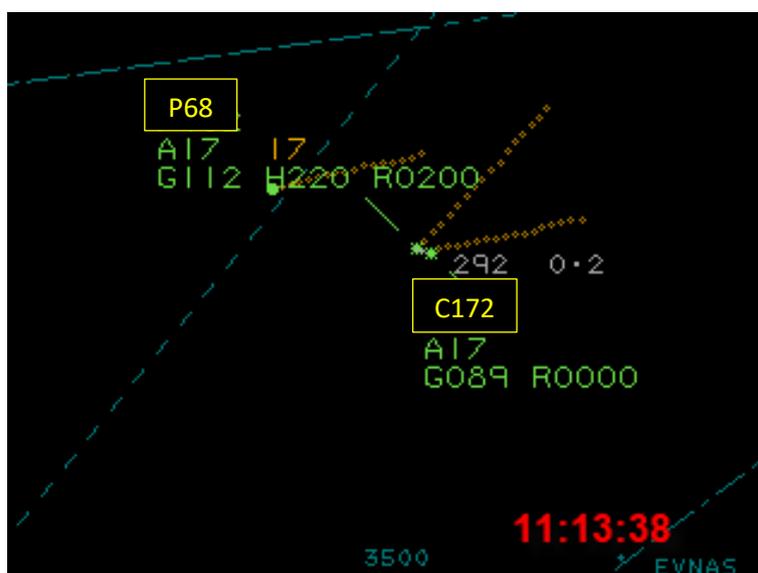
Figure 2

At **1113:18**, the radar displayed [the P68] descend to an altitude of 1600ft whilst initiating a slight left turn of less than 5°, converging further with [the C172] that was also initiating a gradual left turn onto a south-westerly track. [The P68 pilot] initiated a reciprocal right turn onto the approximate previous track of 224° which was displayed over the following two radar updates, before [the P68] displayed an altitude of 1700ft at **1113:34**. The Airprox report from the pilot of [the P68] stated that at “~200m” the pilot of [the P68] turned right to avoid the conflicting aircraft. Radar data did not correspond with the pilot narrative. Safety Investigations assessed the closest point of approach between [the P68] and [the C172] occurred at **1113:38** and was recorded on the LTC Multi-Track radar as 0.2NM and 0ft (see Figure 2).

This proximity was maintained on approximate parallel tracks for two further radar updates, prior to **1113:46** when [the P68 pilot] initiated climb to an altitude of 1800ft, and [the C172 pilot] furthered their left turn onto a diverging track. [The P68] continued on a radar derived track of 217°.
