AIRPROX REPORT No 2021028

Date: 19 Apr 2021 Time: 1032Z Position: 5127N 00120W Location: Chieveley

PART A: SUMMARY OF INFORMATION REPORTED TO UKAB

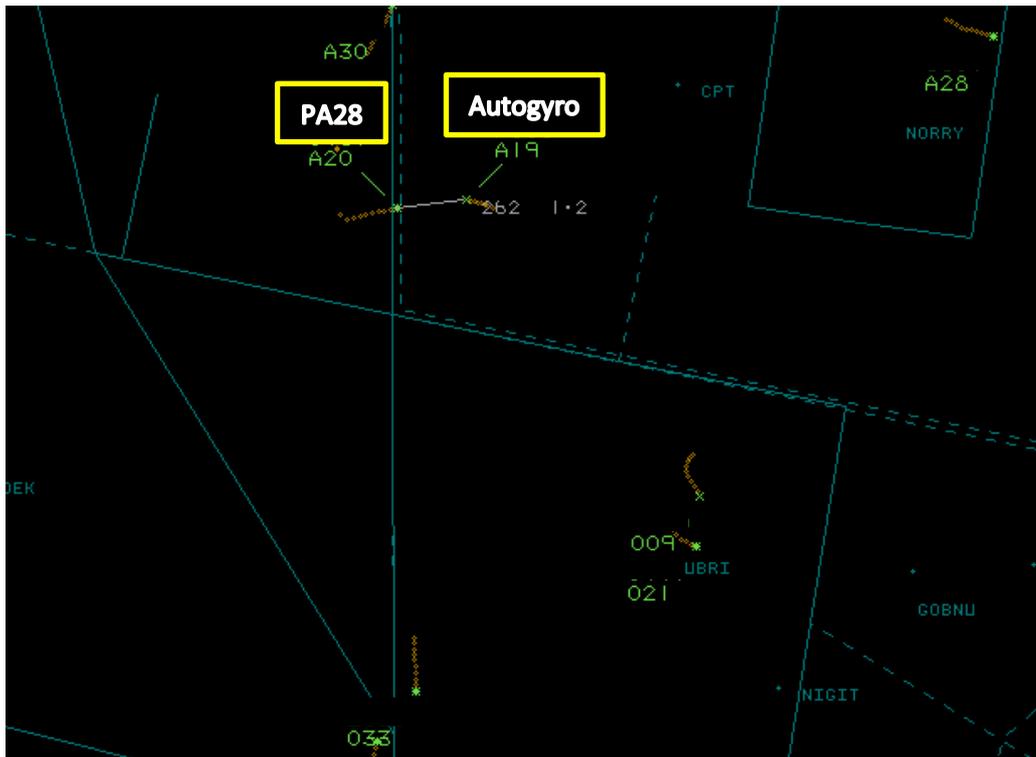
Figure 1 - 1031:17

The radar replay was reviewed, which showed the description of the event from the controller's report was accurate. The controller was asked for their recollection of their use of the pan facility on the radar and whether this had any relevance to the detection, or otherwise, of any risk of collision relating to the event. The controller responded that they were engaged on other tasks looking

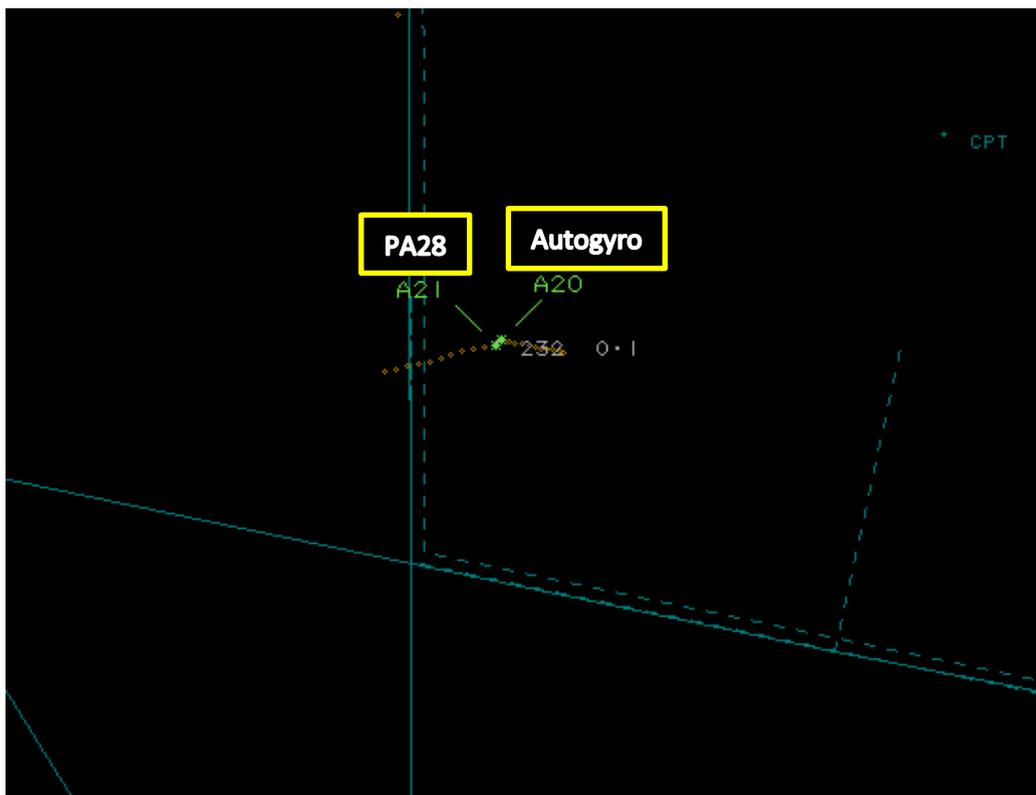
Figure 2 - 1031:42 - CPA

Finally, the Board considered the risk involved in this event. Members noted that the two pilots had assessed the risk of collision as 'medium' and 'high' respectively. They also noted that the CPA, as measured on the NATS radars, showed a vertical separation of only 100ft and a horizontal separation of less than 0.1NM. Members quickly agreed that there had been a risk of collision (**CF8**) and then discussed whether this separation had been generated by the actions of both pilots or whether it had been entirely fortuitous that the 2 aircraft had missed each other. The majority view was that the avoidance manoeuvres from both pilots had generated sufficient separation to reduce the risk of collision, but not to remove it entirely, and that safety had been much reduced. Accordingly, the Board assigned a Risk Category B to this Airprox.

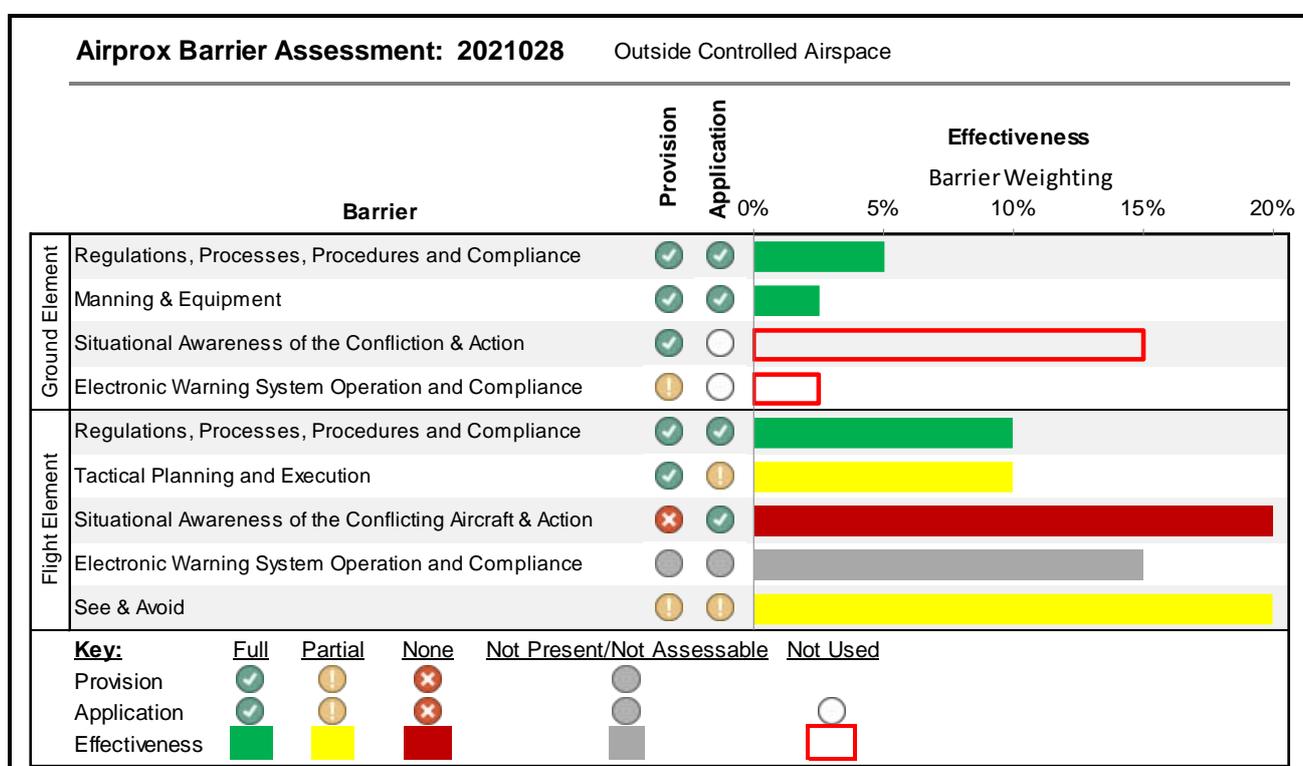
In assessing the effectiveness of the safety barriers associated with this incident, the Board concluded that the key factors had been that:

Situational Awareness of the Confliction and Action were assessed as **not used** because the Farnborough LARS West controller was not required to monitor the PA28 under the terms of a Basic Service.

Electronic Warning System Operation and Compliance were assessed as **not used** because the STCA ‘Select Frame’ available to the Farnborough LARS West controller does not include aircraft below an altitude of 2300ft or alarm against those aircraft displaying a 7000 transponder code.

Tactical Planning and Execution was assessed as **partially effective** because the Autogyro pilot had not chosen to seek an Air Traffic Service, thus denying both the Farnborough controller and the PA28 pilot the opportunity to gain situational awareness of the aircraft’s presence.

Situational Awareness of the Conflicting Aircraft and Action were assessed as **ineffective** because neither pilot had any situational awareness of the other aircraft’s presence prior to the pilots sighting each other’s aircraft.

See and Avoid were assessed as **partially effective** because neither pilot saw the other aircraft until such time as avoiding action had to be taken by both pilots.
