**AIRPROX REPORT No 2021034**

Date: 24 Apr 2021 Time: 0942Z Position: 5226N 00121W Location: 3NM SE Nuneaton

**PART A: SUMMARY OF INFORMATION REPORTED TO UKAB**

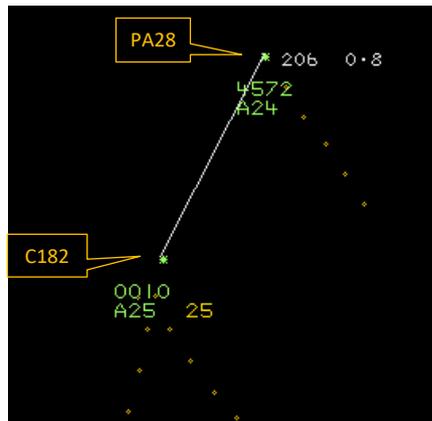
Figure 1 - 09:38.00

At 09:38.00 the controller confirmed the Basic Service again and instructed the PA28 pilot to squawk 4571 (Figure 1). Both aircraft were approximately 32NM south of East Midlands Airport and are likely to have been close to the edge of the controller situational display.

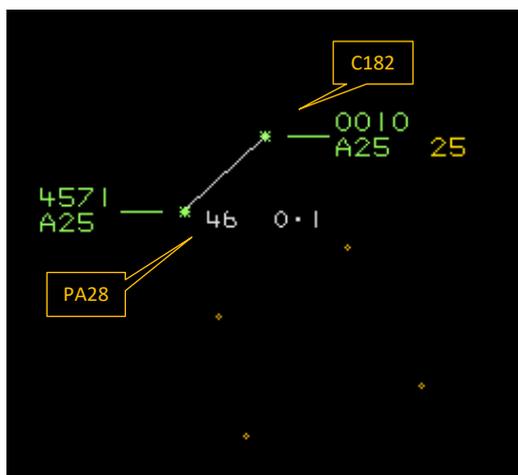
Figure 5 – 09:42.15 CPA

At 09:42.15 CPA occurred, with the two aircraft displayed at the same altitude and 0.1NM apart.

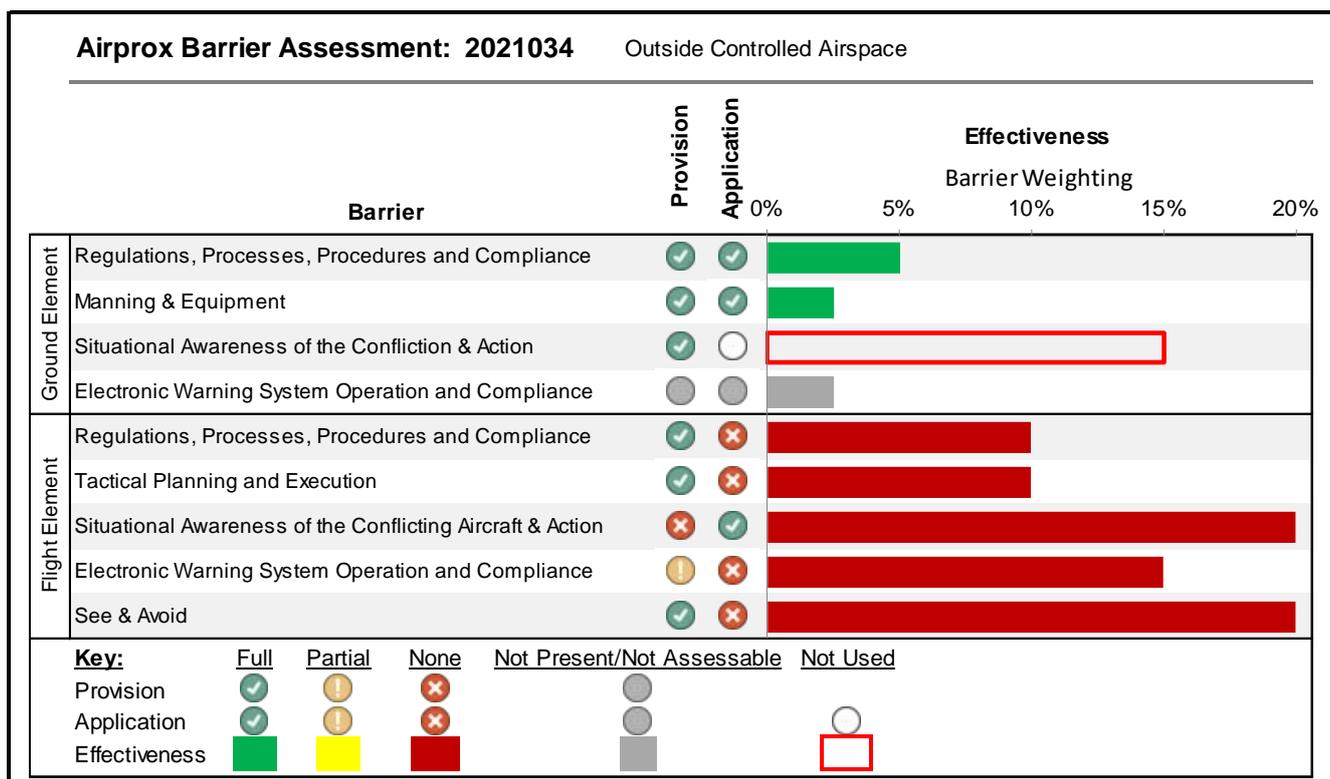
**Regulations, Processes, Procedures and Compliance** were assessed as **ineffective** because the C182 pilot did not continue to give way whilst overtaking.

**Tactical Planning and Execution** was assessed as **ineffective** because the C182 perceived that the PA28 would give way once they were on the right, when in fact the overtaking regulation still applied.

**Situational Awareness of the Conflicting Aircraft and Action** were assessed as **ineffective** because the PA28 pilot had no situational awareness that the C182 was overtaking.

**Electronic Warning System Operation and Compliance** were assessed as **ineffective** because the SkyEcho in the PA28 did not alert as expected.

**See and Avoid** were assessed as **ineffective** because the PA28 pilot did not see the C182 in time to take avoiding action and the C182 pilot did not allow sufficient separation as they overtook the PA28.
