AIRPROX REPORT No 2021043

Date: 20 Apr 2021 Time: 1056Z Position: 5216N 00111W Location: Daventry

PART A: SUMMARY OF INFORMATION REPORTED TO UKAB

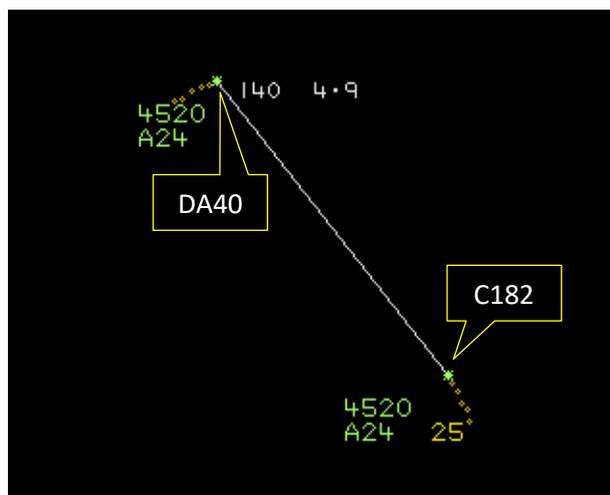
Figure 1 – 1054:31

At **1054:31** the two aircraft were 4.9NM apart, with the C182 predicted to pass well behind the DA40 (Figure 1). Nine seconds later, the controller passed Traffic Information to an aircraft on a Traffic Service, engaged in a telephone conversation with the Tower controller, and responded to an RTF call from an aircraft in the instrument training pattern. During this period, the DA40 pilot had turned onto a southerly heading, and this took the aircraft into direct conflict with the C182.

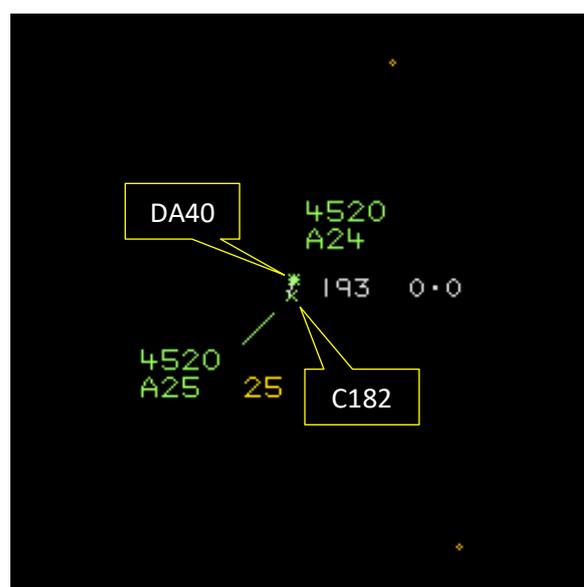
Figure 4 – 1056:02 – CPA

At **1056:00** the controller responded to an RTF call from instrument training traffic, transferred from the Tower frequency to the Radar frequency after the go-around, and a Traffic Service was agreed. At **1056:02** CPA occurred, with the aircraft separated by 0.0NM laterally and 100ft vertically (Figure 4).
