AIRPROX REPORT No 2021044

Date: 01 May 2021 Time: 1038Z Position: 5051N 00313W Location: Dunkeswell – elev 839ft

PART A: SUMMARY OF INFORMATION REPORTED TO UKAB

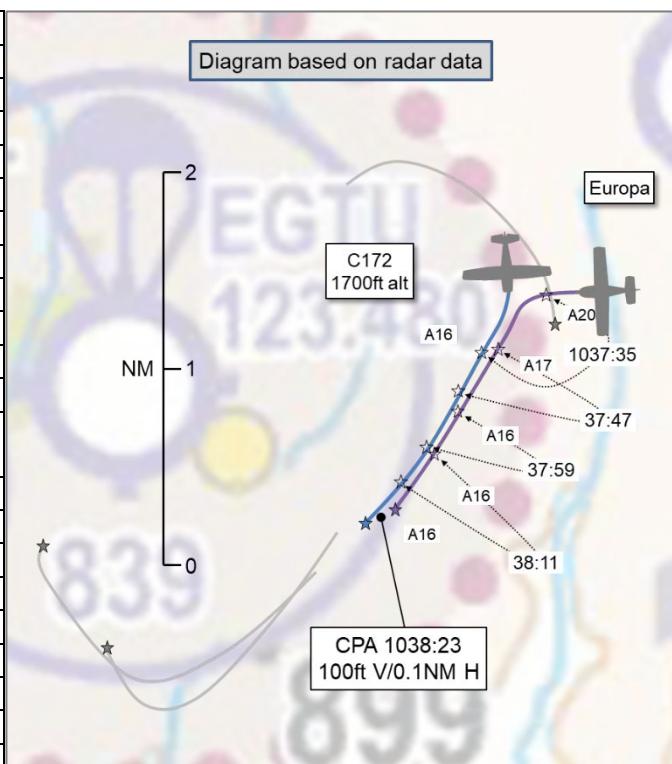
CPA occurred at about 1038:23 and the C172 is seen to climb on radar at 1038:43. The Europa maintained a separation of about 0.2NM whilst downwind, apart from a single sweep with separation of 0.1NM which was deemed to be CPA. The low altitude of the aircraft resulted in some radar track instability.

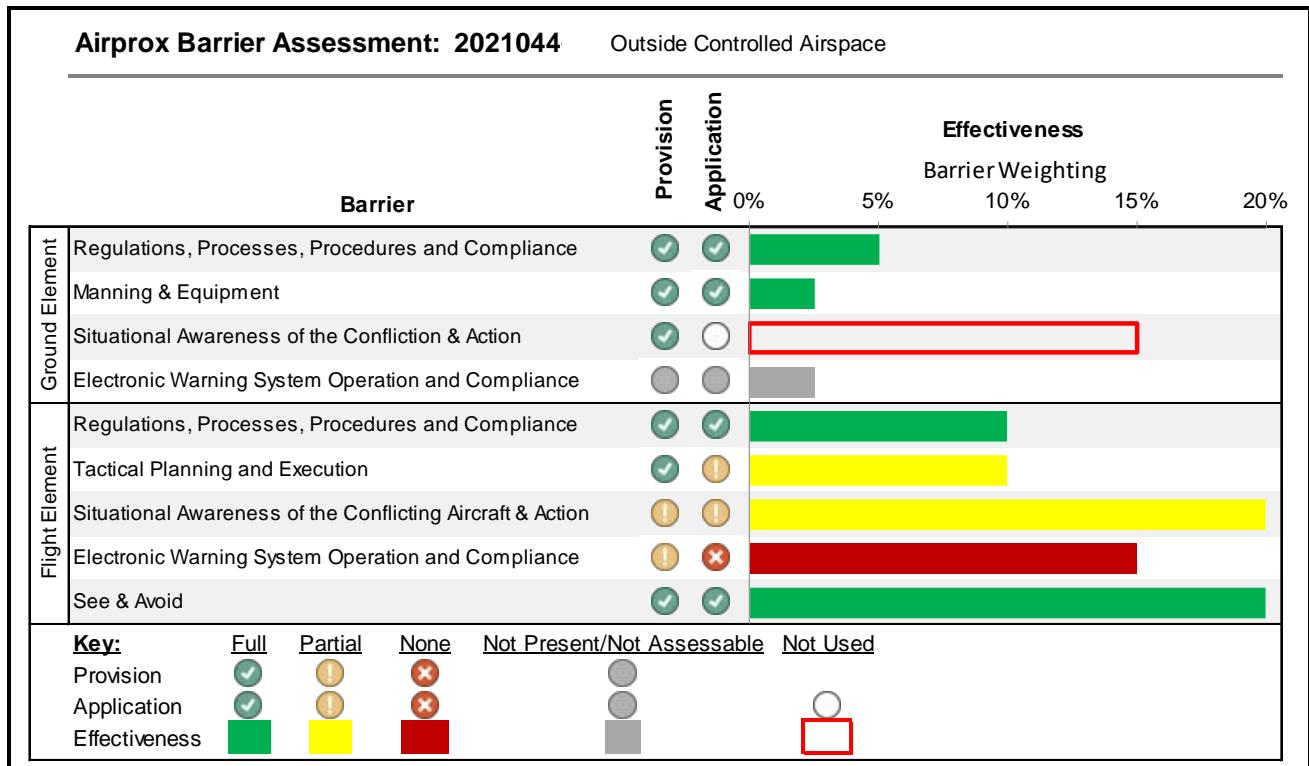
Situational Awareness of the Confliction and Action were assessed as **not used** because both pilots were in receipt of an AGCS.

Tactical Planning and Execution was assessed as **partially effective** because the Europa pilot did not allow sufficient longitudinal separation behind the C172 when joining downwind.

Situational Awareness of the Conflicting Aircraft and Action were assessed as **partially effective** because the C172 was not aware of the joining Europa until informed of its proximity by another pilot downwind.

Electronic Warning System Operation and Compliance were assessed as **ineffective** because the Europa pilot either did not act on the alert or it did not alert as expected.
