AIRPROX REPORT No 2021045

Date: 27 Apr 2021 Time: 1512Z Position: 5129N 00045W Location: White Waltham circuit

PART A: SUMMARY OF INFORMATION REPORTED TO UKAB

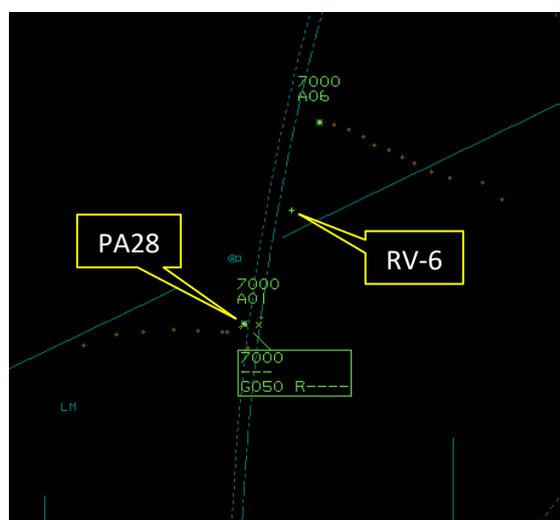
Figure 1 – 1510:26

The PA28 had been conducting circuits and, at 1510:26, was reacquired on both primary and secondary radar on climb out; a primary contact appeared at the same time in a position coincident with the GPS log supplied by the RV-6 pilot (See Figure 1).

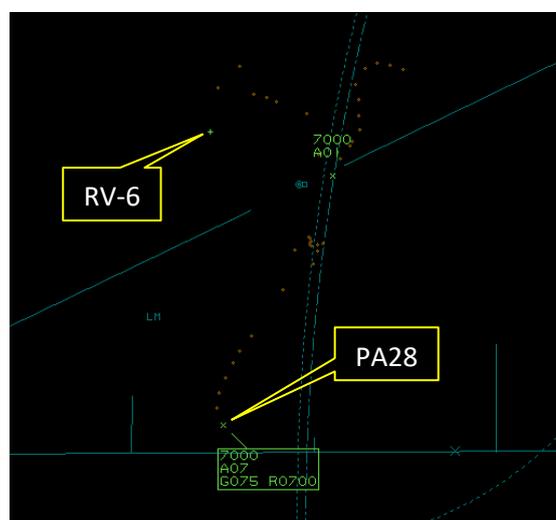
Figure 2 – 1511:00

At 1511:00 (Figure 2) the PA28 was climbing and turning crosswind as the RV-6 was making a continuous turn and a shallow descent to 1100ft (note: this assessment was made with reference to the GPS data supplied by the RV-6 pilot – the primary radar track was too unstable at this time for an accurate assessment of aircraft track to be made). Shortly after this time the 2 aircraft were flying parallel crosswind tracks.

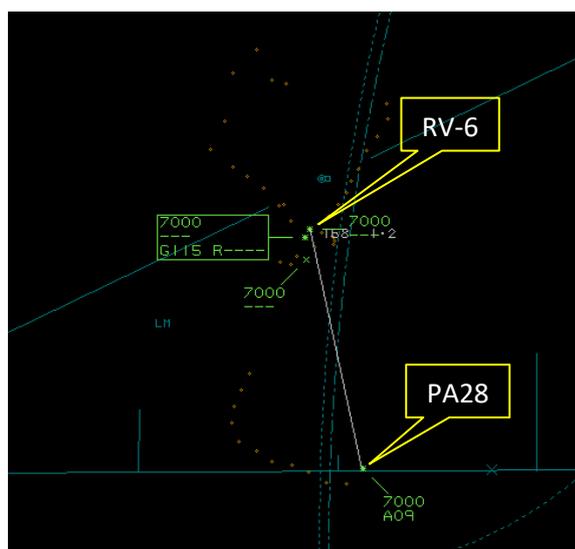
Figure 3 – 1511:26

At 1511:26 (Figure 3) the PA28 pilot had completed their turn onto the downwind leg, placing the aircraft on a 90° intercept path. The PA28 was established at an altitude of 900ft (approximately 800ft aal), as was the RV-6 (altitude data from GPS). Both aircraft then remained at an altitude of 900ft, and approximately the same relative bearing, until CPA at 1511:58 (Figure 4). CPA was measured at ~0ft V (altitude from 2 different data sources) and <0.1NM H.
