AIRPROX REPORT No 2021054

Date: 02 May 2021 Time: 0953Z Position: 5319N 00142W Location: Bradwell Edge, Peak District

PART A: SUMMARY OF INFORMATION REPORTED TO UKAB

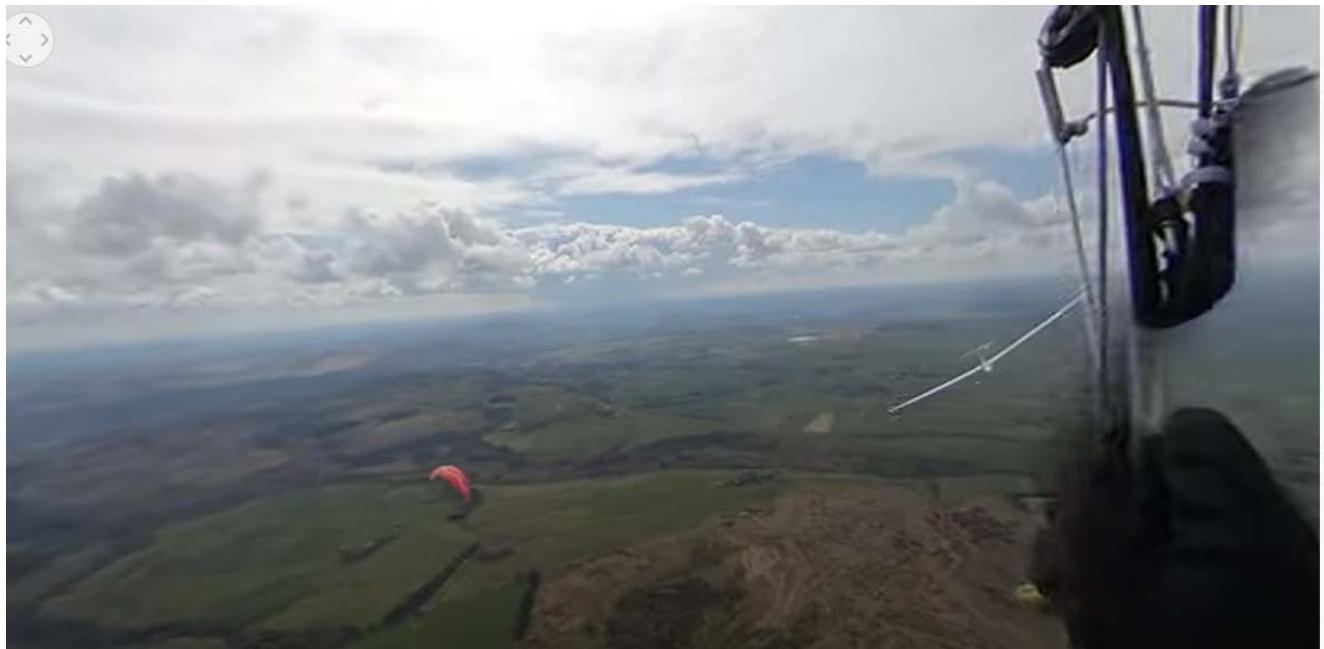
THE PARAGLIDER PILOT reports that they were thermalling in a tight gaggle (around 100m diameter) with other paragliders. A sailplane had been thermalling with the paragliders for some minutes - definitely in excess of the 2.5min since the paraglider pilot joined the thermal. Up until this point, the sailplane had been making circles around the paragliders estimated diameter 500+ m. At 0953:03 the sailplane's orbit coincided with the gaggle of paragliders. The sailplane passed through the gaggle of paragliders with 20ft separation.

The paraglider pilot provided the UKAB with a copy of their video footage, see Figure 1 for a still image taken from that footage.

The BHPA noted that the fact that the PG pilot makes an oral exclamation before the sailplane has flown underneath, suggests that they knew exactly where the sailplane was and was actually looking to their right to keep it in view. The PG pilot would have assumed that the sailplane pilot had visually acquired them beforehand and intended to pass by with sufficient clearance but it is clear from the video that the sailplane pilot had not seen this particular PG pilot. It is extremely fortuitous that the sailplane narrowly avoided hitting the PG pilot and you can hear the fear and surprise in their voice knowing that they are helpless and unable to avoid the expected collision.
