AIRPROX REPORT No 2021060

Date: 27 May 2021 Time: 1151Z Position: 5104N 00102W Location: Colemore Common

PART A: SUMMARY OF INFORMATION REPORTED TO UKAB

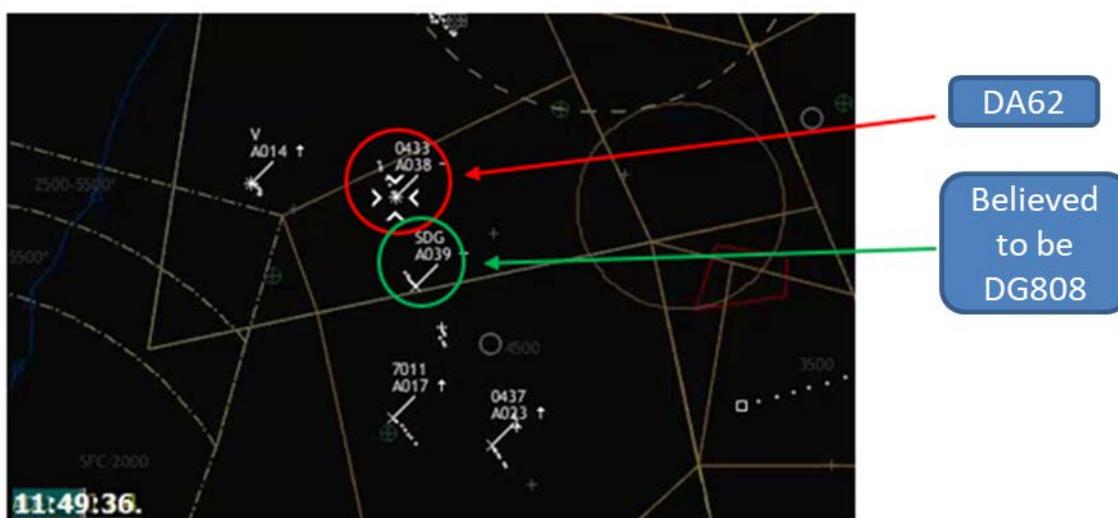
[DA62] was working Farnborough LARS West on a Basic Service. Approximately 5nm South of Lasham, the Controller called traffic information to [DA62] on glider indicating a similar level to [DA62]:

11:49:41 - Radar – “Two Uniform Tango there’s glider traffic ahead of you about er 2 miles similar track to yourself slow moving erm and same altitude keep a lookout”

11:49:49 – [DA62] – “Er yeah, thanks very much Two Uniform Tango”

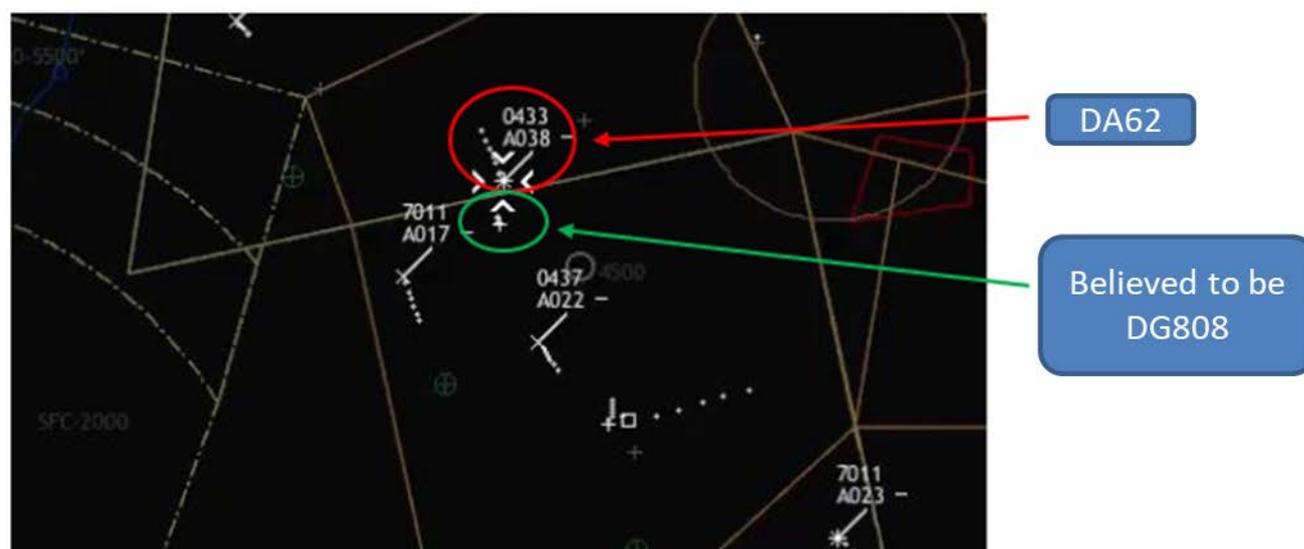
The traffic (wearing a SDG conspicuity squawk) was a glider, [DG808], working LARS West, however the level of [DG808] was not validated a verified due to them wearing a conspicuity squawk. The squawk of [DG808] dropped off radar before [DA62] came into proximity to them, however [DA62] reported visual with the called traffic by LARS West:

11:50:28 – [DA62] – “er Farnborough Two November Golf Uniform Tango er we have that er traffic in sight on our right-hand side”

11:50:36 - Radar – “Two Uniform Tango Roger thank you”

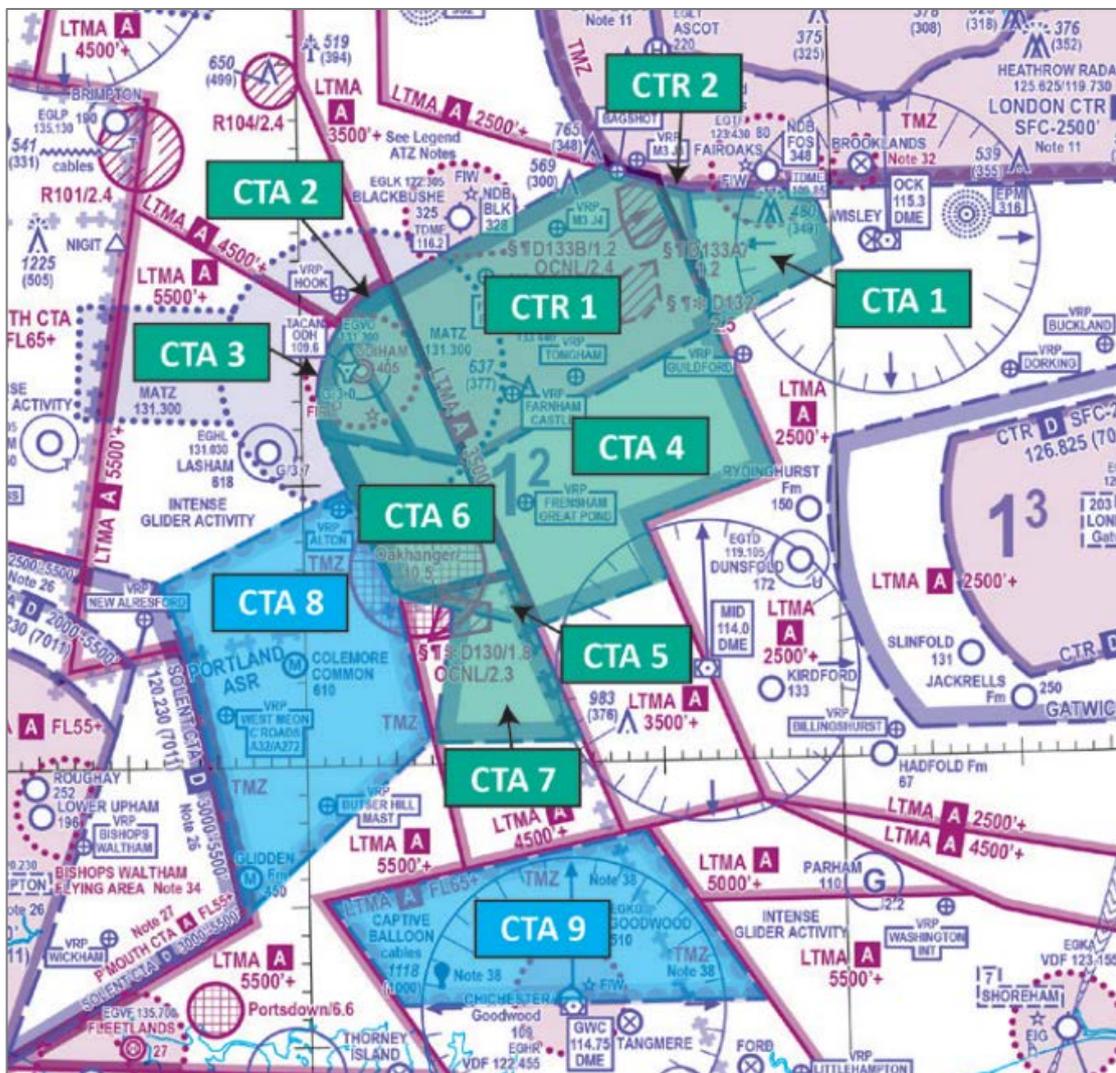
Farnborough airspace: CTA7 Class D base 3500ft, CTA8 Class E+TMZ base 4500ft
