AIRPROX REPORT No 2021070

Date: 05 Jun 2021 Time: 1124Z Position: 5147N 00044W Location: Halton

PART A: SUMMARY OF INFORMATION REPORTED TO UKAB

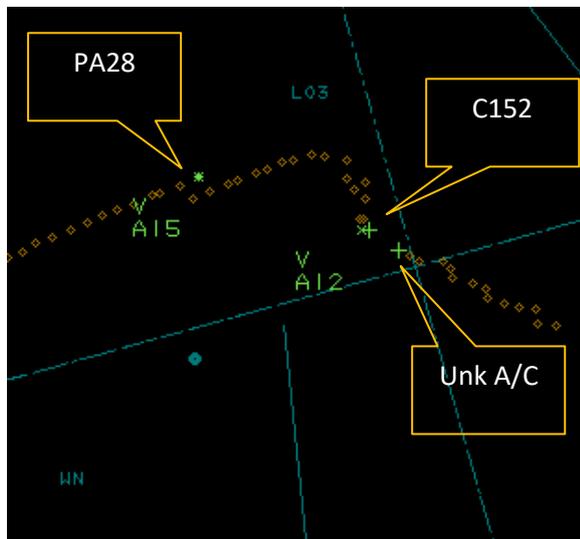
Figure 1: 1124:09

The unknown aircraft could not be traced, throughout it was visible on the NATS radars as a primary only track. It first appeared on radar at 1059z in the vicinity of Epping forest. After the Airprox it tracked WNW and disappeared from radar about 5min later. At Figure 1 the primary only unknown aircraft can be seen in close proximity to a C152 in the Halton circuit. By 1124:44 (Figure 2) the track had continued into proximity with the PA28 on a base leg. The radar track then 'jittered' and so the exact separation could not be measured below 0.4NM, although it is possible that the two aircraft were closer together than this.
