AIRPROX REPORT No 2021023

Date: 12 Apr 2021 Time: 1354Z Position: 5141N 00133W Location: 4NM S Witney

PART A: SUMMARY OF INFORMATION REPORTED TO UKAB

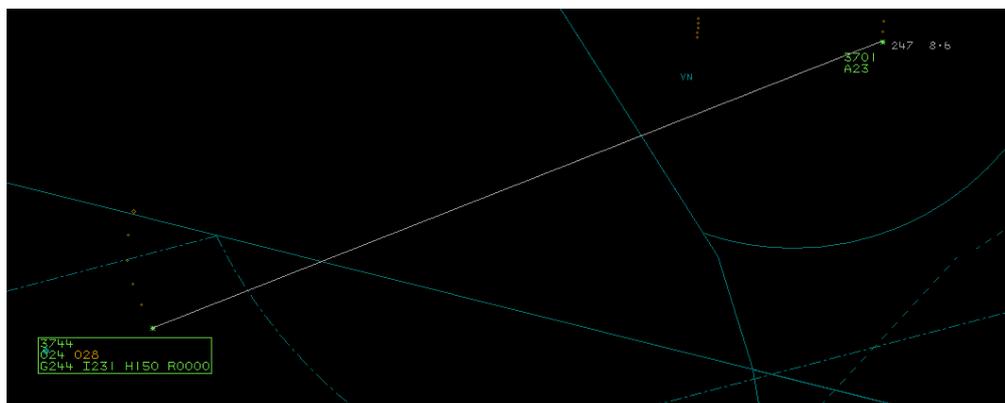
Figure 1: C17 is given a left turn onto 090°.

The C17 pilot was given a left turn to 090° in keeping with a standard turn in the Radar Training Circuit. The DA40 was routing on track to Faringdon and had previously reported visual with the C17. Separation was measured at 8.6NM (Figure 1).

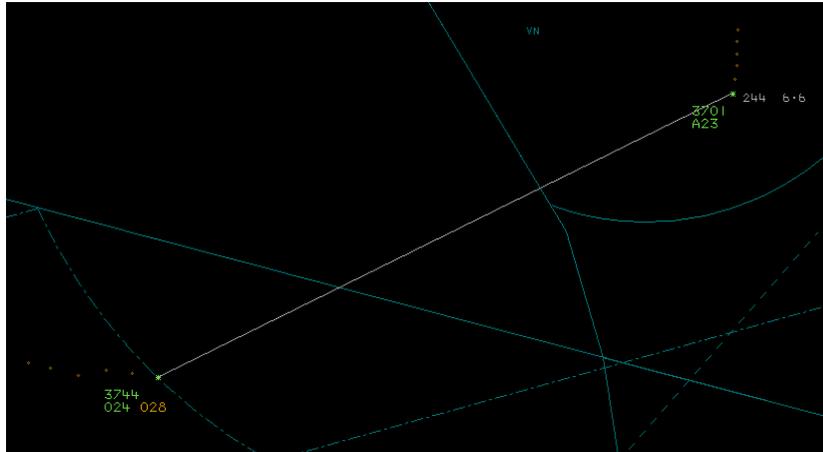
Figure 2: DA40 is provided with updated Traffic Information.

The Brize Norton controller queried whether the DA40 pilot was still visual with the C17 and, after it was confirmed they were not, provided updated Traffic Information “*west 4miles tracking east, 500ft above*”. Separation decreased to 6.6NM (Figure 2).

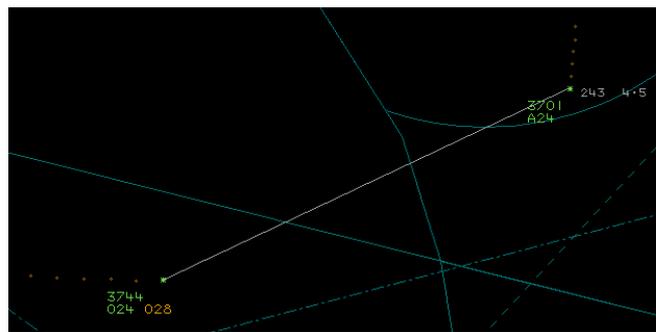
Figure 3:

C17 was given a heading change to 075° with Traffic Information on the DA40.

Three seconds after the DA40 pilot confirmed they were visual with the C17, another aircraft called the controller requesting a service. Once the exchange was complete the controller changed the C17 heading to 075° and provided Traffic Information on the DA40 stating they were “*left 11 o'clock, 3NMs crossing left to right, 400ft below*”. Separation decreased to 4.5NM (Figure 3).

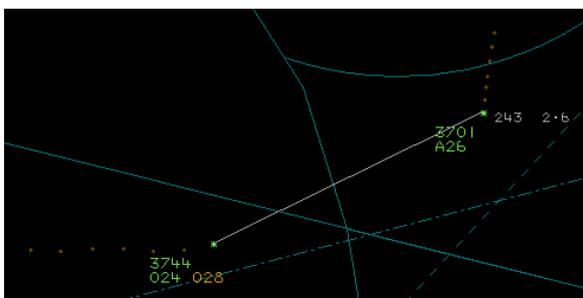
Figure 4:

C17 pilot reported they are intending to turn left.

Twenty-three seconds later the C17 pilot reported that they were going to turn left, the DA40 could be seen to be climbing. Separation decreased to 2.6NM (Figure 4). Nineteen seconds after their

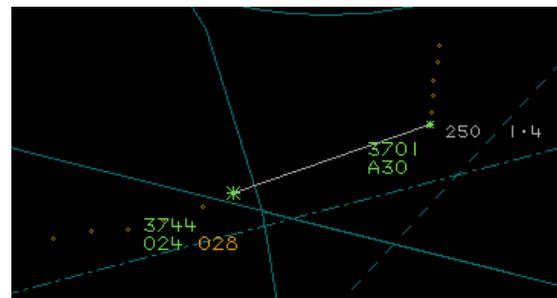
Figure 5:

C17 pilot reported breaking left.

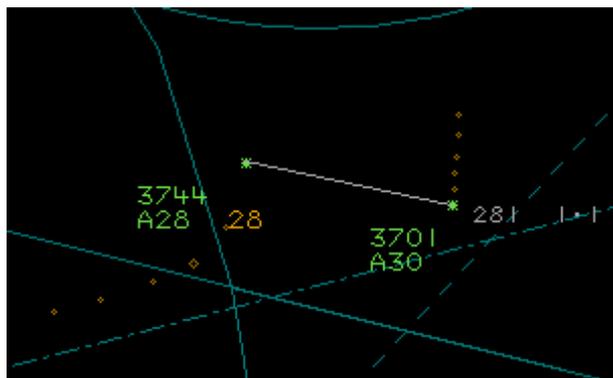
initial report the C17 pilot reported breaking left with separation decreasing to 1.4NM. CPA was measured at 1.1NM and 200ft (Figure 6).

Figure 6: CPA.
