## AIRPROX REPORT No 2021036

Date: 22 Apr 2021 Time: 1128Z Position: 5108N 00015E Location: Tunbridge Wells

### PART A: SUMMARY OF INFORMATION REPORTED TO UKAB

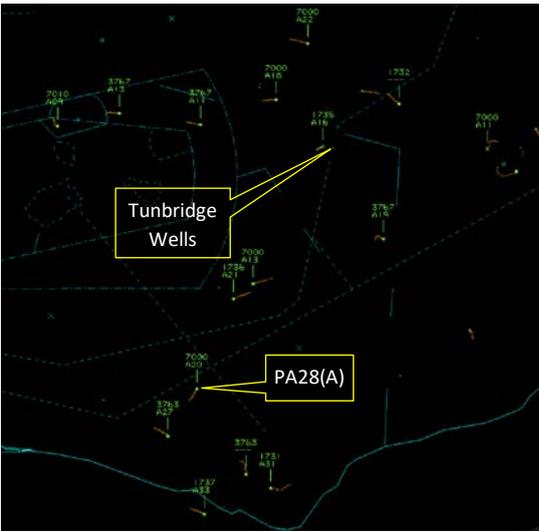
Figure 1 – 1116:28

[The pilot of] PA28(A) had called Farnborough LARS East at **1116:28** advising that they were routing to Tunbridge Wells, Crowborough and Billingshurst. They requested and were provided with a Basic Service (Figure 1). [The pilot of] PA28(B) called Farnborough LARS East at **1121:38**, advising they were at Bough Beach reservoir at 1200ft, shortly climbing to 2000ft for general handling in the local area. A Basic Service was requested and agreed with the Farnborough controller (Figure 2).

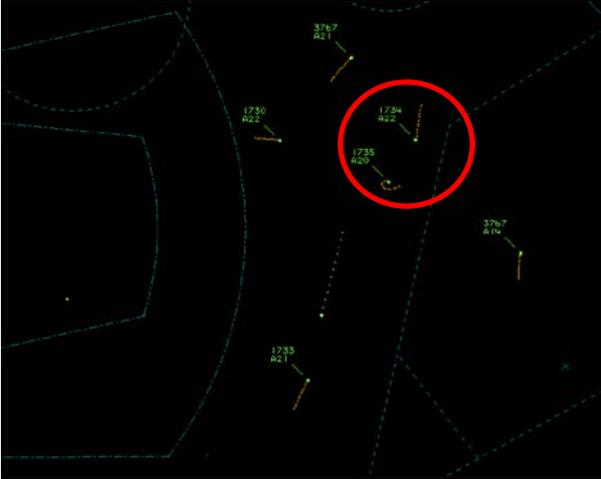
Figure 3 – 1123:55

Whilst handling other aircraft calls, the Farnborough controller, at **1123:55**, passed Traffic Information to an aircraft tracking towards another at a similar level in the vicinity of Tunbridge Wells (circled in Figure 3). Between the period **1125:00** to **1127:45** the Farnborough controller was fully occupied with aircraft calls (Figures 4 – 8).

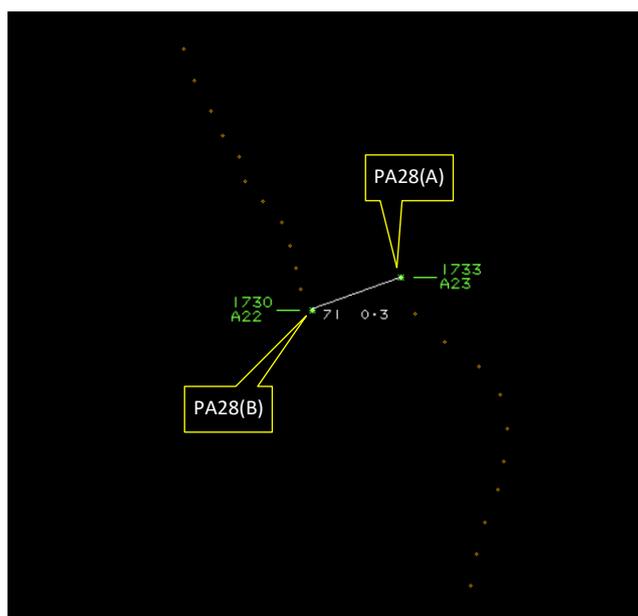
Figure 9 – 1127:30 – CPA

CPA occurred at **1127:30** with the aircraft separated by 0.3NM laterally and 100ft vertically (Figure 9). [The pilot of] PA28(A) reported the Airprox to the Farnborough controller at **1127:47**.

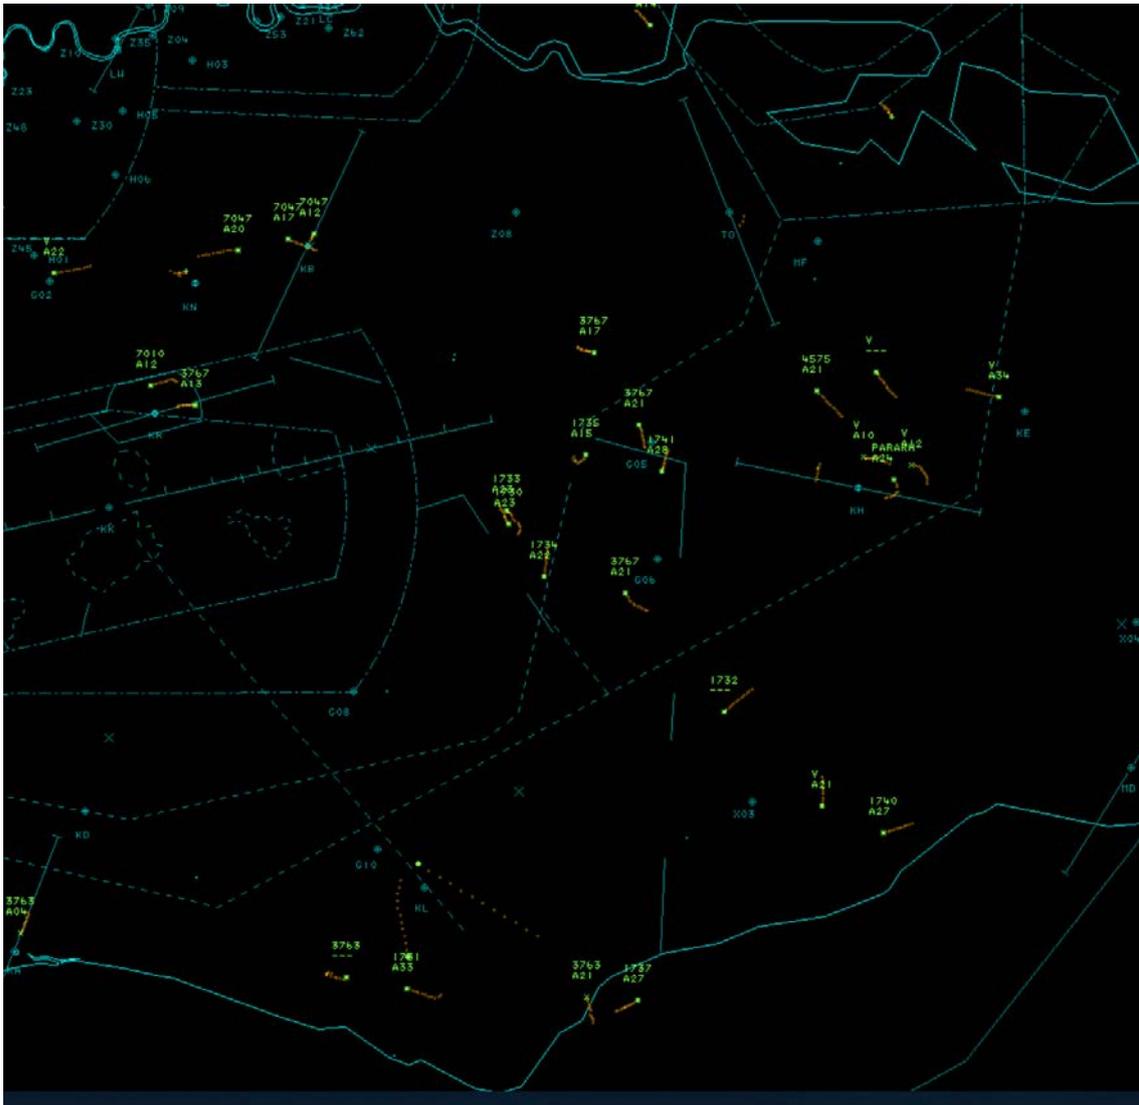
Figure 11 – Farnborough LARS East

In their report the Farnborough controller did state that splitting of the two sectors was not possible due to “social distancing requirements”. The unit investigation did not identify any additional issues nor did it comment on whether consideration had been given to closing a sector. Farnborough LARS sectors can be closed, but normally as a result of reduced staff numbers. In such cases East is the first to be closed, then North.
