AIRPROX REPORT No 2021037

Date: 25 Apr 2021 Time: ~1359Z Position: 5744N 00359W Location: IVO Easter airfield circuit

PART A: SUMMARY OF INFORMATION REPORTED TO UKAB

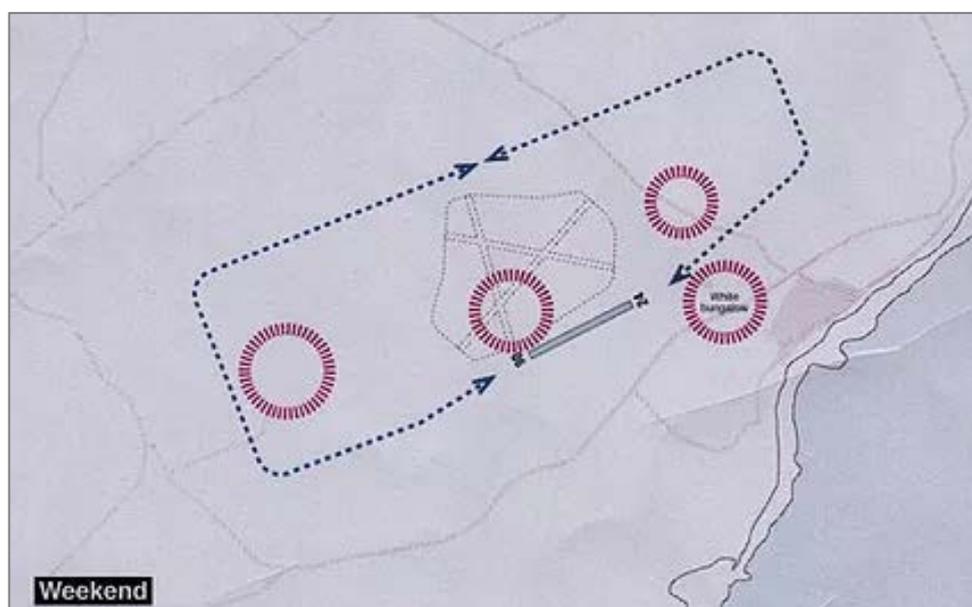
Figure 1 - Easter airfield noise abatement diagram

The Board first considered the local procedures as published on the Easter Airfield website and discussed how the specification of an 'entry/exit lane' affected traffic patterns around the airfield. Members agreed that instructing pilots to use this entry/exit lane increased the likelihood of aircraft coming into proximity and was contributory to this Airprox (**CF1**). The Board noted that there were no instructions pertaining to the altitudes/heights to be flown on entry and exit, meaning that it was for individual pilots to decide their own flight parameters on arrival and departure, and the Board felt that it may be beneficial for the Easter Airfield owner to review the procedures on the website and consider a procedural altitude deconfliction for arriving and departing aircraft. Whilst this cannot guarantee the separation of aircraft (at some point, aircraft departing from RW06 would need to cross the approach path for arriving aircraft), it may reduce the likelihood of a recurrence of an event such as this Airprox.

Regulations, Processes, Procedures and Compliance were assessed as **partially effective** because the published procedures for Easter airfield instruct pilots arriving and departing to use the same routing, thus inducing a potential conflict between traffic joining and traffic departing.
