**AIRPROX REPORT No 2021048**

Date: 02 May 2021 Time: 1332Z Position: 5158N 00121W Location: IVO Barford St John

**PART A: SUMMARY OF INFORMATION REPORTED TO UKAB**

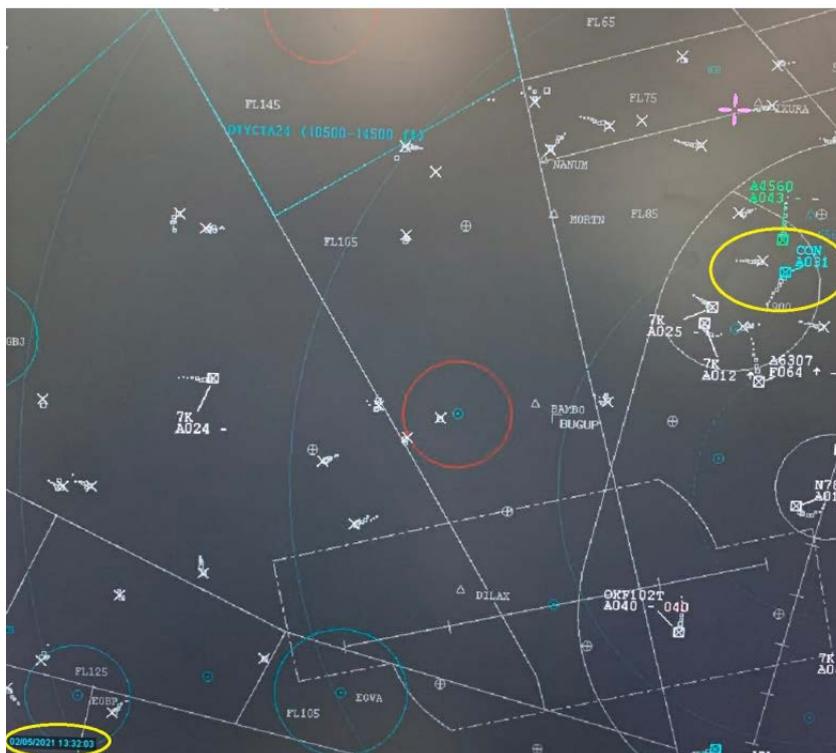
Figure 2: 1332z

It was noted that the aircraft had been operating under a Basic Service at the time of this Airprox. It should therefore be remembered that as per CAP774 the pilot should not expect any form of Traffic Information from a controller under this service and that whether Traffic Information has been provided or not, the pilot remains responsible for collision avoidance without assistance from the controller. That said, CAP774 also notes that, “where a controller/FISO has information that indicates that there is aerial activity in a particular location that may affect a flight, in so far as it is practical, they should provide traffic information in general terms to assist with the pilot’s situational awareness”. Therefore it could be argued that Traffic Information in general terms may have been prudent on this occasion, owing to the observed quantity of non-transponder equipped aircraft along the aircraft intended flight path together with the knowledge that adjacent sites (Little Rissington and Weston-on-the-Green) were active with gliding activity.

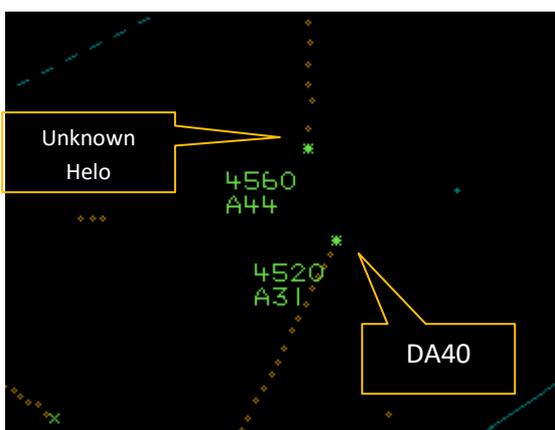
Figure 3: 1332:06

The UKAB Secretariat had the benefit of the GPS data log from the glider, not available to the Oxford ATC investigation. Comparing this with the NATS area radars (not the radar utilised by Oxford) showed that the Airprox occurred at around 1332:27. On the NATS radar the track of a helicopter can be seen routing southbound, as reported by the glider pilot (see Figure 3). Although an intermittent contact could be seen in the area earlier, it had faded from the radar by the time the DA40 was in the vicinity, and at 1332:27 (Figure 4) the DA40 had descended from 3100ft, approximately the same height as the glider, to 2800ft, consistent with the DA40 pilot’s report. Comparing the radar with the GPS data gave an approximate CPA of 300ft and less than 0.1NM.

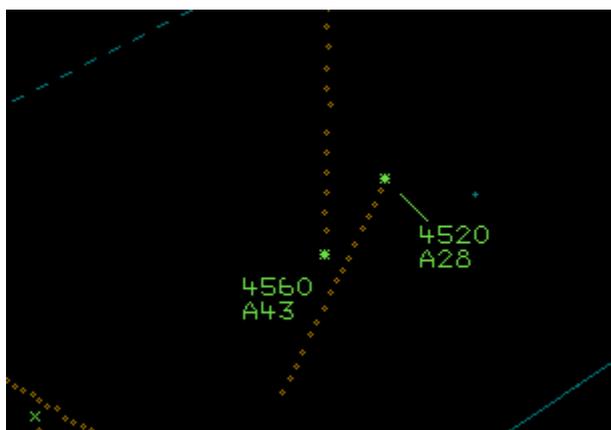
Figure 4: 1332:27  
DA40 descends (glider not on radar)
