AIRPROX REPORT No 2021076

Date: 09 Jun 2021 Time: 0904Z Position: 5405N 00145W Location: ivo Pateley Bridge

PART A: SUMMARY OF INFORMATION REPORTED TO UKAB

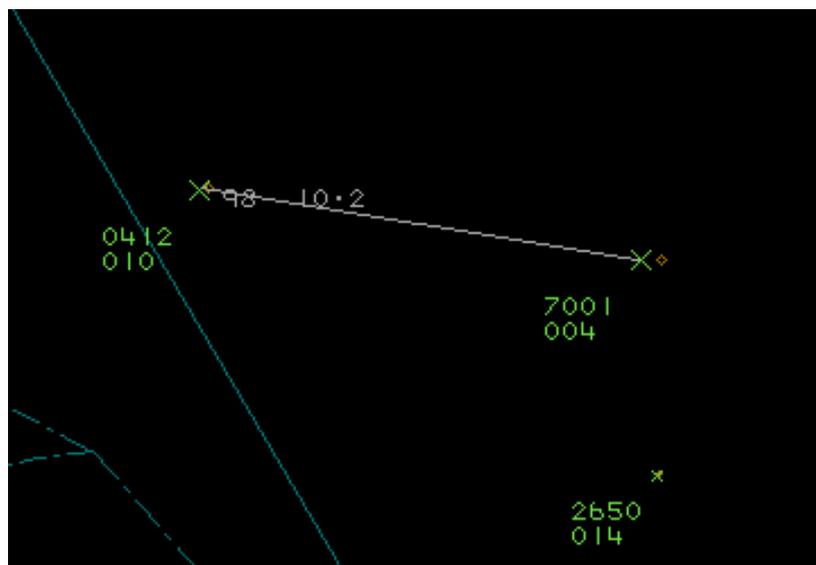
Figure 1: Prefect (0412) and Hawk (7001) at 0902:00. Separation is 10.2NM and 600ft.

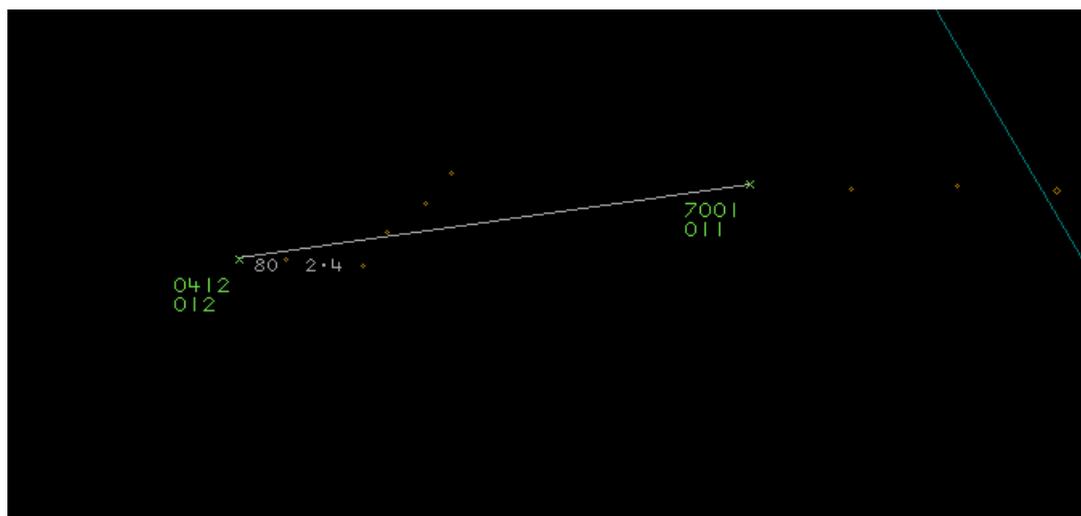
Figure 2: Traffic Information passed to the Prefect.

The Leeming Approach Controller passed Traffic Information to the Prefect as *“traffic six o’clock, two miles, similar heading, similar level”*. Separation decreased to 2.4NM and 100ft.

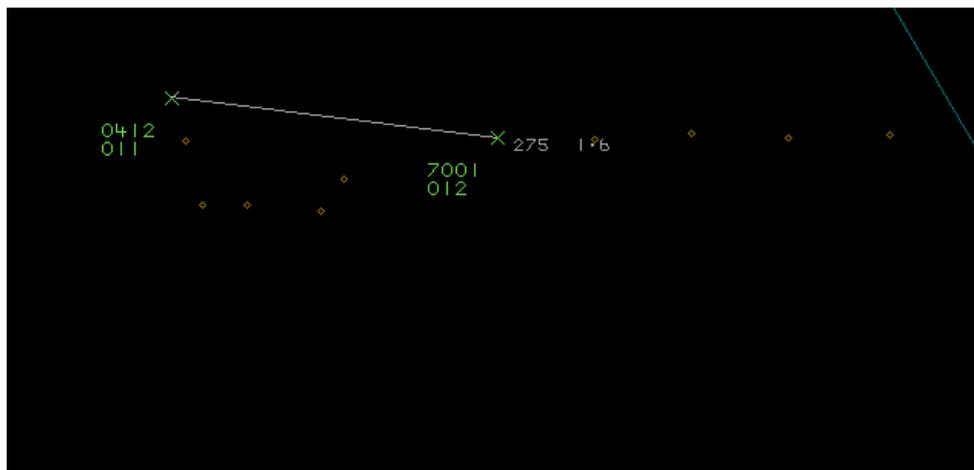
Figure 3: Prefect reports that they are climbing.

Eight seconds after the Prefect is passed Traffic Information, they report that they are climbing. Separation decreased to 1.6NM and 100ft.

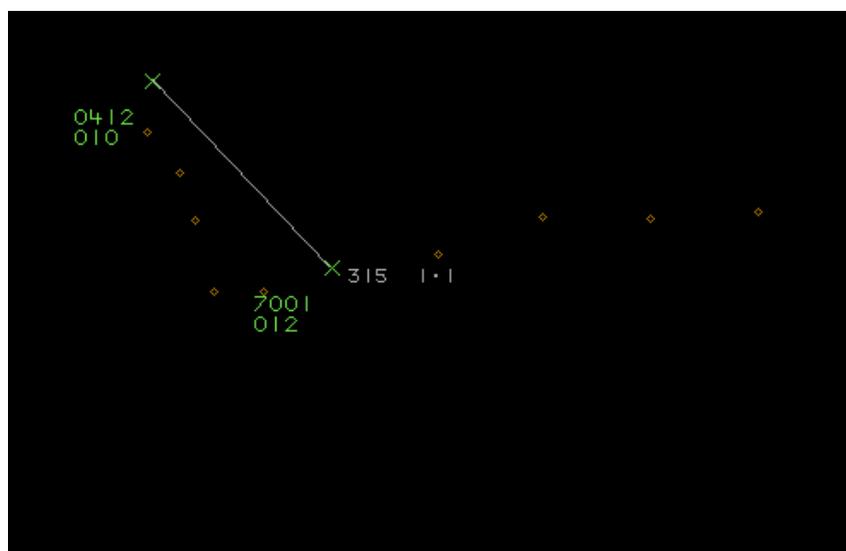
Figure 4: CPA was measured at 1.1NM and 200ft.

The Prefect and Hawk pilots shared an equal responsibility for collision avoidance and not to operate in such proximity to other aircraft as to create a collision hazard¹. Separation at CPA was measured as 1NM on the NATS Ltd radar replay available to UKAB.

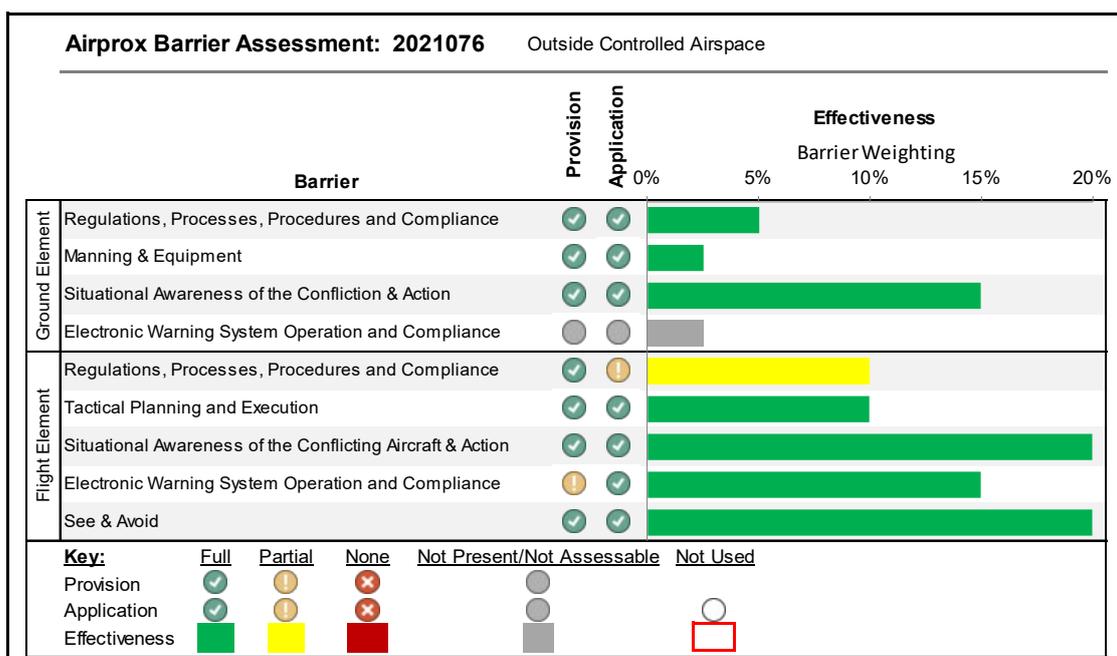
Regulations, Processes, Procedures and Compliance were assessed as **partially effective** because the Prefect pilot's CADS booking was not active at the time of the Airprox, denying SA to both parties.
