AIRPROX REPORT No 2021089

Date: 19 Jun 2021 Time: 1245Z Position: 5147N 00044W Location: Halton elev 369ft

PART A: SUMMARY OF INFORMATION REPORTED TO UKAB

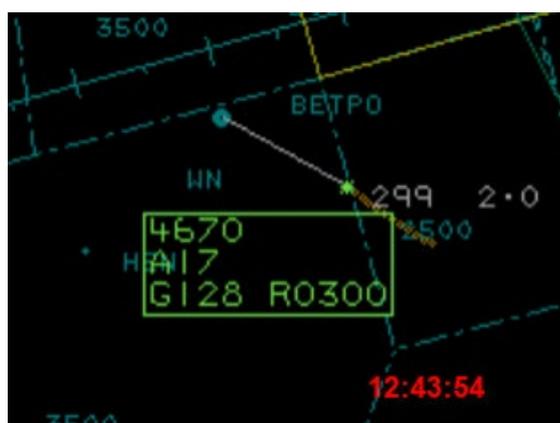
Figure 1

The pilot of [C182 C/S] contacted the Luton Intermediate Director (GW INT) at 1240:02 (all times UTC) and requested a Basic Service. The pilot stated that they were approaching Bovingdon (BNN) at an altitude of 1700ft. Radar displayed that the C182 was on an approximate track of 290°. The GW INT controller instructed the pilot to remain outside of controlled airspace, squawk Mode-A 4670, and provided the Luton QNH of 1015hPa, to which the pilot confirmed their altitude as 1700ft. The aircraft indicated track would have positioned [C182 C/S] to the south of Halton, within 1 mile of the Halton centre fix. At BNN, [C182 C/S] initiated a right turn of approximately 10°, tracking towards the Halton overhead. Radar displayed that [C182 C/S] infringed the Halton ATZ at 1243:54

at an indicated altitude of 1700ft (see Figure 1). The next radar update displayed Mode-C at altitude 1800ft.

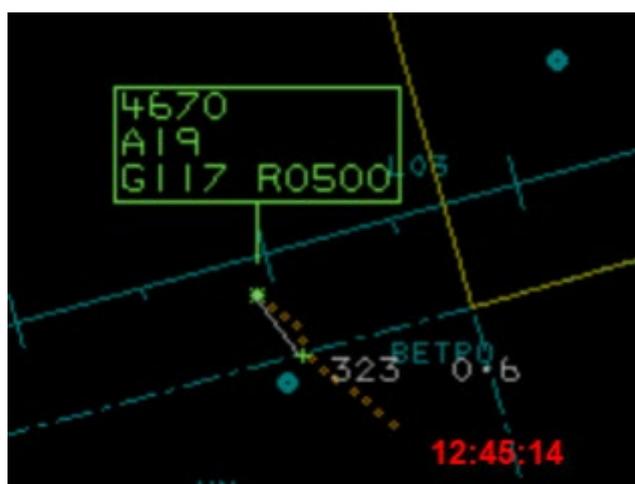
Figure 2

[C182 C/S] continued to track to the east of the Halton overhead, by an approximate 0.3NM and was positioned 0.7NM north of Halton when radar started to display a primary return, believed to be [ASK21 C/S].

This was coincident with the Closest Point of Approach (CPA) between the two aircraft and was recorded by Multi-track radar as 0.6NM (see Figure 2).

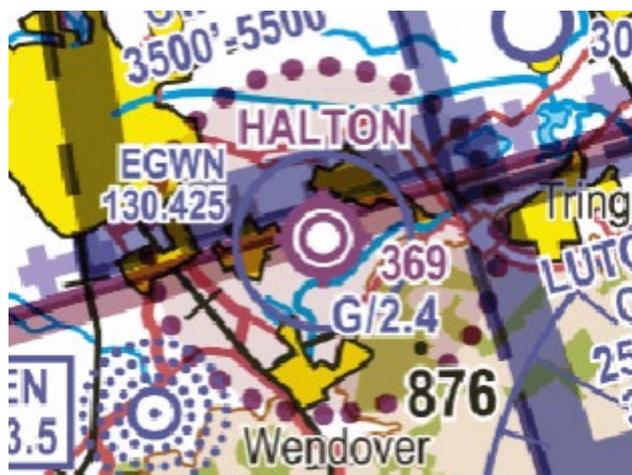
Figure 3

The VFR Aeronautical Chart 1:500,000 also displayed Halton Aerodrome as winch launching up to altitude 2400ft (see Figure 3).

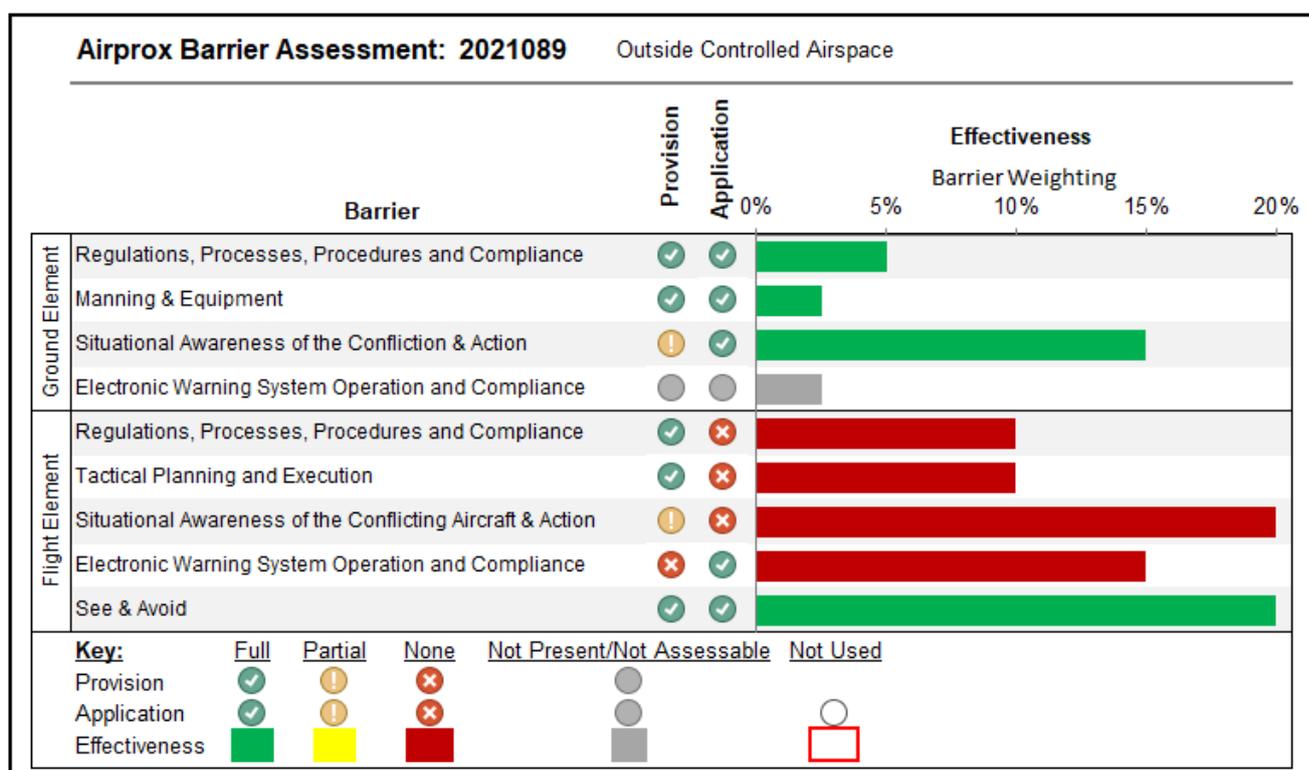
Regulations, Processes, Procedures and Compliance were assessed as **ineffective** because the C182 pilot flew through the ATZ without communicating with Halton.

Tactical Planning and Execution was assessed as **ineffective** because the C182 pilot did not take the Halton ATZ into consideration when planning their route or didn't contact Halton when weather forced them to descend.

Situational Awareness of the Conflicting Aircraft and Action were assessed as **ineffective** because the C182 had generic information that gliders operated out of Halton, but the ASK21 pilot had no prior knowledge that the C182 was approaching.

Electronic Warning System Operation and Compliance were assessed as **ineffective** because the FLARM in the ASK21 could not detect the C182.
