## AIRPROX REPORT No 2021100

Date: 01 Jul 2021 Time: 1506Z Position: 5250N 00041W Location: Saltby Gliding Site

### PART A: SUMMARY OF INFORMATION REPORTED TO UKAB

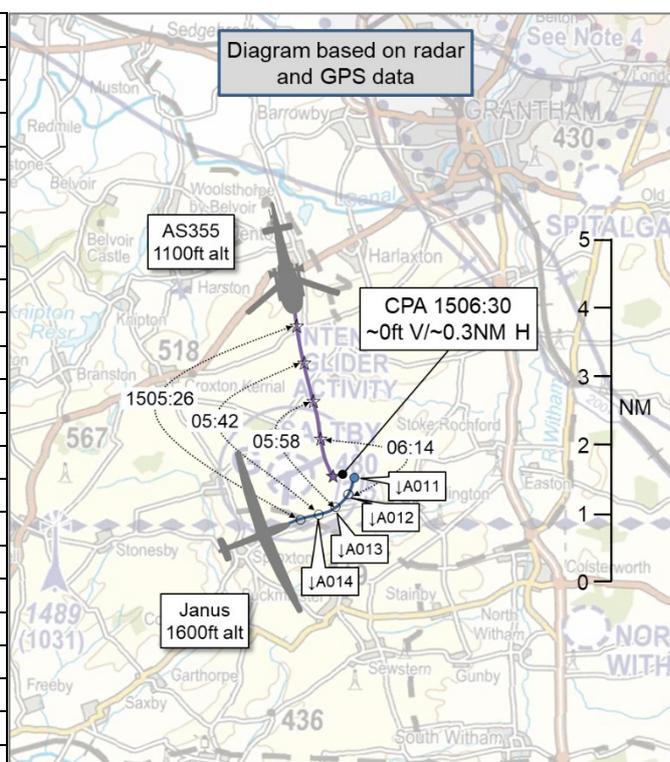
<sup>2</sup> Separation derived from GPS data for the Janus glider and radar data for the AS355.

An analysis of the NATS radar replay and the GPS data provided by the Janus glider pilot was undertaken. The AS355 was identified using radar data and a steady track was observed in the moments leading up to the Airprox. The AS355 was observed to maintain 1100ft and not deviate from its course as it flew past the area of Saltby Gliding Site. The GPS data provided by the Janus glider pilot was correlated with the radar track of the AS355; CPA was measured as ~0ft V and ~0.3NM H by comparison of the positional information from the 2 different data sources.
