AIRPROX REPORT No 2021105

Date: 11 Jul 2021 Time: 1010Z Position: 5112N 00113W Location: Popham Airfield

PART A: SUMMARY OF INFORMATION REPORTED TO UKAB

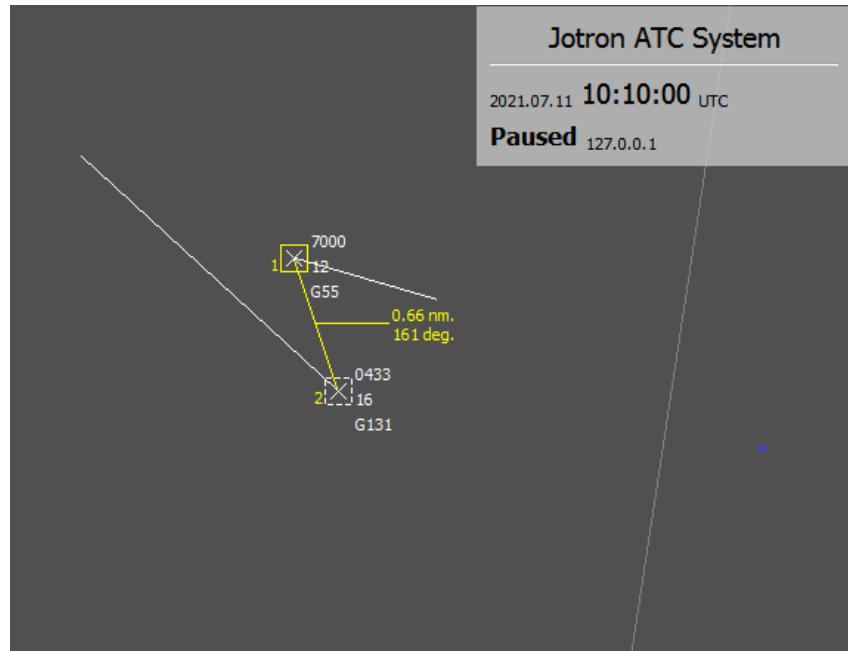
At 10:10:00 [C177] pilot sets the squawk and appears on radar. At this stage, the aircraft are 0.66NM horizontally and 400ft vertically apart according to the raw data. The distances and times are then as follows:

Figure 1: 1010:00 (Sqk 0433 C177, 7000 EV97)

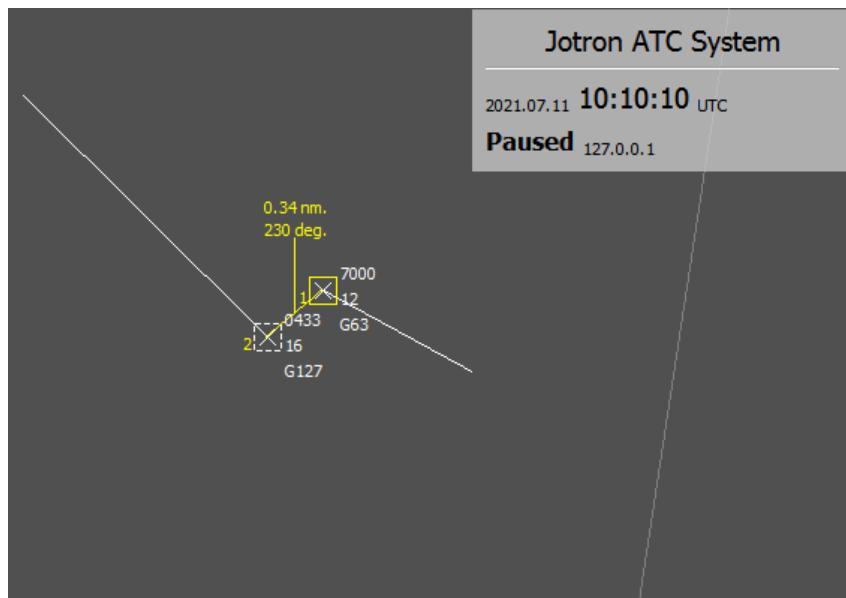
Figure 3: 1010:10 CPA 0.34NM H / 400ft V

The Airprox occurred in the overhead of Popham. Radar replays show that the aircraft were 0.34NM laterally and 400ft vertically apart. This occurred moments after a Basic Service for [C177 pilot] was requested and accepted by Farnborough.

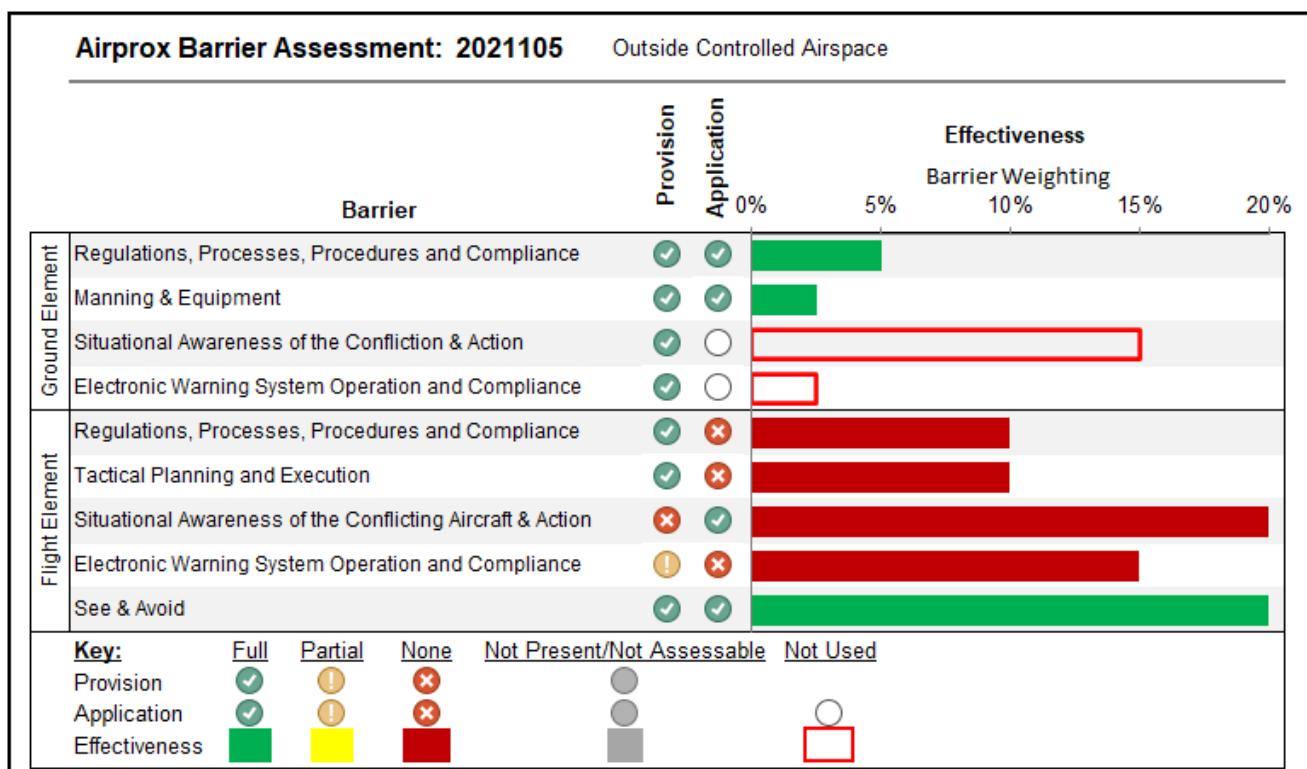
Situational Awareness of the Confliction and Action were assessed as **not used** because the controller did not need to monitor the aircraft under a Basic Service.

Regulations, Processes, Procedures and Compliance were assessed as **ineffective** because the C177 pilot flew through Popham without avoiding the pattern of traffic already formed.

Tactical Planning and Execution was assessed as **ineffective** because the C177 pilot flew though Popham airfield's overhead without allowing a suitable separation from the circuit traffic.

Situational Awareness of the Conflicting Aircraft and Action were assessed as **ineffective** because neither pilot had any situational awareness of the other aircraft.

Electronic Warning System Operation and Compliance were assessed as **ineffective** because the C177's SkyEcho did not register the EV97 as expected.
