**AIRPROX REPORT No 2021107**

Date: 13 Jul 2021 Time: 1040Z Position: 5626N 00322W Location: Perth

**PART A: SUMMARY OF INFORMATION REPORTED TO UKAB**

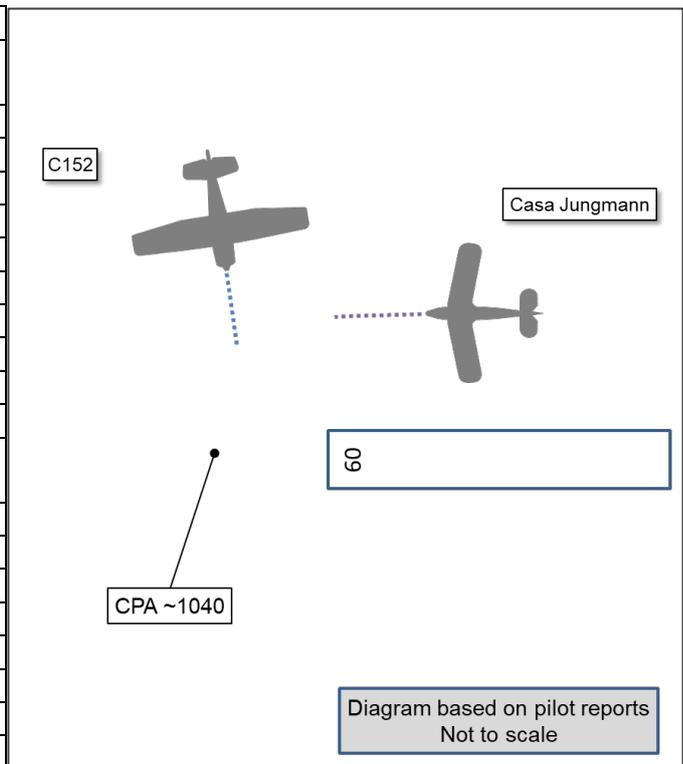
**THE C152 PILOT** reports they were conducting circuits and were on base leg. The biplane had joined a very tight downwind without communicating it was so close in, as they approached their turn onto finals they noticed the biplane in front of them to the left, about 100ft below. At this point both pilots made a hard right turn to avoid each other, the C152 pilot then proceeded to make a full stop landing.

**THE CASA JUNGSMANN BI-PLANE PILOT** reports that they were in the visual circuit, there were 3 aircraft in the circuit at the time. They fly a tighter circuit than other aircraft so that in the event of an engine failure they can still make a landing on the runway. There was the possibility that the other aircraft was obscured behind their upper wing. They first saw the other aircraft at a range of 300m, also on a base leg, they turned to starboard to pass behind and continued in the circuit.

**THE PERTH AGO** reports that the Cessna 152 (dual instruction) was in the circuit. The Casa Jungmann joined the circuit in the overhead, positioning crosswind and then downwind. The pilot of the Casa Jungmann started to turn base leg with the C152 on base leg. The Casa Jungmann then descended went to the dead side and re-joined the circuit and landed.
