AIRPROX REPORT No 2021118

Date: 16 Jul 2021 Time: 1202Z Position: 5147N 00119W Location: 4NM NW of Oxford

PART A: SUMMARY OF INFORMATION REPORTED TO UKAB

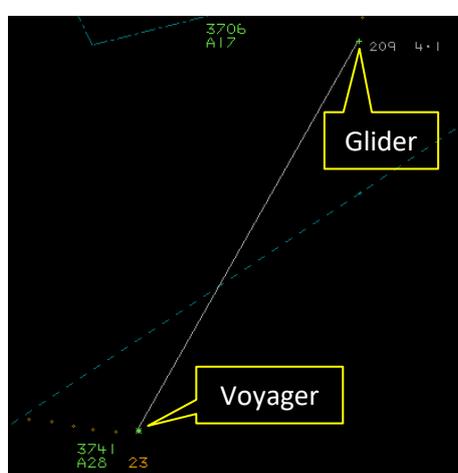
Figure 1 – The A330 pilot had been cleared on the NDB ILS DME and had been passed Traffic Information on the CTR transit.

The Director had given the A330 pilot Traffic Information on the CTR transit then proceeded to pass a control instruction to the pilot of the other aircraft under their control. Separation was measured at 4.1NM.

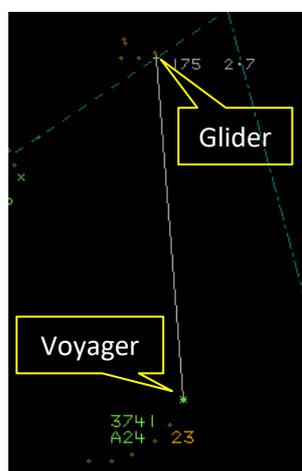
Figure 2 – Traffic Information was passed to the A330 pilot regarding the glider.

Fifty-one seconds after the control instruction was passed to the pilot of the other aircraft under their control, the Brize Director passed Traffic Information to the A330 pilot stating “*pop-up traffic north two miles manoeuvring slow moving believed to be outside controlled airspace*”. Separation decreased to 2.7NM.

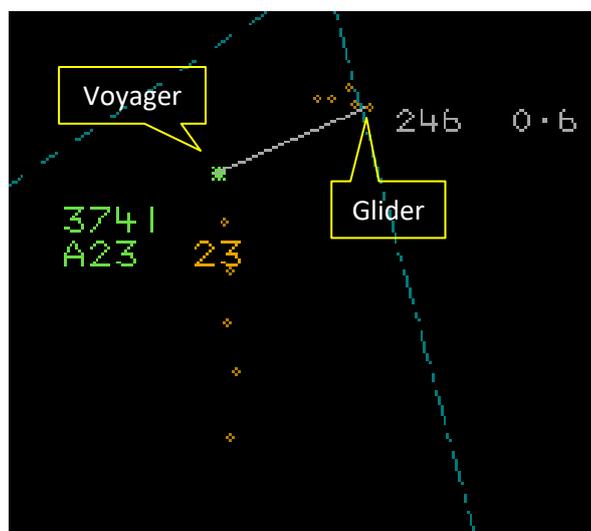
Figure 3 – CPA

Fifty-one seconds later CPA occurs, separation decreased to 0.6NM. On the next radar sweep the glider disappears from radar.
