AIRPROX REPORT No 2021119

Date: 17 Jul 2021 Time: 1518Z Position: 5118N 00044W Location: Frimley

PART A: SUMMARY OF INFORMATION REPORTED TO UKAB

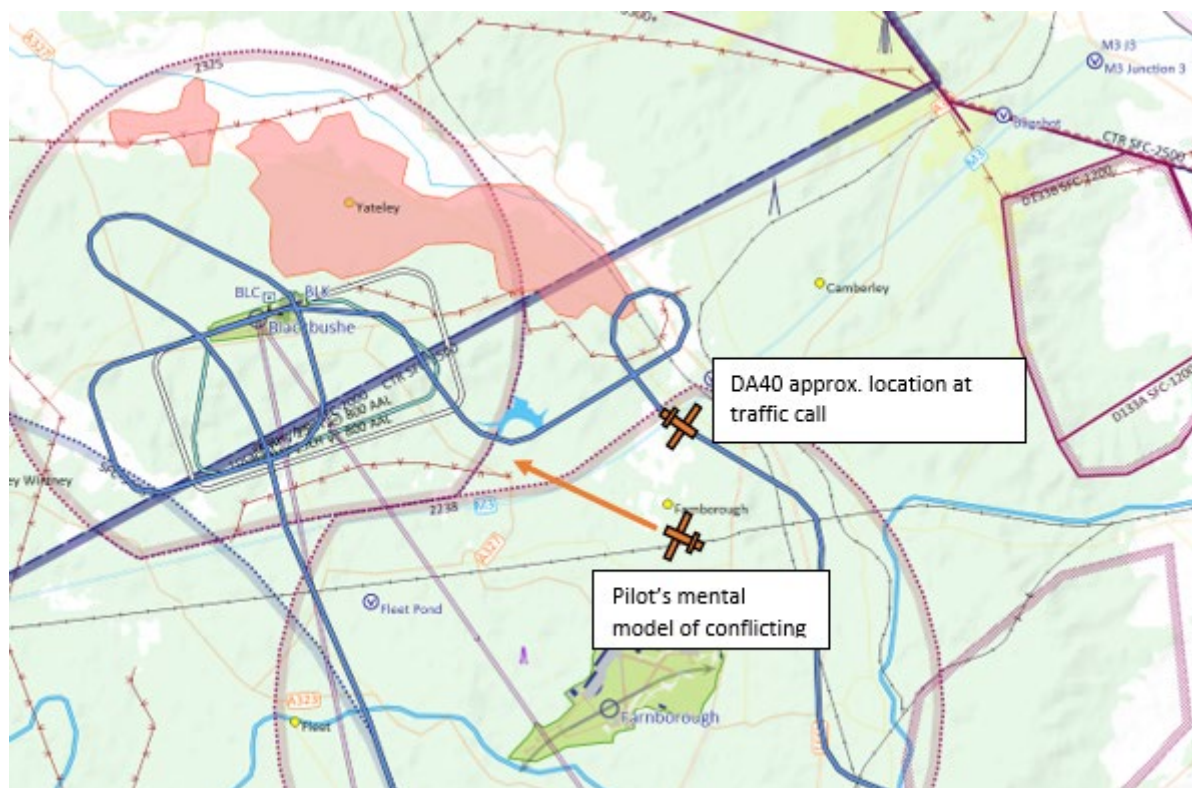
Figure 1

Approach 133.440 as per their departure clearance and upon selecting the frequency noted it to be very busy. Once the controller had finished liaising with other traffic they asked whether they [the DA40 pilot] was on frequency, to which they replied that they were approaching overhead M3J4 VRP level at 1500ft and their current pressure setting (QNH as passed from Blackbushe Information before departure). They were then cleared to transit through Farnborough zone, not above altitude 2000ft VFR direct from M3J4 to Guildford and so took up heading direct to Guildford VRP remaining at 1500ft. During this conversation they conducted a left hand orbit north of the VRP. They recalled being passed 2 traffic calls which they believed to be pertaining to the traffic in question, along with notification that they were under Radar Control; although where exactly they received all of these calls they could not recall. Both traffic calls notified the traffic south of them, at range 1NM inbound to Blackbushe. They could not recall what, if any, altitude information was passed. On both occasions they scanned for the traffic in the 12-1 o' clock sector given their south-easterly track but could not identify the traffic. They also had SkyDemon connected to a SkyEcho2 electronic conspicuity device. This information was displayed via their phone mounted on a suction mount affixed to the canopy. They did not recall seeing this contact via these means either. They reported traffic not sighted on both occasions and were not overly concerned about a confliction. This was because the traffic was called south of them inbound to Blackbushe so they expected it to be level at 1600ft tracking NW bound away from them for an overhead join, as per their joining procedures; given Blackbushe was around 4NM west of their position at this time. Annotated on the SkyDemon log file (Figure 1) is their mental model of the traffic as called by Farnborough Radar. In retrospect they did not know what routing this aircraft had been approved for its transit across Farnborough Zone. They first sighted the traffic 12 o' clock range 0.5NM ahead climbing from underneath the nose directly towards them (almost no aspect) and it passed about 300ft above. They did not take any avoiding action because by the time they had reacted the traffic was diverging above and behind them, no additional separation would be gained by manoeuvring, and manoeuvring would take them away from their approved transit routing and cause them to loiter longer in the missed approach path for inbound Farnborough arrivals. The pilot noted that they believed ATC had provided all of the information their capacity permitted and to their knowledge met ATC's requirements given separation is not assured VFR-VFR in Class D airspace.

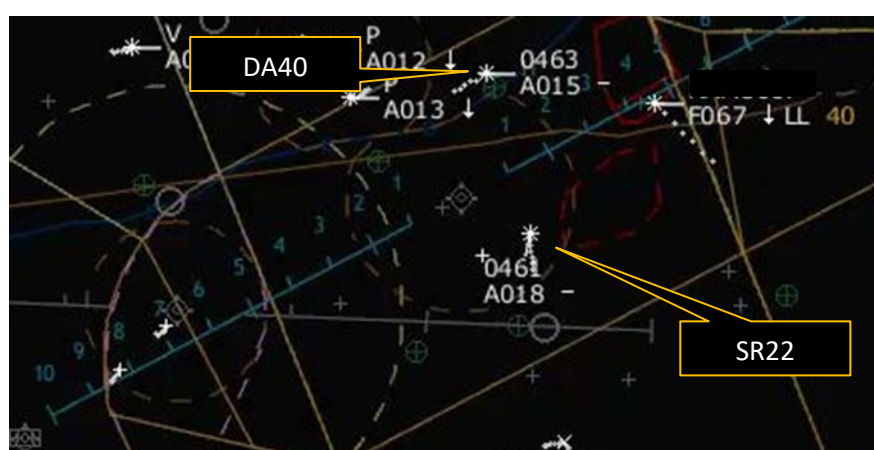
Figure 2: 1515z

[DA40 C/S] was given a standard M3J4 VRP departure from Blackbushe, was airborne and was showing on the radar routing towards M3J4 VRP squawking 0463 with Mode C indicating 1500ft. [SR22 C/S] was a northbound Zone crosser not above 2000ft routing from the vicinity of Tongham towards M3J4 VRP squawking 0461 with Mode C showing 1800ft.

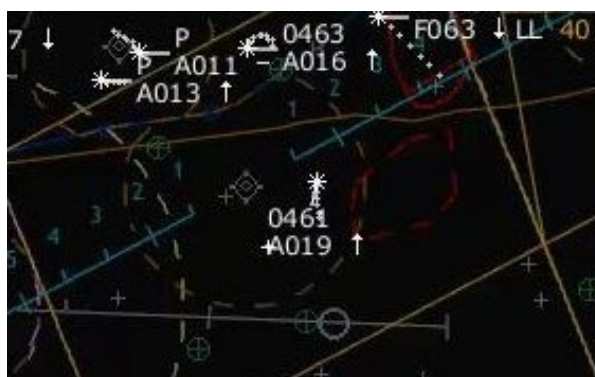
Figure 3: 1517z

1517:25(RAD)"[SR22 C/S] DA40 north of you by 2 miles at the M3J4 routing to Guildford 1600 feet"

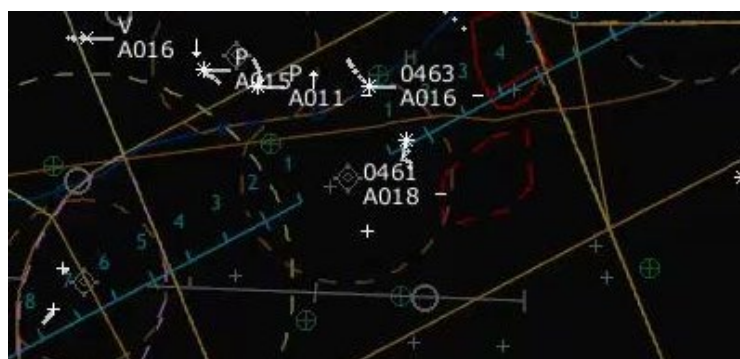
Figure 4: 1517:50z

1517:41(RAD)"[DA40 C/S] the um EGLK [Blackbushe] inbound traffic 1 mile south of you now 1800 feet"

1517:50(DA40)"Still not in sight [C/S]"

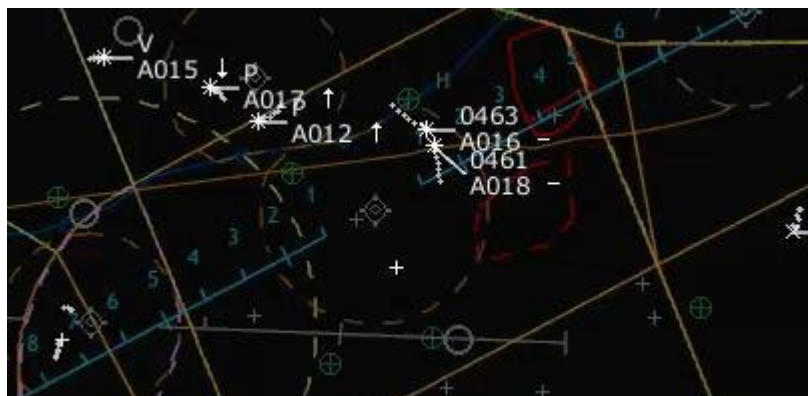
Figure 5: 1518z

1518:08(SR22)"*unintelligible* [C/S]avoiding traffic had to climb *unintelligible* coming right for me"

1518:08 [SR22 C/S] squawking 0461 and [DA40 C/S] squawking 0463 contacts merge Mode C indicated the SR22 200ft above DA40 at 1600ft and 1800ft respectively.

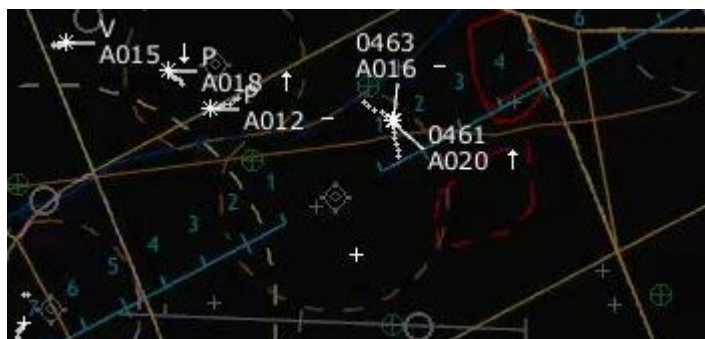
Figure 6: 1518z

1518:13 0461 [SR22 C/S] Mode C indicated 2000ft.

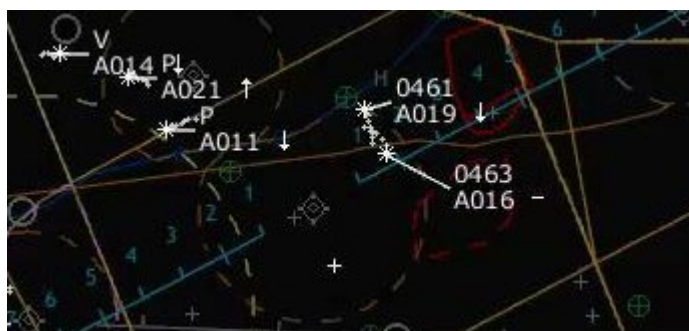
Figure 7: 1518:30z

1518:22(SR22)"[C/S] that was a near miss I think we should report that *unintelligible* air traffic zone"

1518:29(RAD)"[SR22 C/S] roger you had Traffic Information VFR versus VFR however if you need to file you can do it on the ground"
