**AIRPROX REPORT No 2021120**

Date: 18 Jul 2021 Time: 1530Z Position: 5050N 00017W Location: Shoreham circuit

**PART A: SUMMARY OF INFORMATION REPORTED TO UKAB**

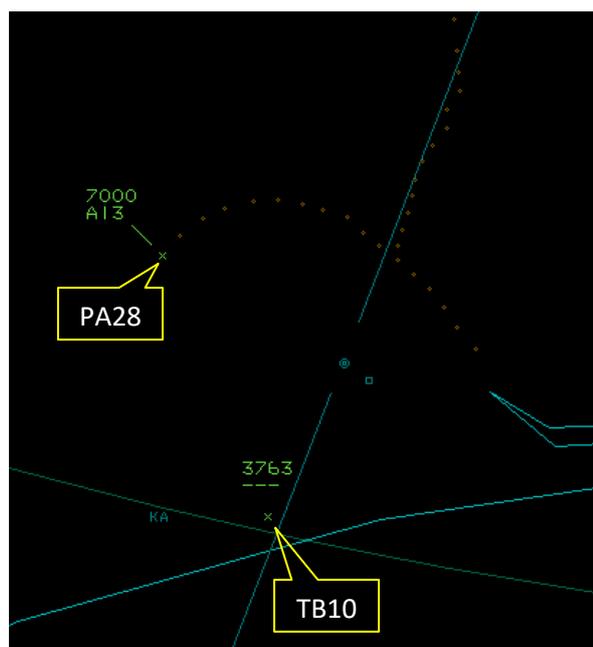
Figure 1 – 1528:58

Analysis of the NATS radar replay showed the PA28 executing a standard overhead join and descending to circuit altitude (Shoreham airfield elevation is 7ft) on the deadside of the circuit. The Tobago was first detected by the NATS radars shortly after its departure, at 1528:58 (see Figure 1). The PA28 pilot flew crosswind at an indicated altitude of 900ft and paralleled the track of the Tobago for approximately 15-20sec before the Tobago pilot turned downwind. After this turn, the PA28 and the Tobago remained on an almost constant relative bearing until CPA. Because the Tobago was not displaying any Mode C information it was not possible to determine the vertical separation at CPA. Horizontal separation was measured at <math><0.1\text{NM}</math>.

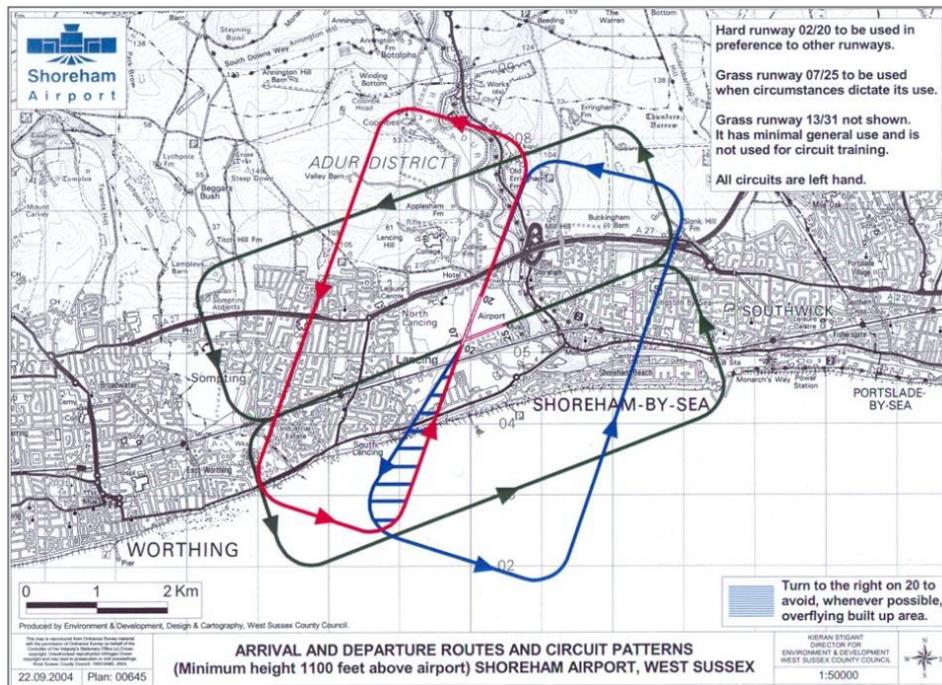
Figure 3 – Shoreham published circuit pattern<sup>1</sup>

Figures 3 and 4 below depict the circuit patterns published on the Shoreham Airport website and the standard overhead join as published in the Skyway Code respectively.
