AIRPROX REPORT No 2021121

Date: 19 Jul 2021 Time: 1044Z Position: 5253N 00045W Location: ivo Belvoir Castle

PART A: SUMMARY OF INFORMATION REPORTED TO UKAB

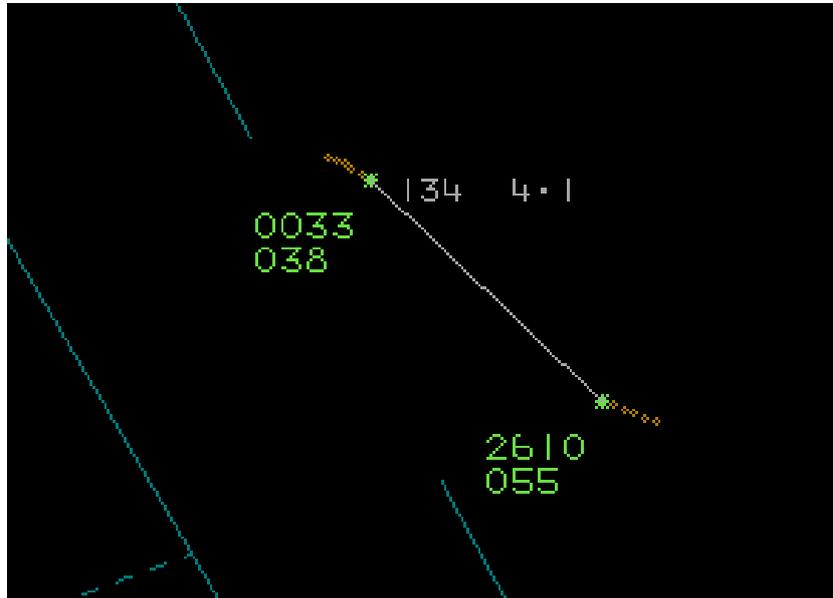
Figure 1: Traffic Information is first passed to the Prefect pilot (2610)

In response to advising two minutes to recover the Cranwell Departures controller passed Traffic Information to the Prefect pilot regarding the position of the C208. Separation was 4.1NM and 1700ft.

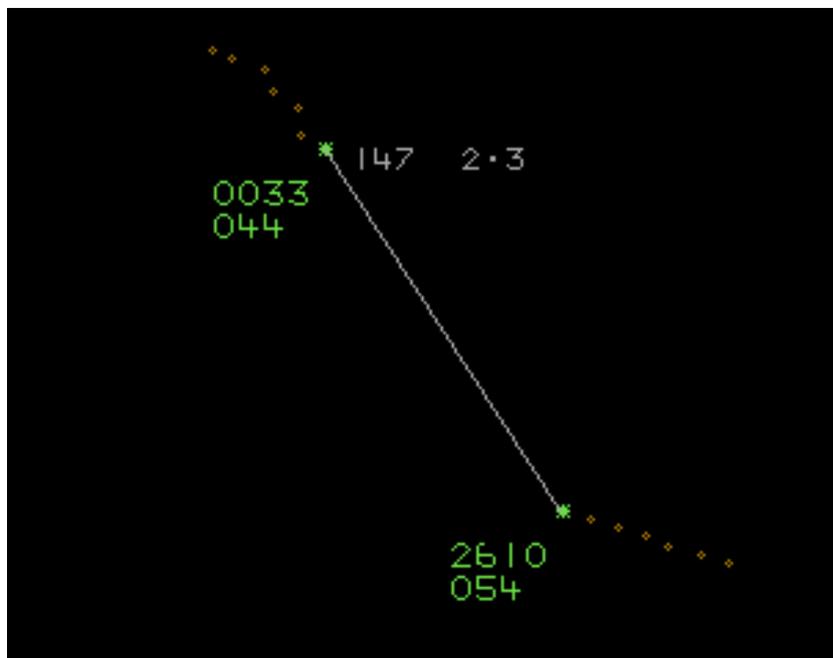
Figure 2: Traffic Information is updated.

Twenty seven seconds later the the Cranwell Departures controller provided updated Traffic Information to the Prefect pilot. Separation decreased to 2.3NM and 1000ft.

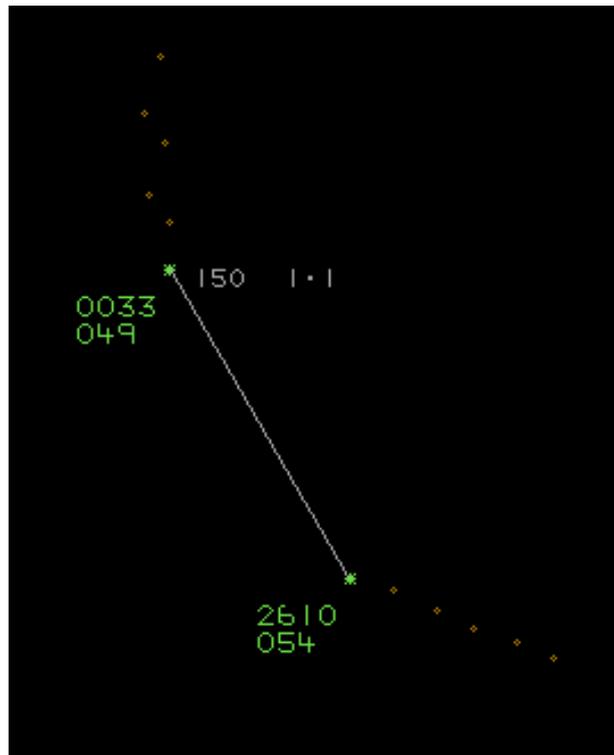
Figure 3: Traffic Information is updated again.

Twenty three seconds later the Traffic Information was provided for the third time. Six seconds after being passed the Traffic Information the Prefect pilot reported that they were visual with the C208. Separation decreased to 1.1NM and 500ft.

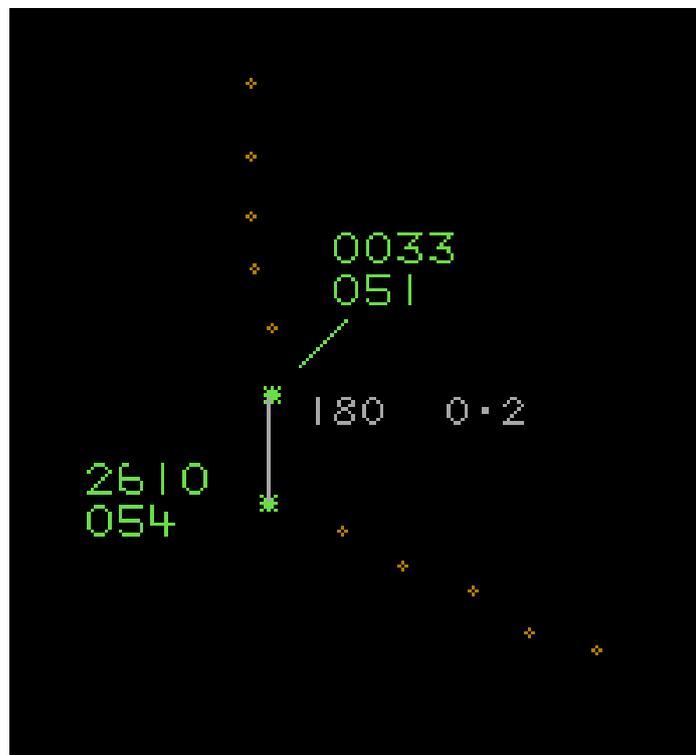
Figure 4: CPA.

Fourteen seconds later CPA occurred which was measured at 0.2NM and 300ft.
