AIRPROX REPORT No 2021124

Date: 20 Jul 2021 Time: 1144Z Position: 5050N 00112W Location: Lee-on-Solent

PART A: SUMMARY OF INFORMATION REPORTED TO UKAB

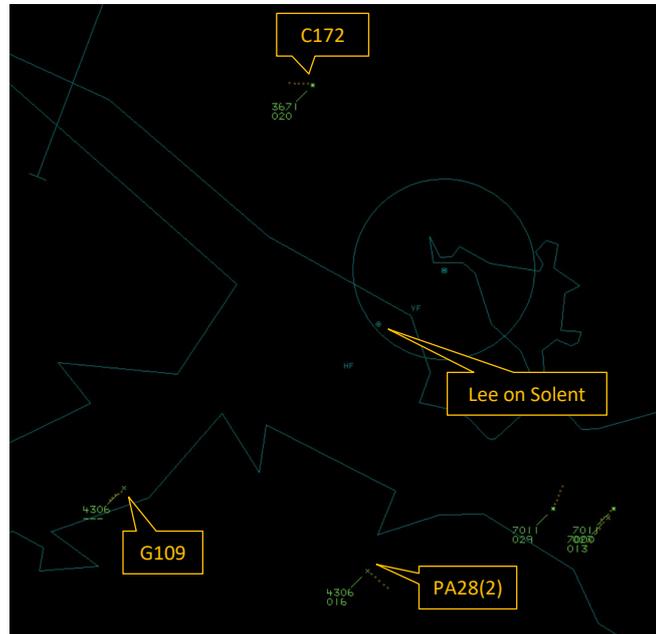
Figure 1 – 1139:00

At 1134:20 the pilot of the G109 called the Lee-on-Solent AFISO advising that they were approaching Cowes for rejoin. The AFISO passed them the runway in use, (23 right-hand) and the QFE. At 1137:50 a PA28(1) took off to operate in the Lee-on-Solent circuit and at 1139:00 a second PA28(2) called up for joining instructions from the Cowes area (Figure 1).

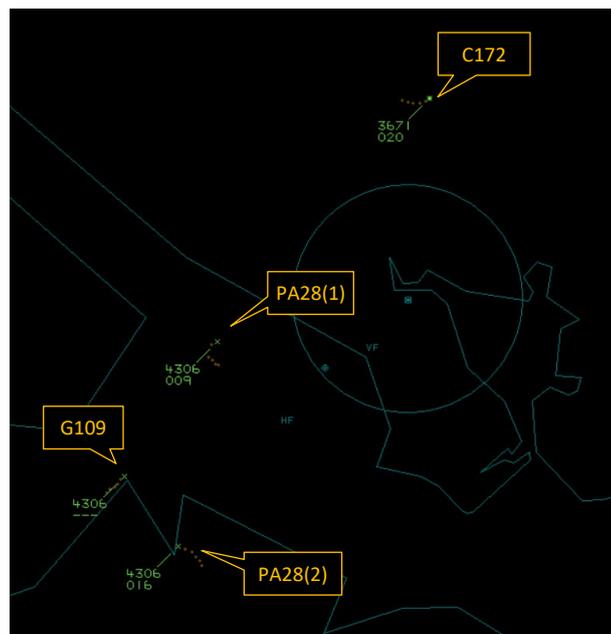
Figure 2 – 1141:08 (PA28(1) in circuit visible)

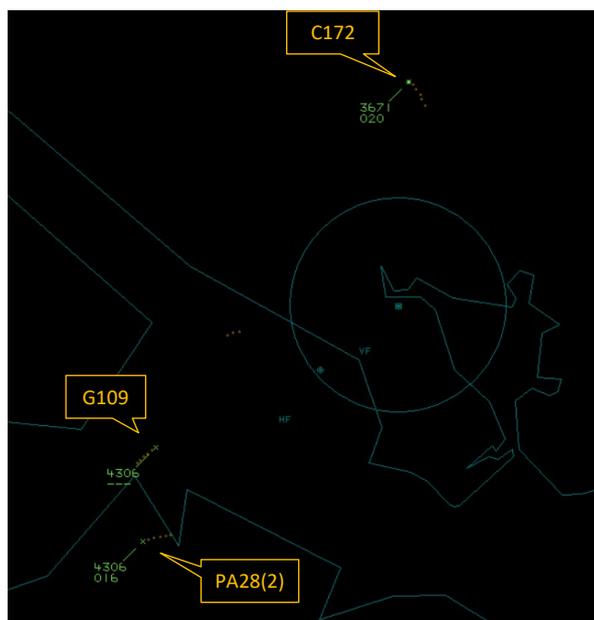
Figure 3 – 1141:37

At 1141:37 the pilot of the PA28(2) advised that they were “*taking an orbit at Cowes just for spacing. (G109 C/S) are you mid-channel er mid-Solent now?*”. The G109 pilot confirmed that they were “*mid-channel*”.

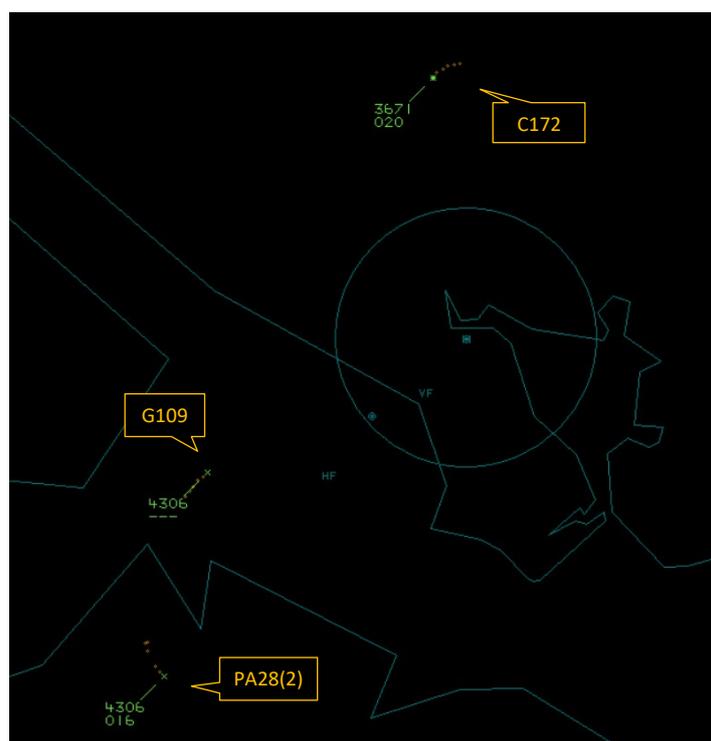
Figure 4 – 1142:07

At 1142:07 the pilot of the C172 called overhead Wickham requesting rejoin instructions (Figure 4).

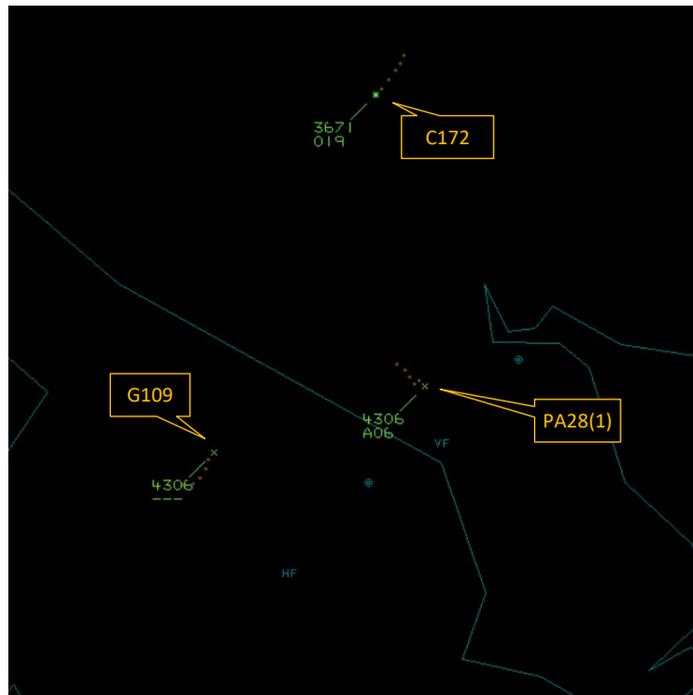
Figure 5 – 1143:15

At 1143:15 the G109 pilot reported downwind (Figure 5).

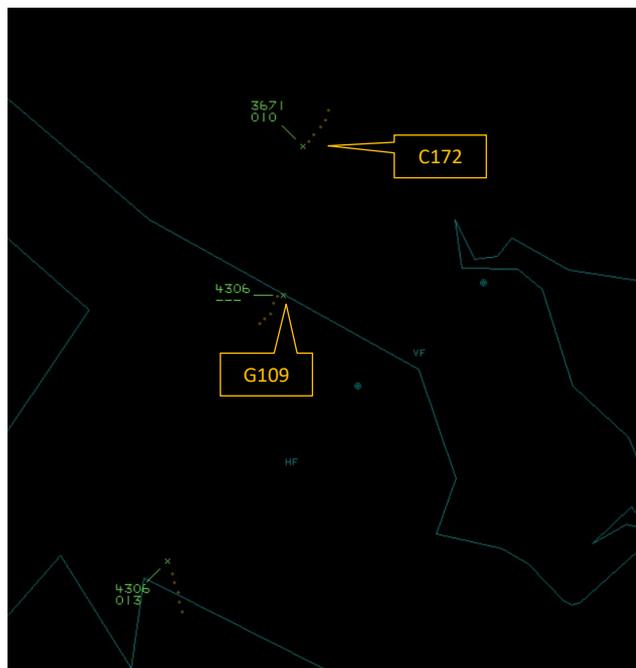
Figure 6 – 1144:05

At 1144:05 the pilot of the C172 reported “*about to turn right-base and not visual with the downwind traffic*” (Figure 6).

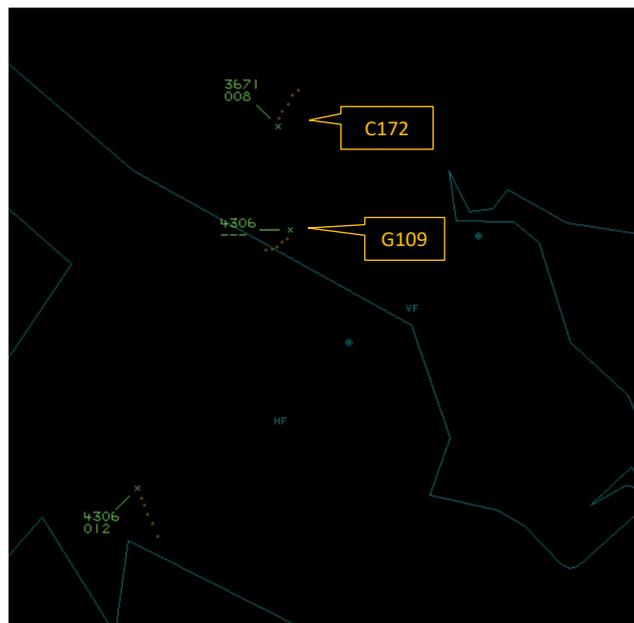
The AFISO replied “*roger, you’ll be looking out for a motor glider reported downwind*”. At 1144:21 the pilot of the G109 advised that they were “*going to orbit left and climb*” (Figure 7).

Figure 7 – 1144:21 (C172 1.2NM N of G109)

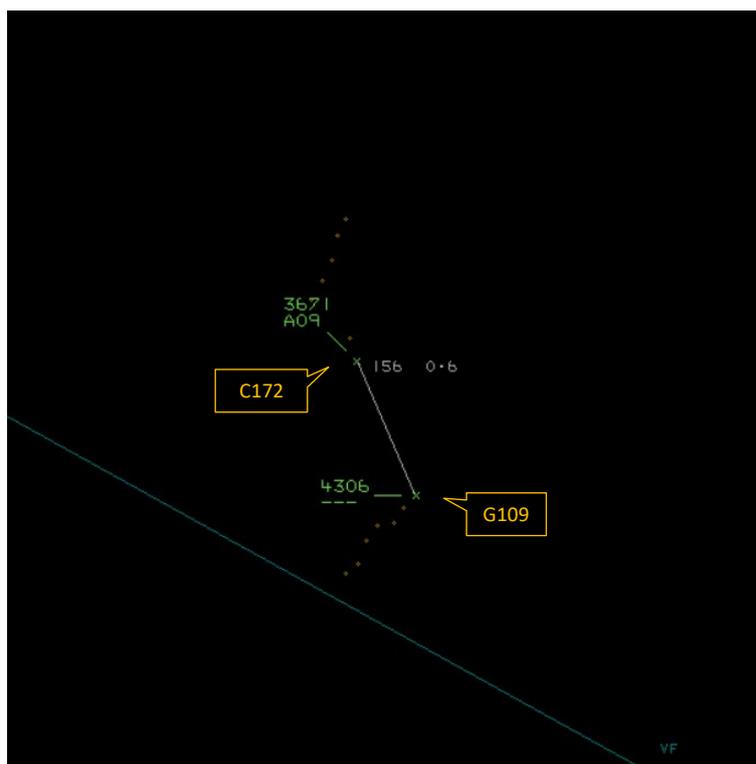
Figure 8 – 1144:32

Then at 1144:32 the pilot of the C172 advised that they were “base leg and now visual with the motor glider” (Figure 8).

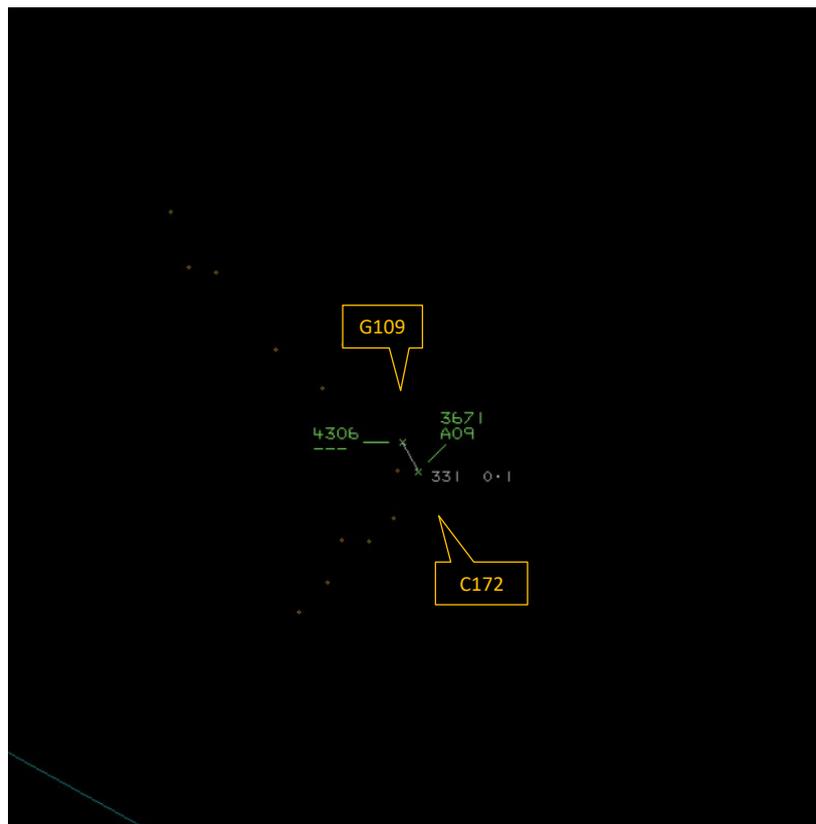
Figure 10 – 1144:55

According to the radar replay CPA occurred at 1144:55 (Figure 10).
